Penn State Berks

Campus Exterior Architectural Plan
July 2007

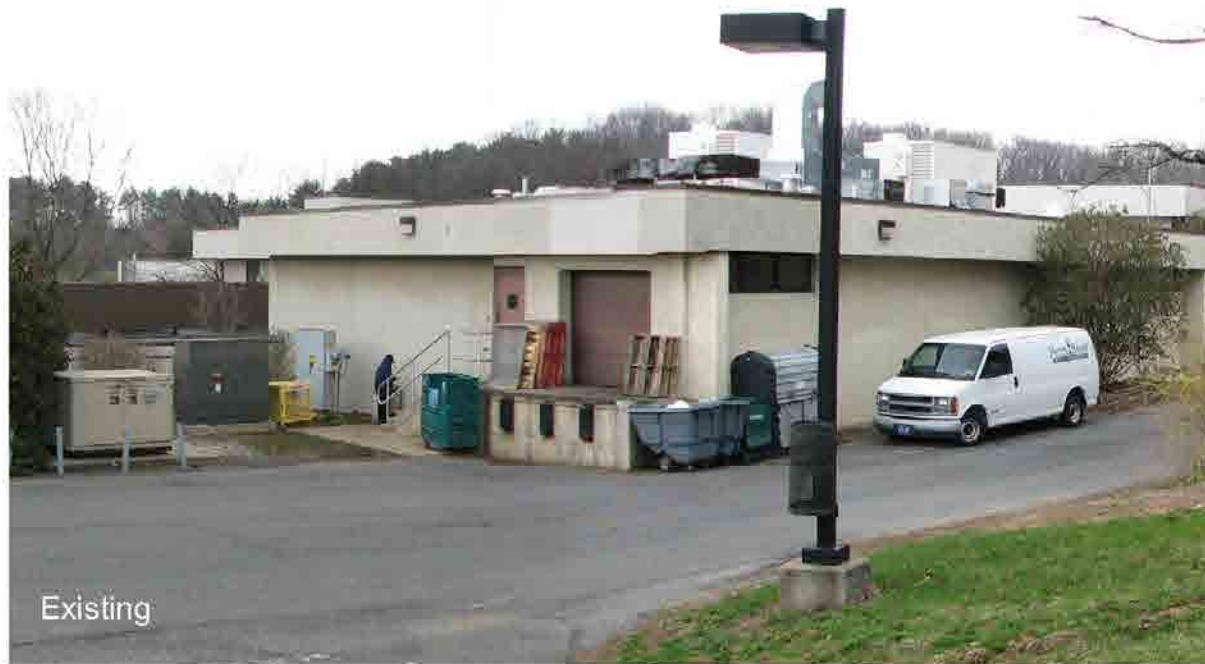
Perkins Service Area & Rooftop Mechanical Equipment

The service dock area at the southeast corner of the Perkins Student Center is located at the intersection of a primary pedestrian walkway between the academic core of campus and student housing. The rooftop mechanical equipment and loading dock are plainly visible to passers-by.

Recommend that the equipment be screened like other equipment on the west side of the building. In addition, a screen panel could be erected at the dock to hide other unsightly utility equipment as well as providing a place to store temporary delivery paraphernalia. The existing electrical transformer and building entrance doors should be painted to match the screen panel.

Screen roof top mechanical equipment

- Paint doors to match screen panels
- Store pallets and other dock equipment behind new screen panel
- Paint transformer to match

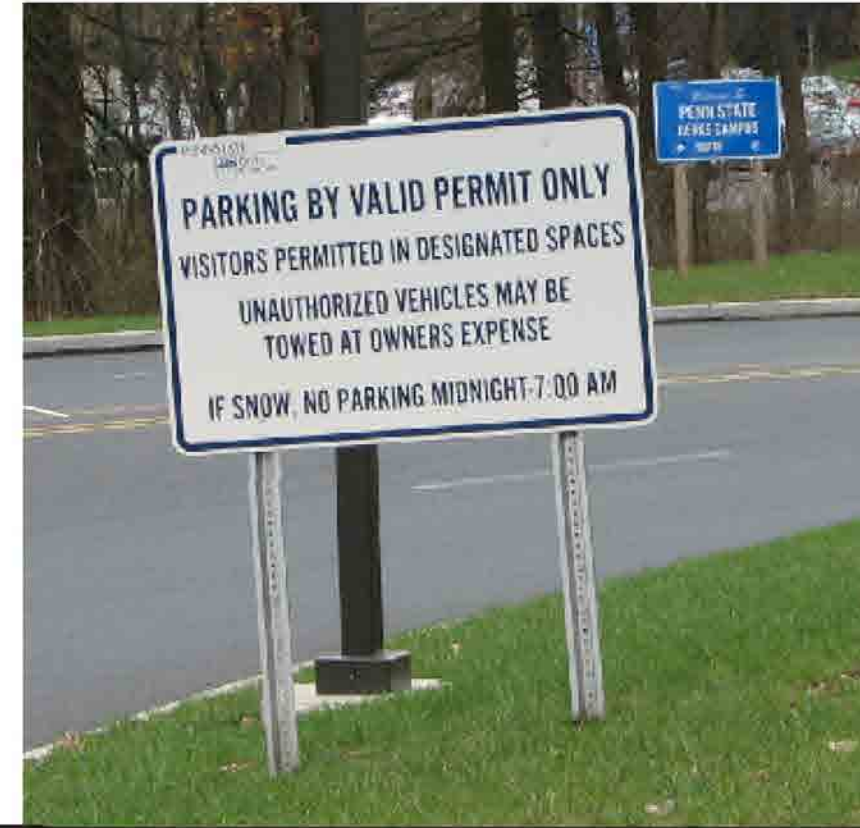
- Existing parking regulatory signage is difficult to interpret and may be unenforceable.
- Recommend a comprehensive parking lot signage upgrade to clearly delineate regulated areas.
- Parking regulation signs should be removed from primary campus entrances.
- Location, size and design of campus maps should be included in the signage assessment.

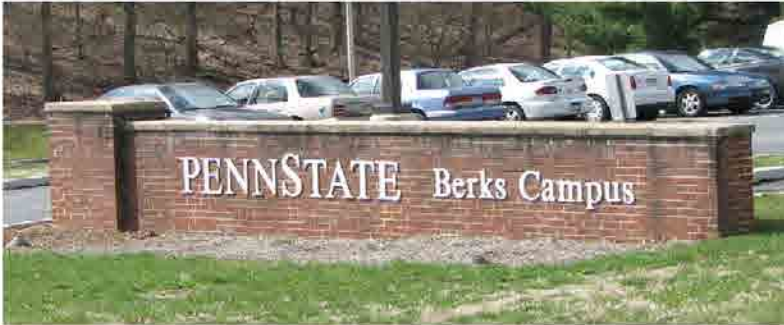
Existing Sign at Tulpehocken Road

The existing campus identification sign along Tulpehocken Road should be updated to reflect the campus signature mark. In addition the masonry should be cleaned and repaired as necessary.

Provide an appropriate ornamental landscape planting to visually enhance this entrance to campus.

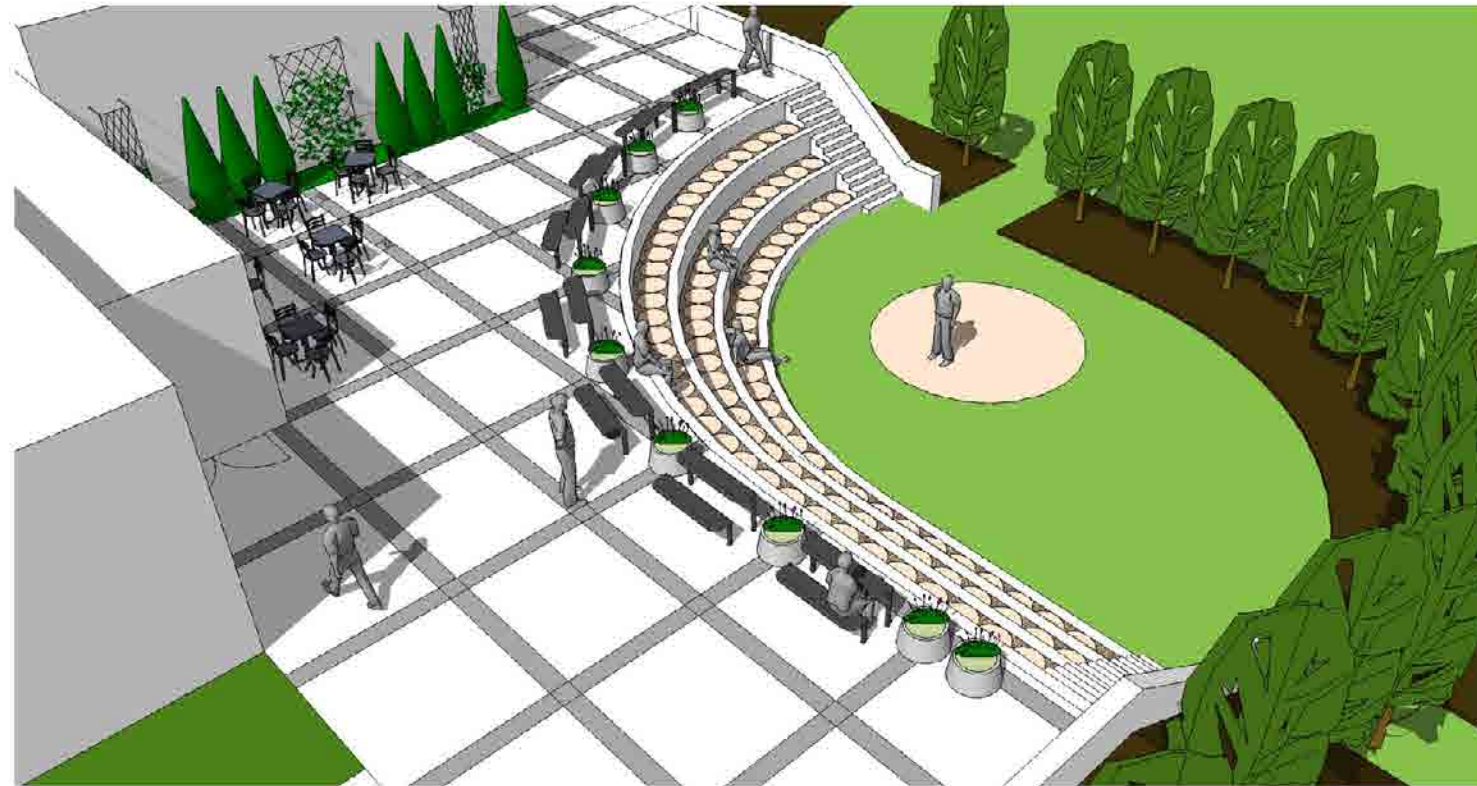
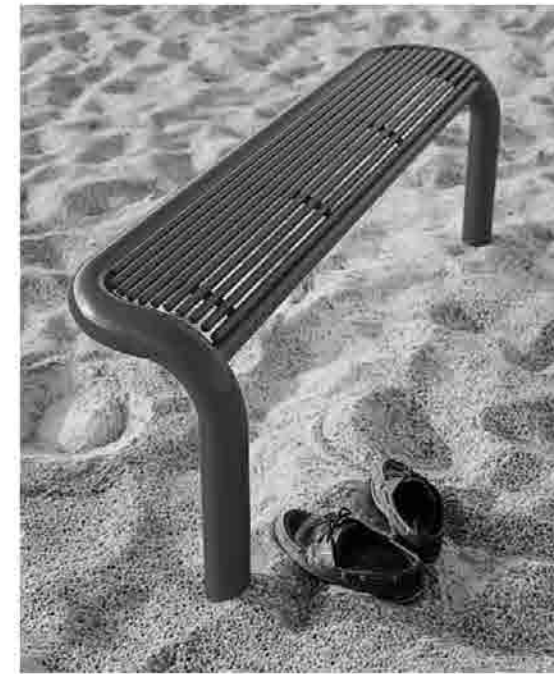
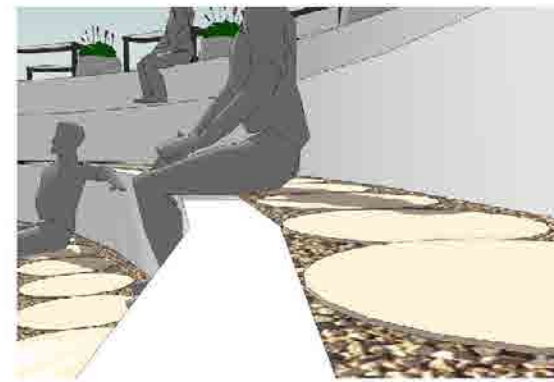
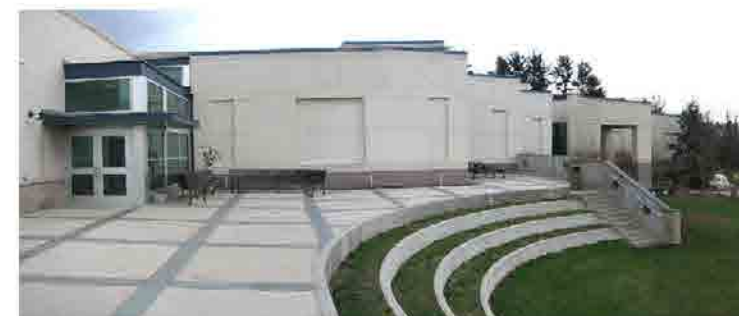
Franco Amphitheater

The existing amphitheater at Franco Building is uninviting and feels incomplete. There is minimal development of comfortable, usable seating. The terraced seat steps are turfed providing a poor quality seating surface.

The vertical drop at the uppermost edge of the amphitheater is unprotected which could result in a fall. Recommend the installation of bench seats with tables to provide the necessary barrier as well as usable seating.

Recommend the replacement of turf seat steps with a paver that will provide a clean, supportive surface for seating as well as eliminating a high maintenance surface.

The focal point of the amphitheater is undefined. Recommend the installation of a hard surfaced stage from which to entertain or instruct. A visual backdrop to the stage area is necessary to define the focus of the amphitheater.

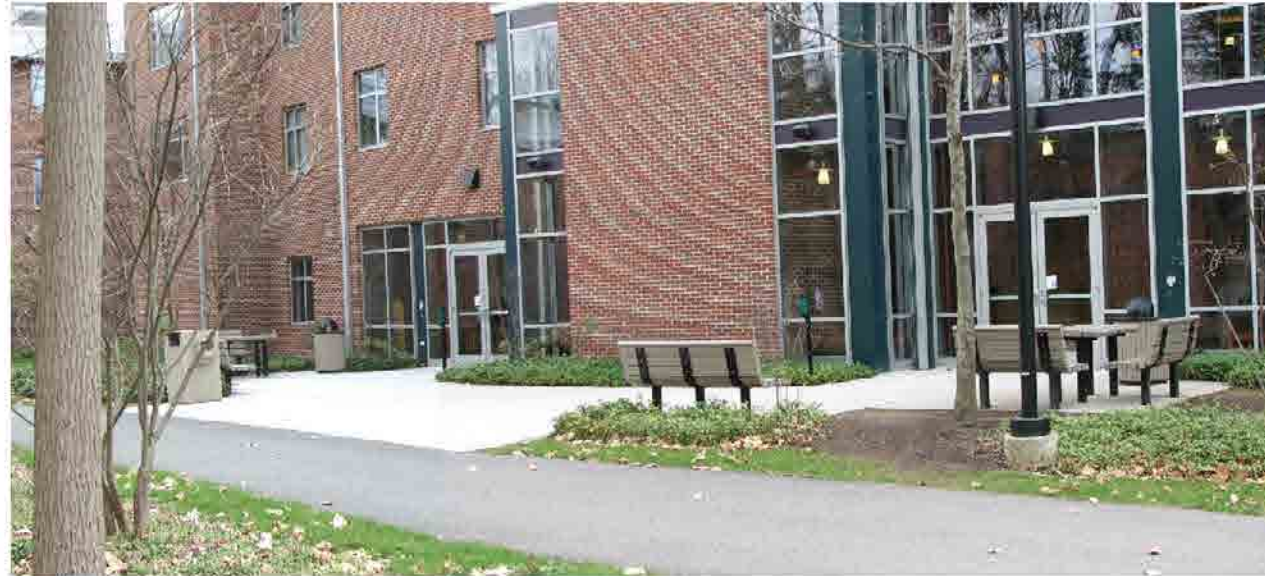
5E Post & Chain

Before - Pedestrian "desire lines" forming through landscape plantings

After - Place post and chain in strategic locations to discourage short cutting.

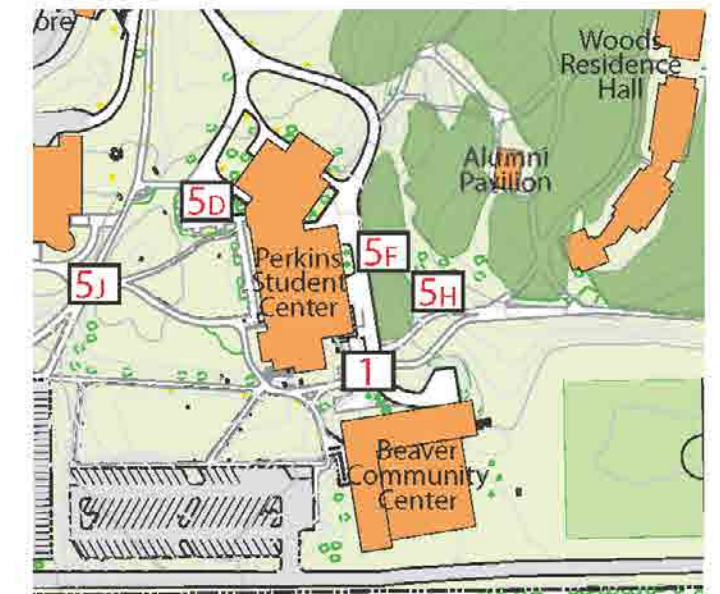
5F New Walkway

This primary access to the academic core from the housing area of campus is bisected by a service drive used to supply Perkins Student Center. Users have established a shortcut through the lawn.

Recommend the construction of a new walkway segment to connect the housing area to the rear of Perkins Student Center and beyond into campus. The connection will traverse a slope and tie into the existing drive opposite the northeast entrance to Perkins. Not only will this new connection make campus access more direct for some destinations but it will draw pedestrians away from the loading dock area where safety conflicts and aesthetic challenges exist.

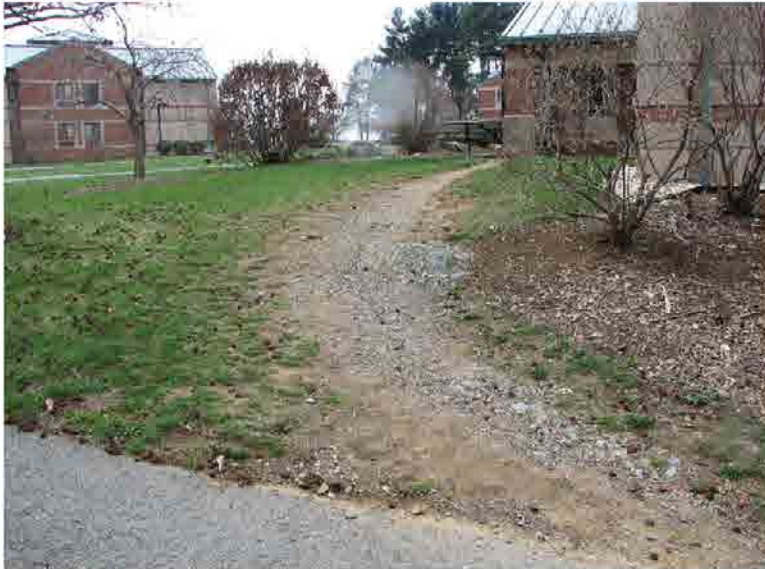
5G Walkway

The existing pedestrian circulation network between Greenbriar and Sage Halls inadequately accommodates movements between the commuter parking lot and core campus. It is recommended that a segment of walkway be constructed to eliminate the existing short-cut through the turf area.

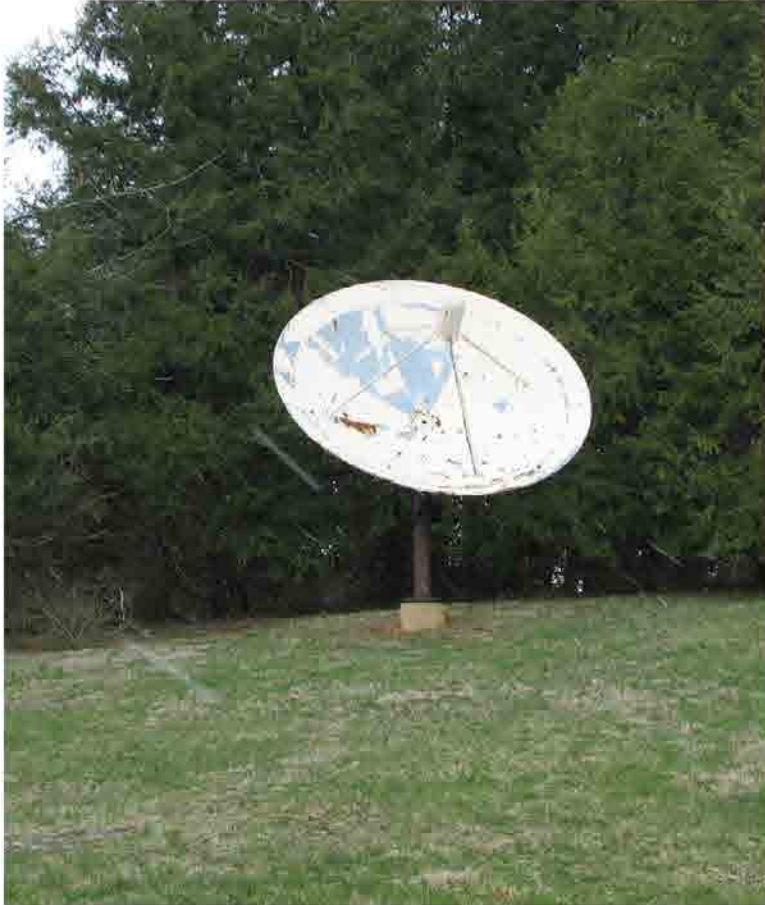
5H Dish Removal

The existing satellite dish located to the east of Perkins Student Center should be removed from the site.

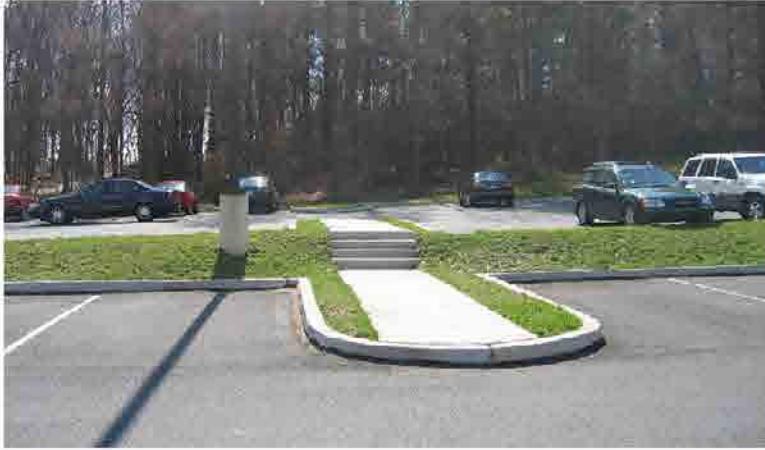
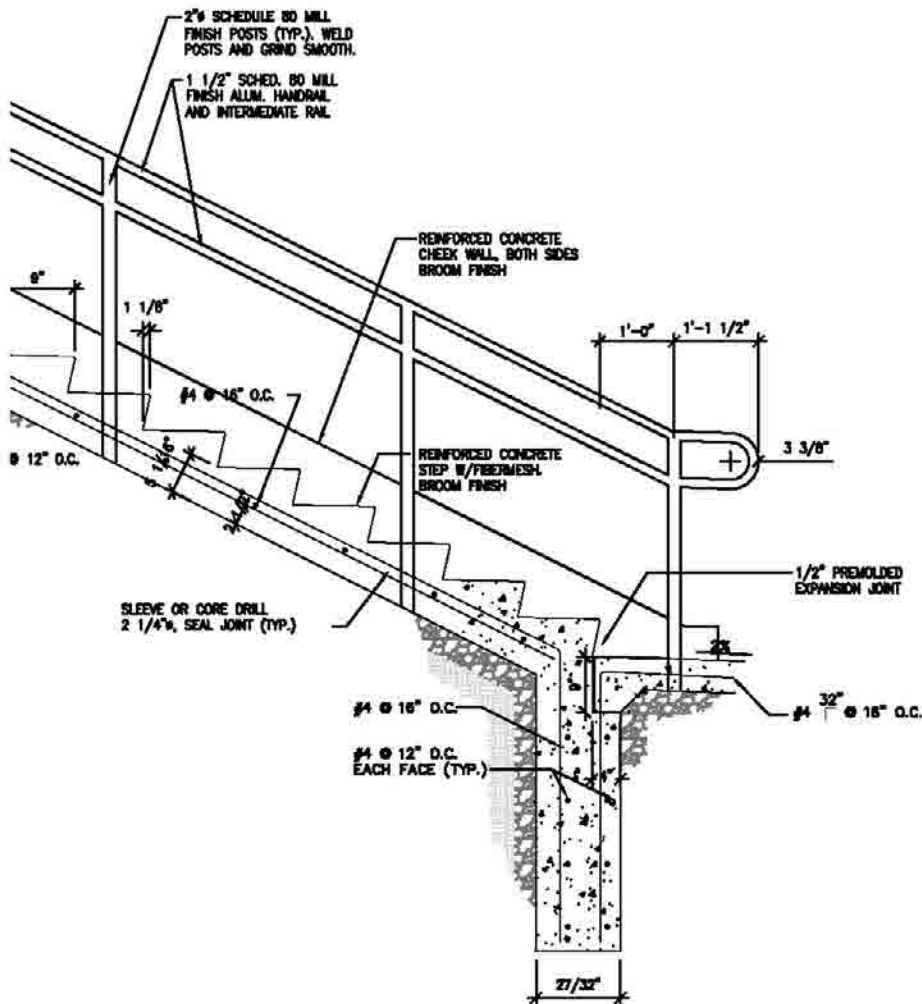
5I Handrail

The existing site steps in the commuter portion of the Handwerk Road parking lot do not have code required handrails in place. It is recommended that this deficiency be corrected.
