Penn State Schuylkill

Campus Exterior Architectural Plan
February 2009

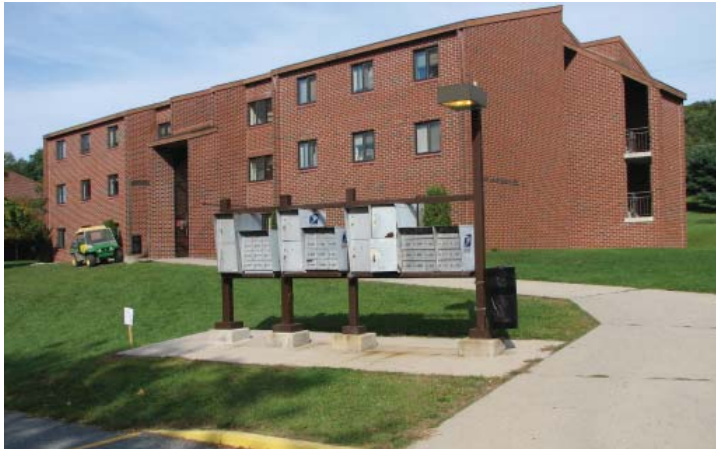
1B Replace Mailbox Kiosk

An opportunity exists to replace the worn and rusted mailbox kiosk at the Nittany Apartments with a new one designed as a double-sided complete unit.

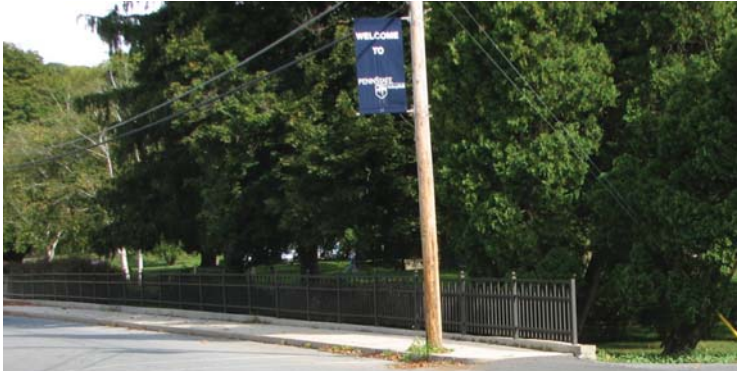
4B

Barberry is extensively used for hedging in the core of campus. Barberry forms dense stands in natural habitats and alters soil pH, nitrogen levels, and biological activity in the soil. Once established, barberry displaces native plants and reduces wildlife habitat and forage. The plant is spread into natural areas by birds that eat the plant berries. All barberry plants should be removed from campus and replaced, where necessary, with other forms of hedging and campus standard post and chain.

Hedges are unnecessary behind the fence along University Drive and need not be replaced.

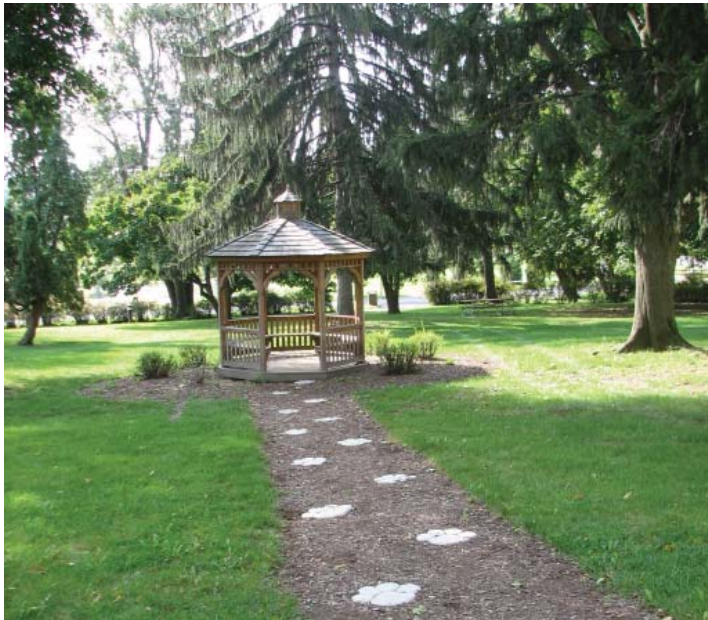
4E Gazebo Landscaping

Landscape plantings are sparse surrounding the gazebo and the wood chip path leading to it are not universally accessible. A compacted crushed stone path would maintain the rustic character of the context while providing a suitable surface for handicapped users.

The Penn State Dirt and Gravel Roads Studies "Trail Mix Specifications" should be used when specifying materials to assure a compact surface:

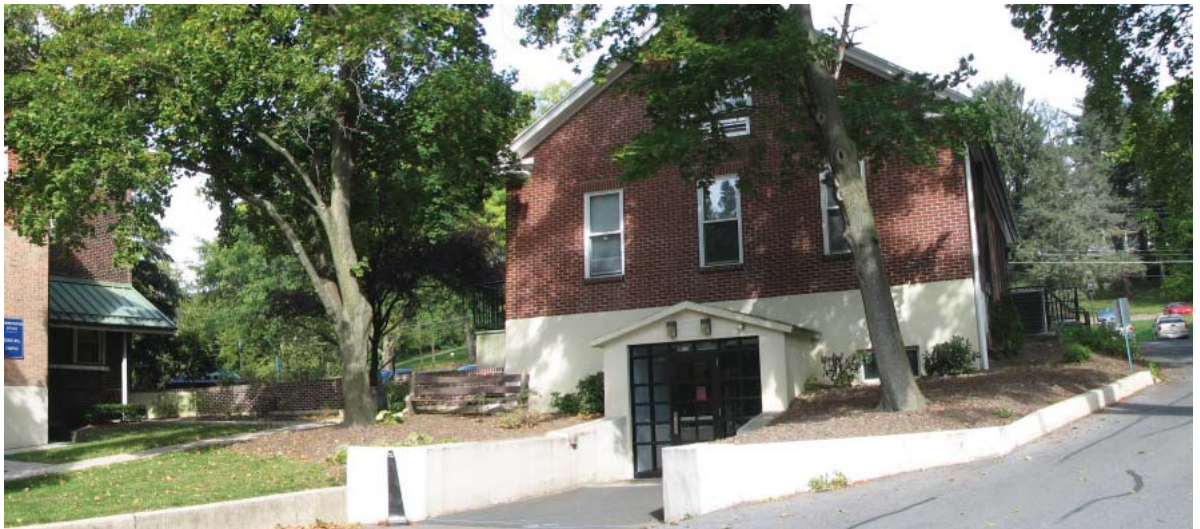
4G Landscape Business and Academic Services Building

Excessive mulch makes the mall side of the Business and Academic Building appear barren. The mulched beds should be planted with groundcover or turf at minimum. Shrubs would also ground the building to its site and soften the architectural transition from brick to foundation on this side of the building.

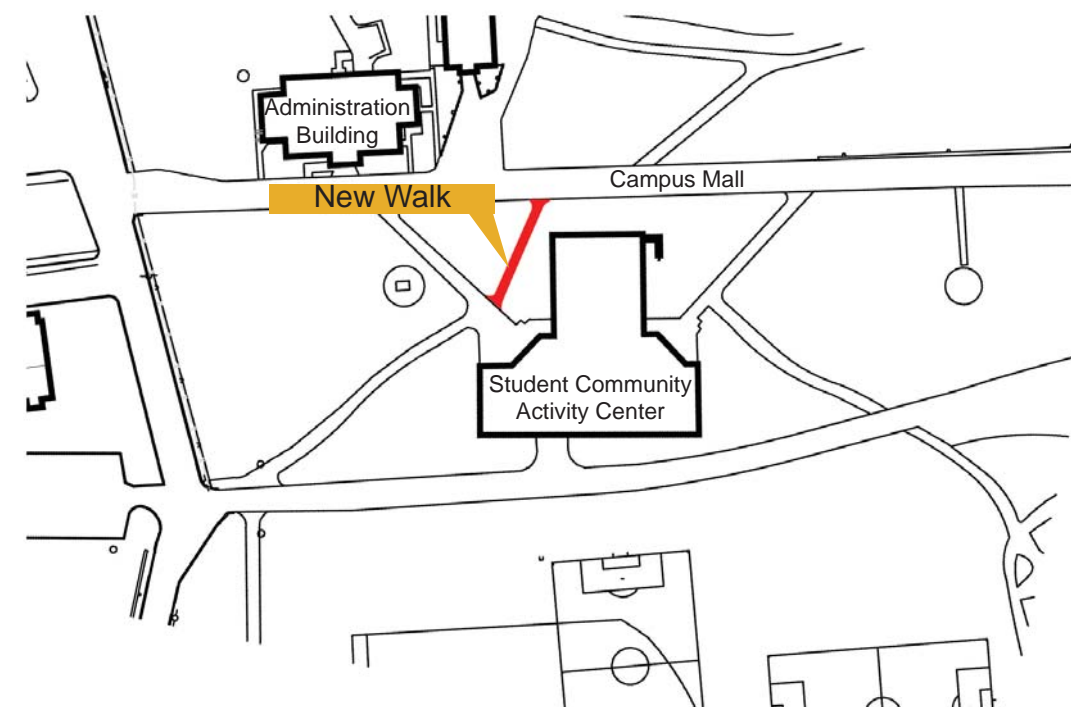
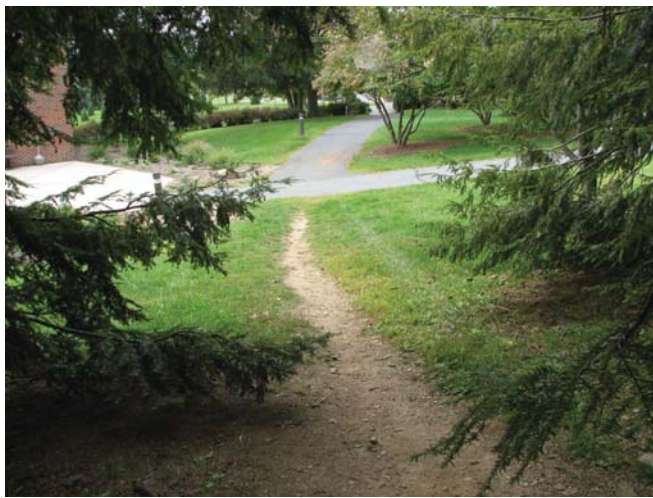
Pave Student Community Activity Center "Cowpath"

The existing pedestrian circulation network between the mall and the west entrance to the Student Community Activity Center inadequately accomodates movements between these two areas. It is recommended that a segment of walkway be constructed to eliminate the existing short-cut through the lawn. Stairs would be required to negotiate the existing grade change.

New concrete walk with stairs

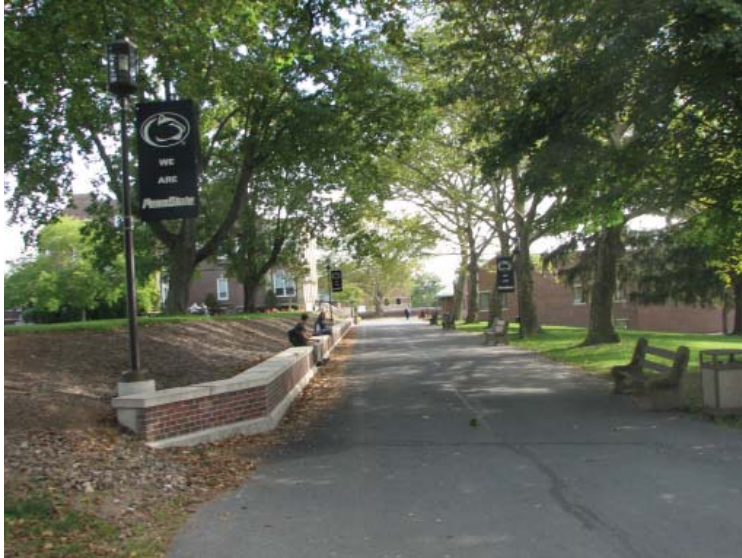
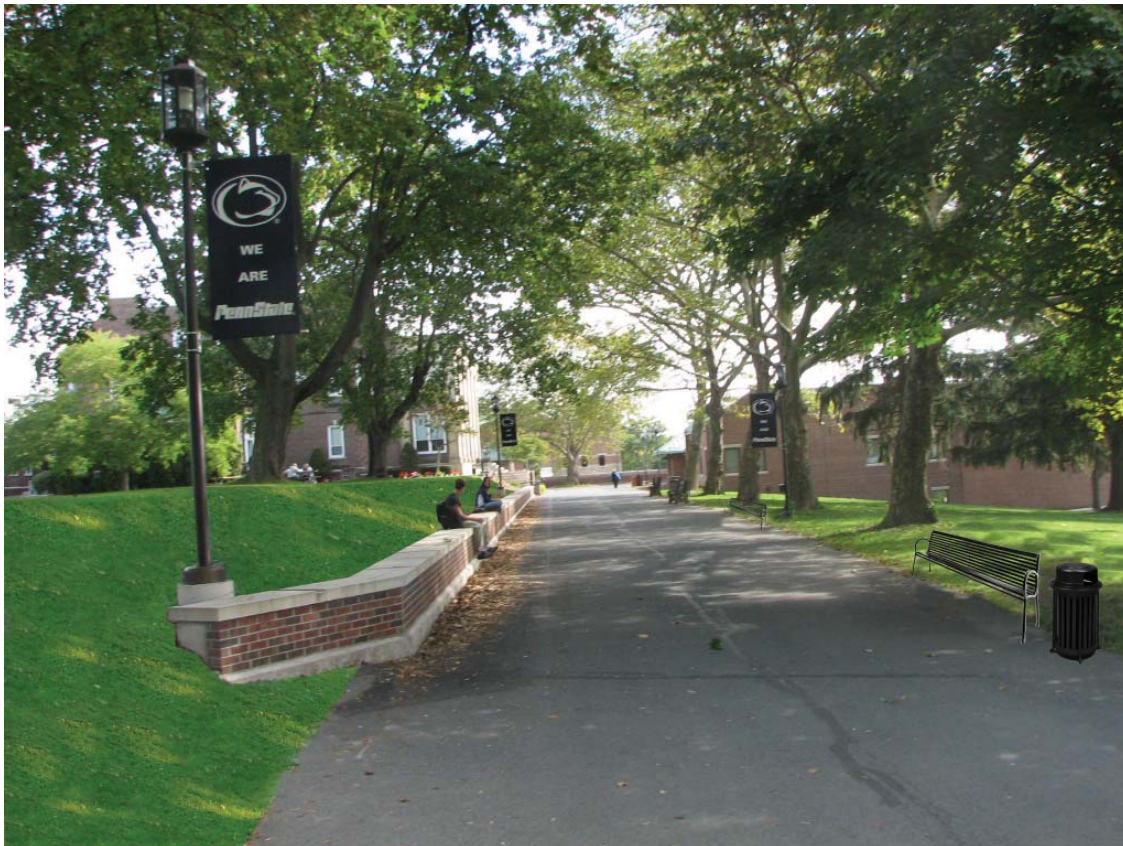
4K Seed Slope Along Mall

The mulched slope adjacent to the new retaining/seating wall along the mall appears incomplete in the landscape. Shrub and/or perennial plantings would probably be inappropriate for such a long stretch of bed.

Recommend the seeding of the slope with an appropriate grass to complete the transition from the campus green to the new seating wall.

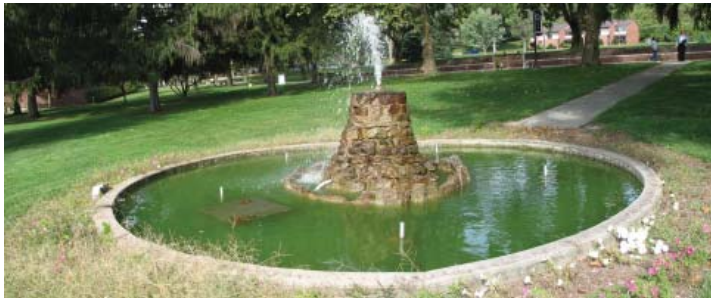
Fountain Landscaping

The existing fountain is a remnant from original property that was donated to the University in 1966. An opportunity exists to strengthen the visual impact of this central feature. A shallow layer of riverjack stone in the fountain pool to cover piping is suggested. A concrete walk surround is recommended as well as supplemental landscape plantings. Benches would accommodate users wishing to linger.

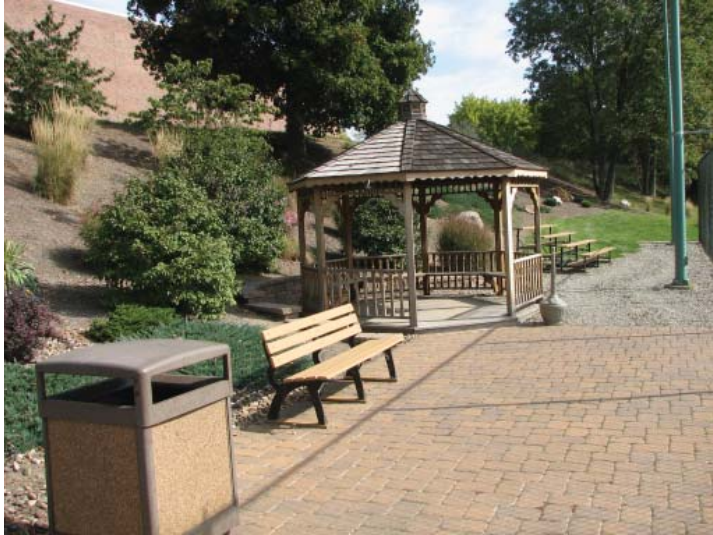
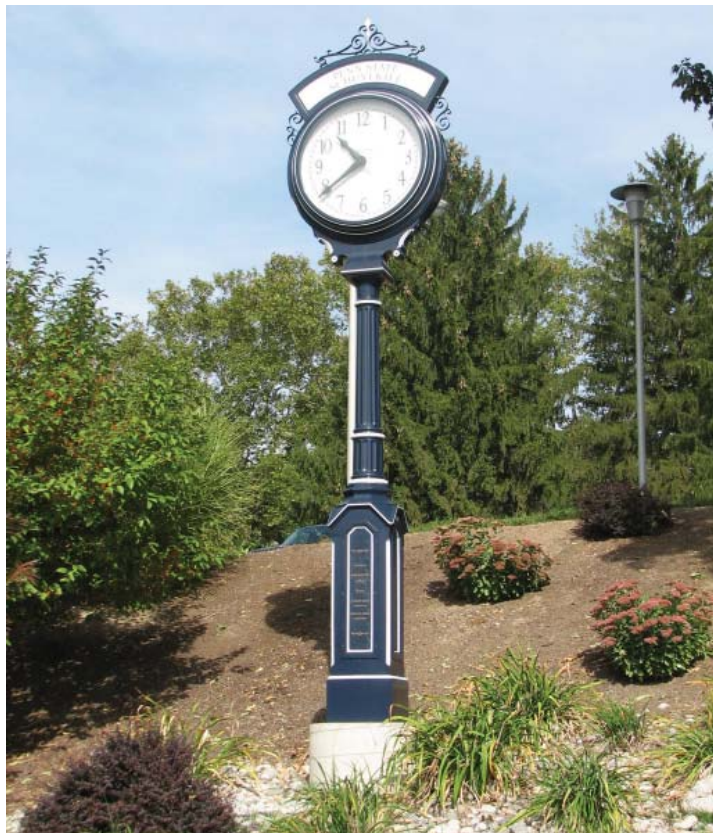
40 Tennis Court Slope

The slope to the north of the tennis courts would benefit from supplemental landscape plantings to fill the voids. Expanded use of “woody” shrubs and ground cover would eliminate expanses of bark mulch. It is recommended that a landscape architect review the existing scheme and develop a unified landscape plan.

Use of campus standard site furnishings would complete the aesthetic enhancement.

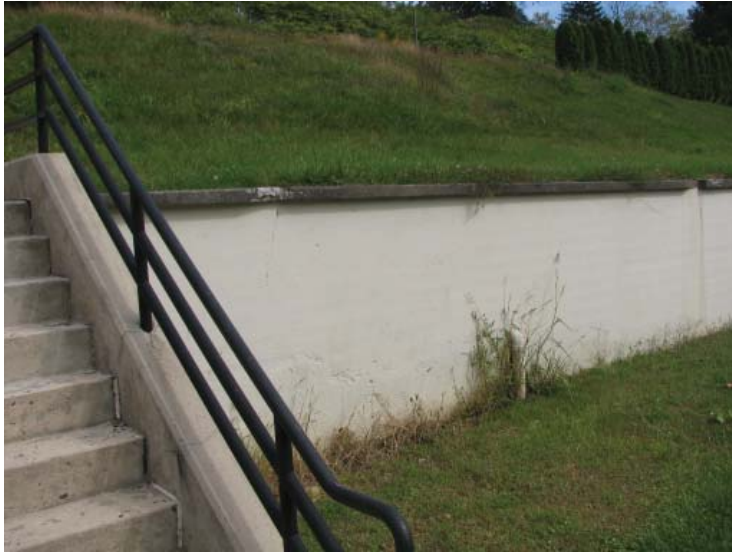
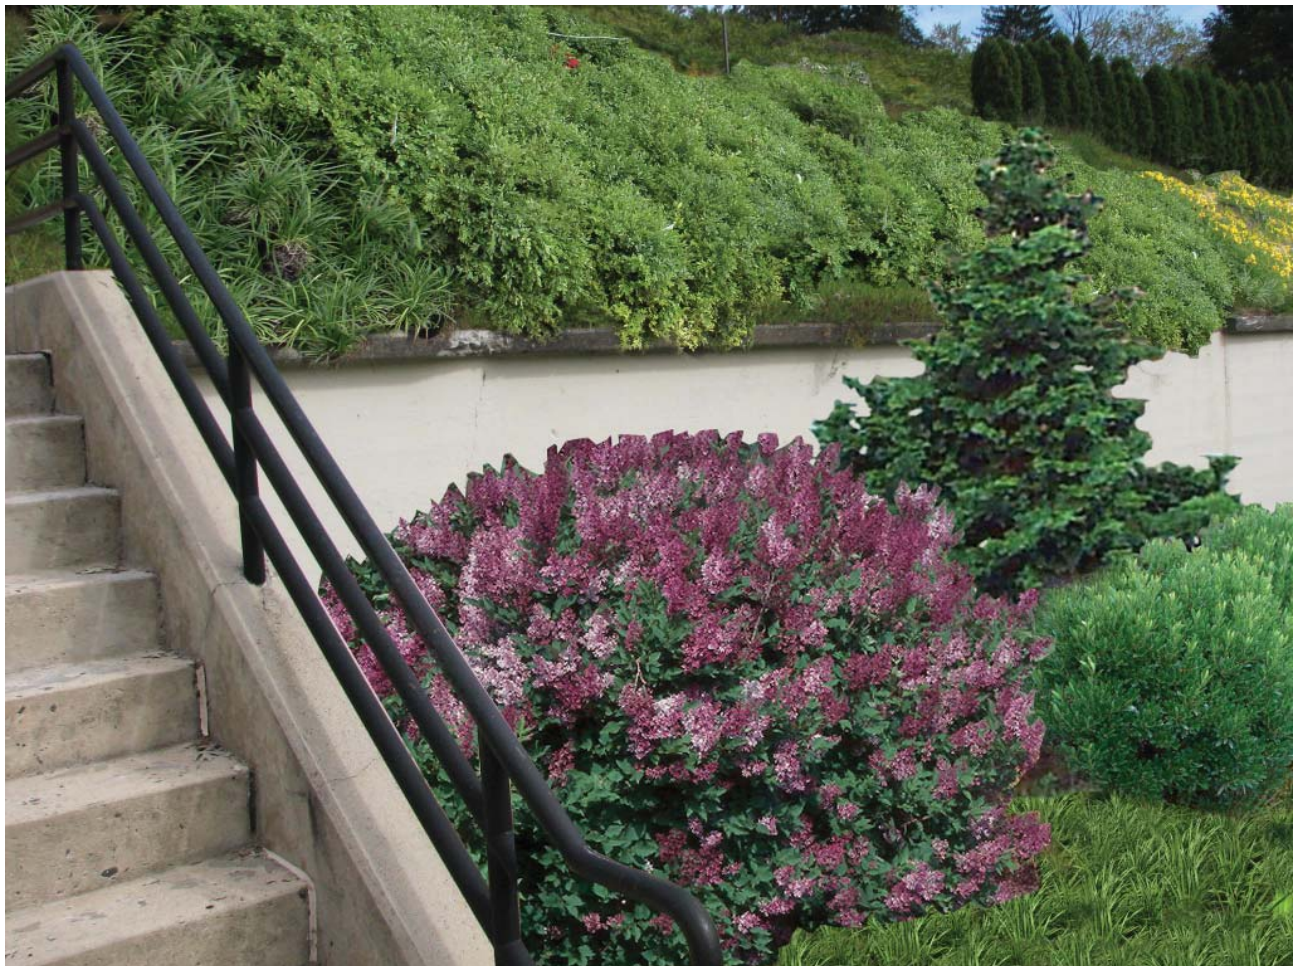
4P Steep Slope and Wall

The steep slope above the wall to the north of the Classroom Building parking should be planted with spreading groundcovers instead of lawn to minimize a potential falling hazard when mowing.

It is recommended that the strip of lawn in front of the wall be planted with shrubs and perennials to break up the visual monotony of the long painted wall

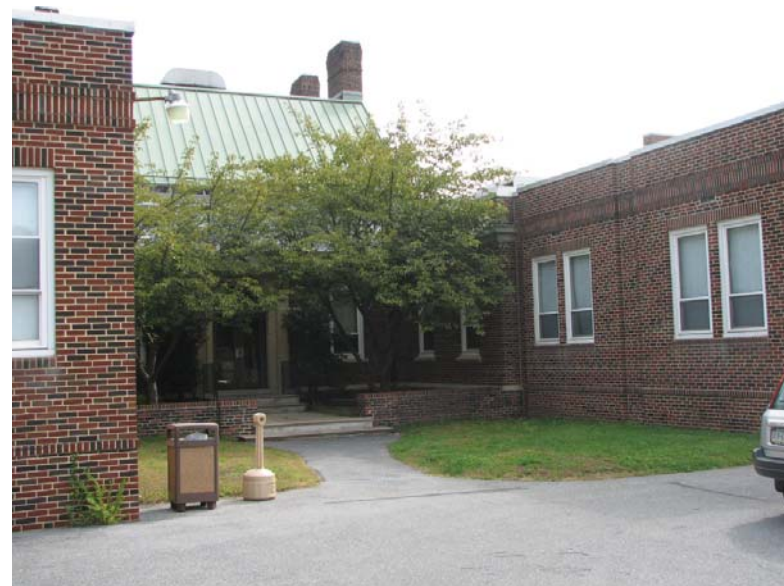
Classroom Building Landscape Improvements

The west frontage of the Classroom Building is convoluted and visually littered with utility units and service entrances. It would also benefit from separation from the parking lot. This boundary can be better defined by sidewalks and hedging. There is ample space to pull this boundary away from the building to create space for tree and shrub plantings along the building frontage. This would also help to camouflage the utility and service areas surrounding the building.

The path that leads to the main west entrance should be straightened and paved with concrete. It is recommended that all proposed sidewalks be concrete, not asphalt.

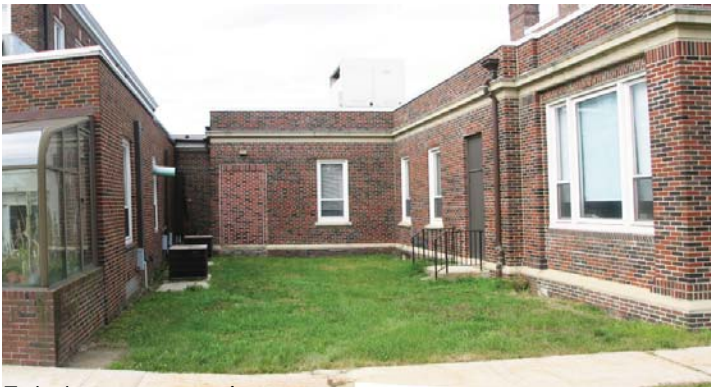
4R

The east frontage of the Classroom Building is punctuated by an undeveloped courtyard space containing AC units and a secondary entrance into the building. An opportunity exists to create an intimate seating space while structurally unifying the “missing tooth” in the building frontage with hedges.

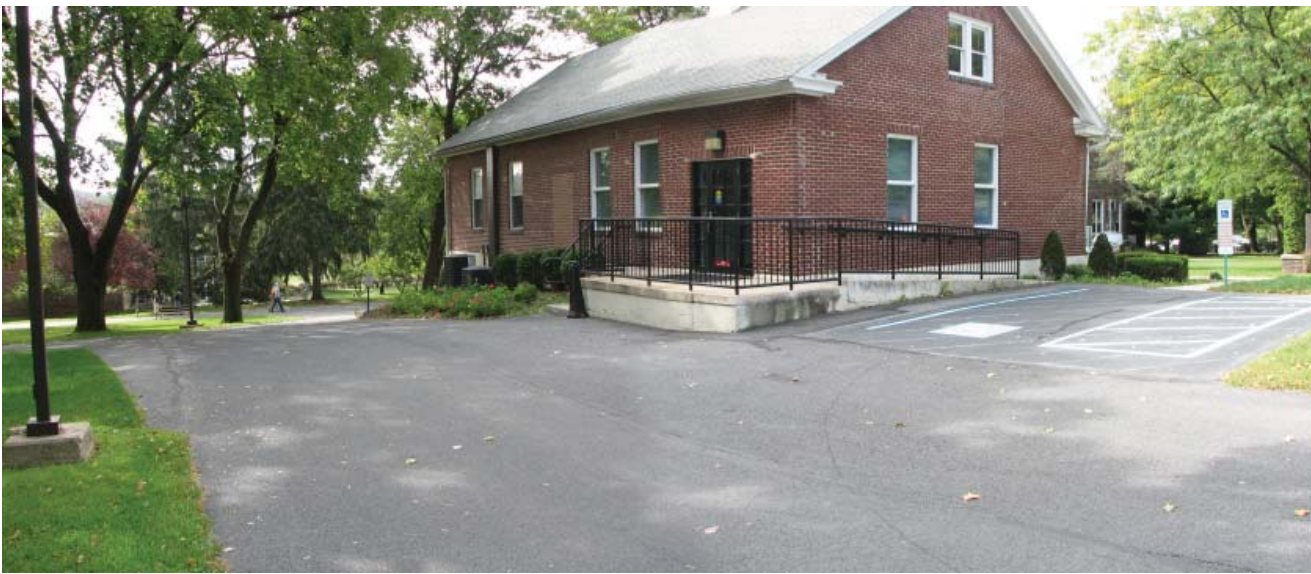
5c

Excess pavement contributes to excess water runoff and solar heat island effect.

The opportunity exists to reduce pavement. A minor vehicular cartway need be no more than 11' in width. The "after" photo below also shows a repaired and cleaned accessible ramp.
