Penn State

University Park Campus

Stormwater Guidance, Policies, and Master Plan

Latest Revision
December 2016

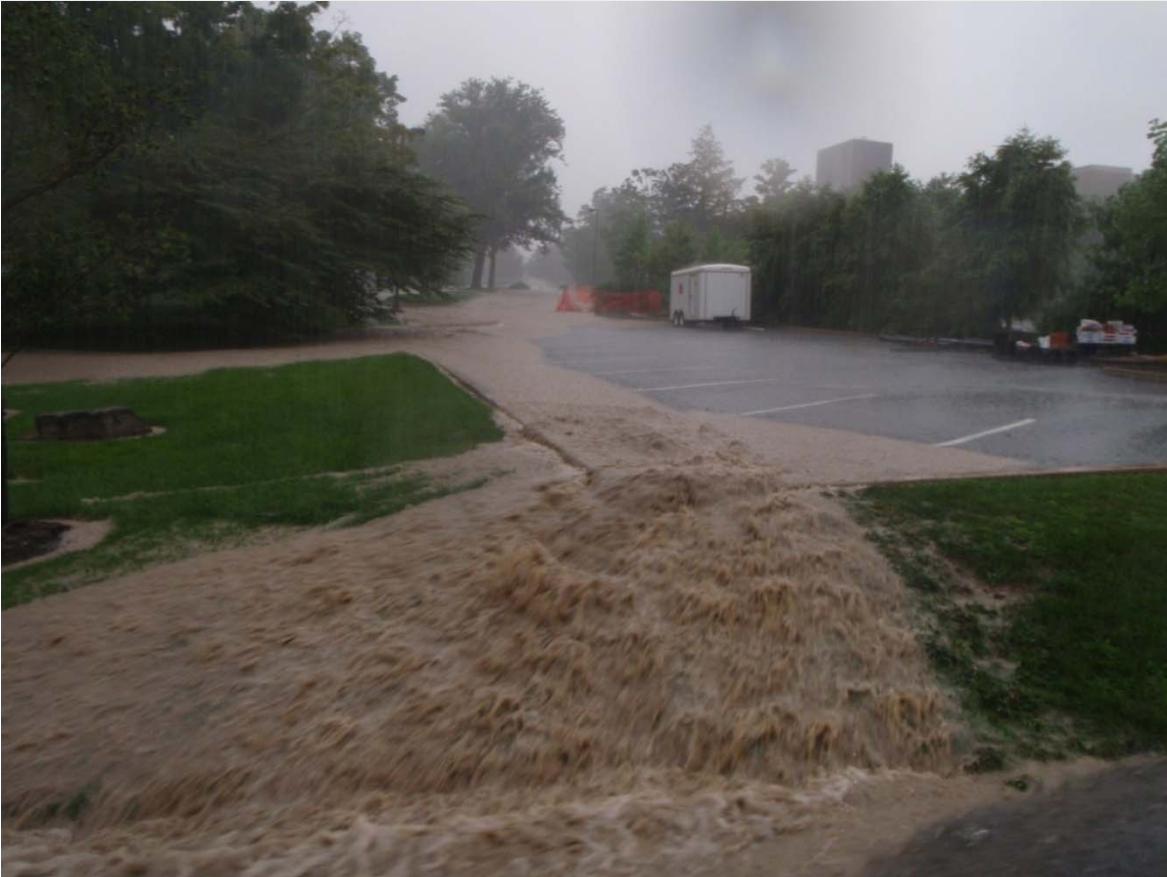
Figure 4.b. Case 1 Type Flooding along Bigler Road

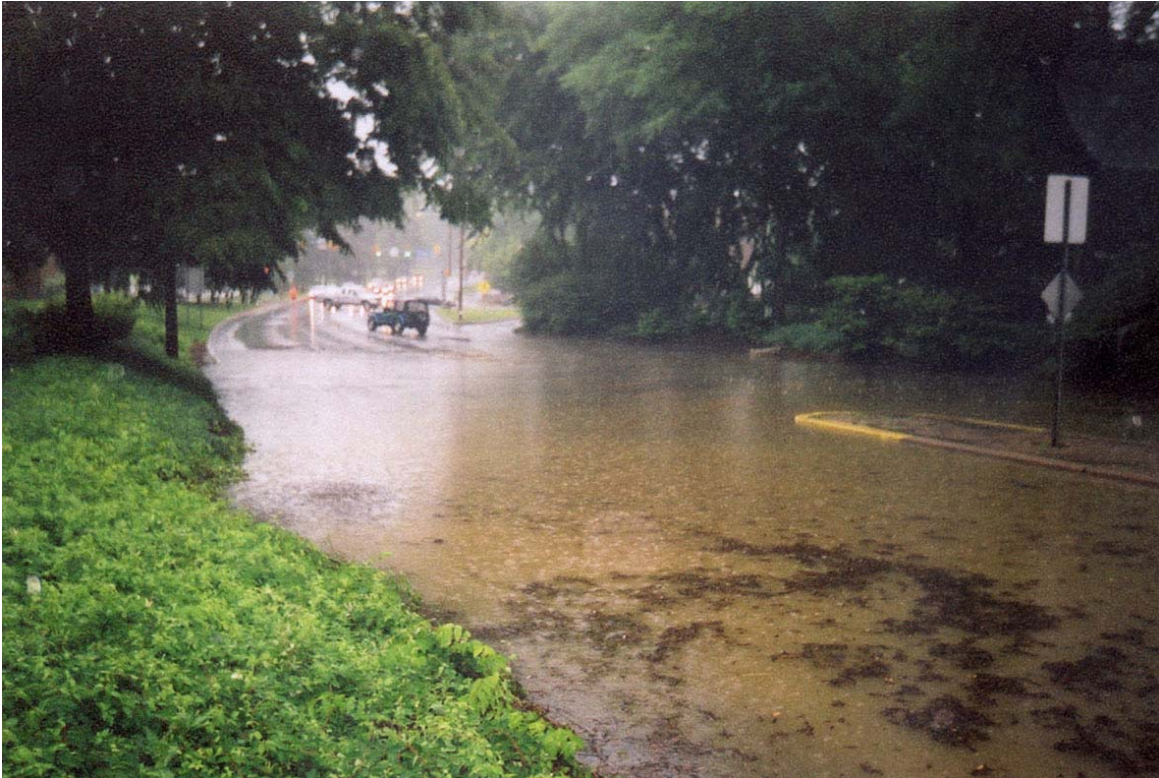
Figure 4.c. Case 2 Type Flooding along Atherton Street

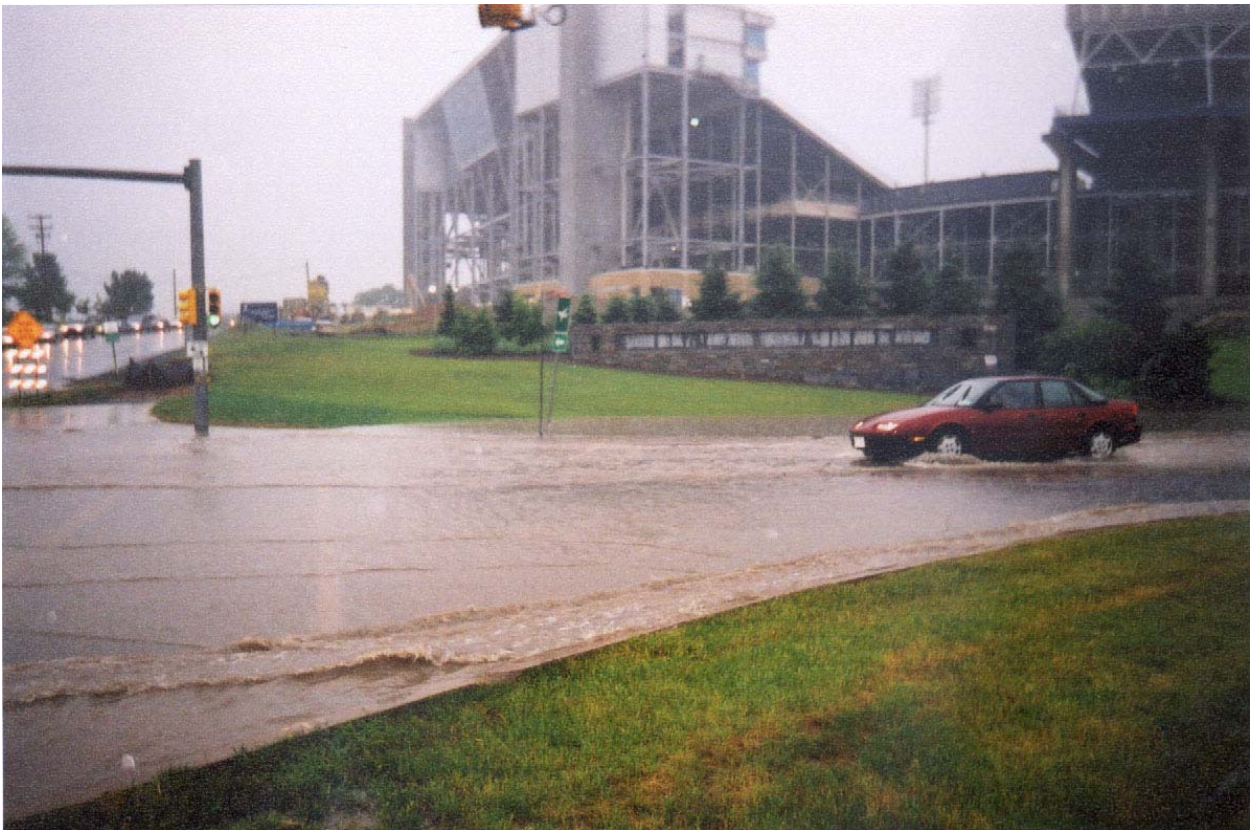
Prior to 2002, the intersection of Park Avenue and Fox Hollow Road flooded frequently during high intensity rainfall events as seen in Figure 4.h. The University Installed over 2,100 lf of 42” storm drain piping in conjunction with a \$3,000,000 storm drain project downstream, which included water quality, and quantity controls. In 2003, Phase 3 of this project repaired and replaced the 10 ft wide and 8 feet deep eroded gully below the Office of Physical Plant (OPP) and Fleet Services, which can be seen in Figure 4.i.

Figure 4.h. Flooding of the Intersection of Fox Hollow Road and Park Avenue

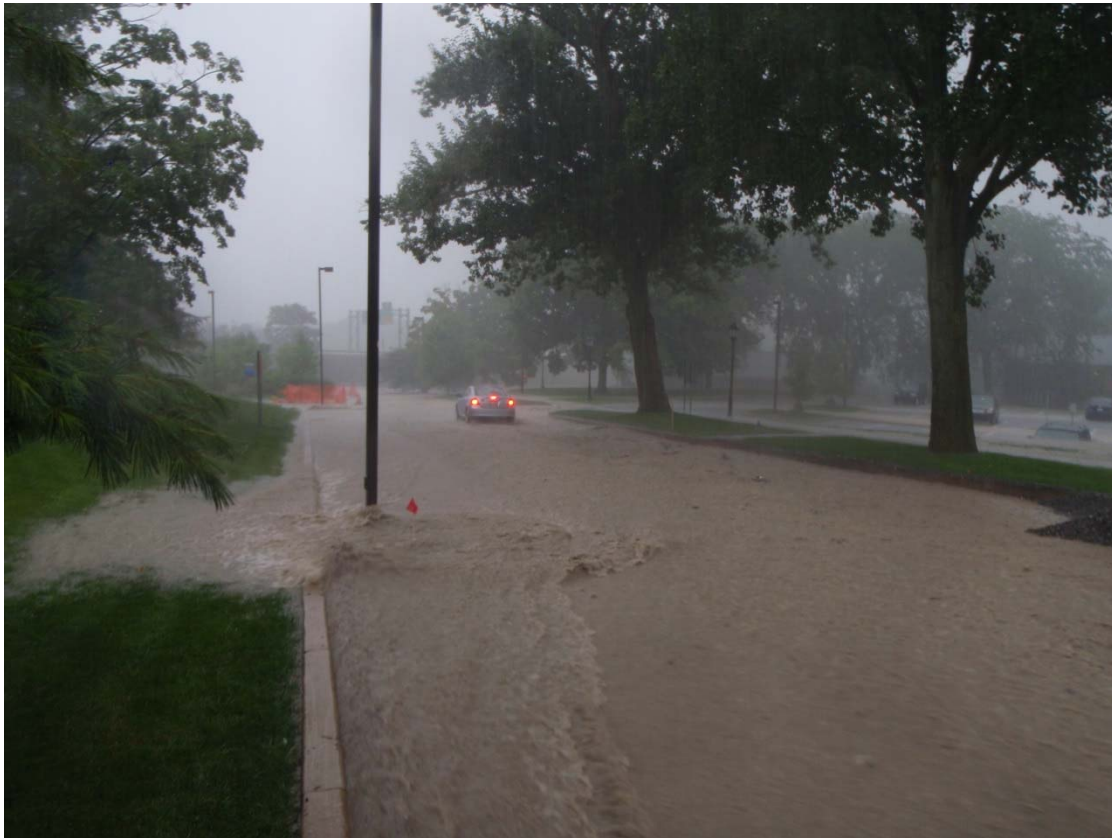
In 2015, the University installed approximately 1,000 lf of 42" and 48" storm drains to remedy flooding along the lower portion of Bigler Road, which was a significant life safety issue as seen in Figure 4.j. It's anticipated that the second Phase of the project will continue up McKean Road extension going towards East Area Locker Room.

Figure 4.j. Flooding of Lower Bigler Road

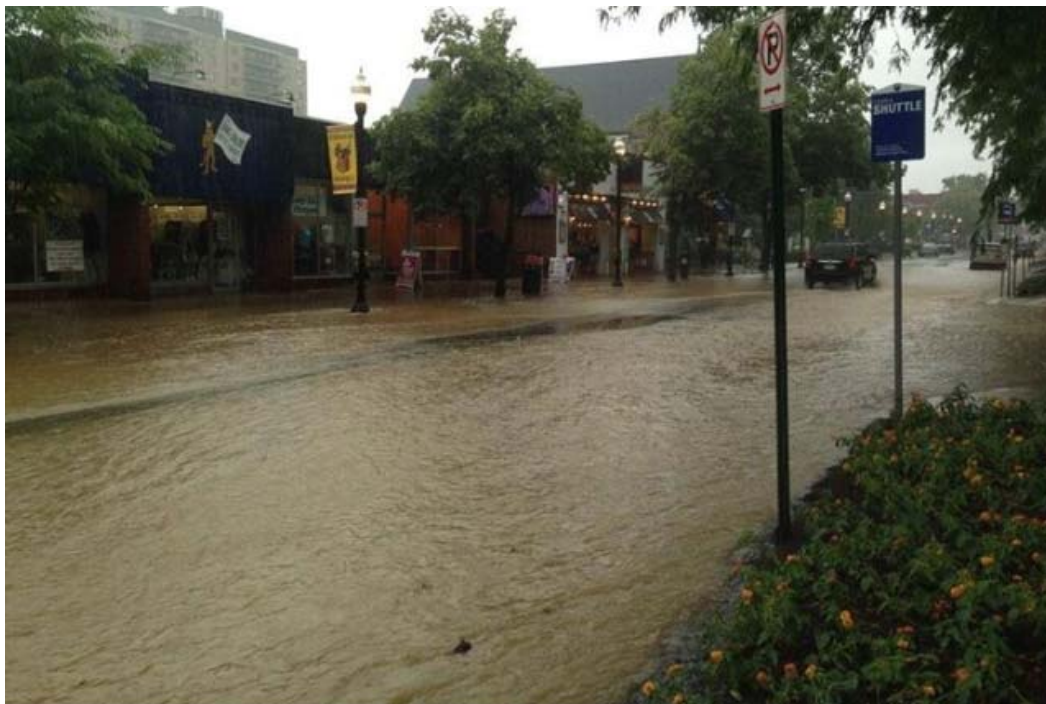
Occasionally, there's flooding along College Avenue and Calder Alley during larger runoff events (refer to Figure 6.c). The June 27th 2013 event seen in the figure resulted from 3.38" of rainfall, of which 2.05" fell in one hour (recorded by the Walker Building Weather Station), which is approximately equivalent to a 25-year IDF rainfall event. During these types of events, bypass from the Main Campus Basin can occur.

Figure 6.c. Flooding Along College Ave on June 27th, 2013
Section 6-2

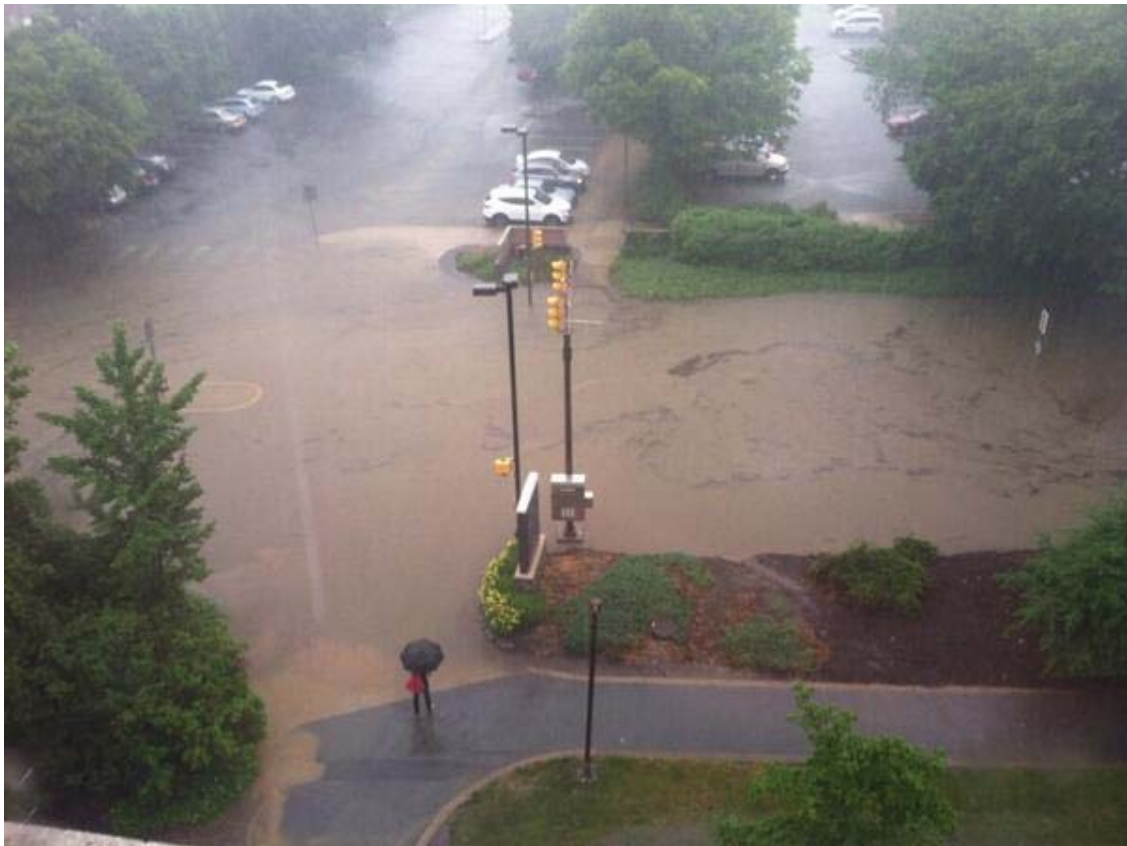
Prior to the construction of the IST building, parts of Campus on the east side of Atherton Street drained to the west side and then to the 24" under the road. This issue was fixed by the University during the IST Building construction, but today the roadway still floods approximately two or three times a year during high intensity rainfall events. Increasing the 24" pipe size is impossible and prohibited by the University because of existing downstream flooding.

Figure 6.k. Atherton Street Flooding viewed from Walker Building

While the downstream conveyance systems are already taxed; and therefore, pipes logically cannot be increased to push flooding safely downstream, PennDOT is currently conducting stormwater conveyance improvements along Atherton Street. Until such a time, no University efforts should be conducted. The possible solutions are to provide detention storage somewhere instead of on the roadway, remove large amounts of imperviousness, or divert runoff to the West Campus Watershed. Retrofitting the entire area with green practices or attempting stormwater reuse for extreme event control is unpractical in this area. Therefore, the only viable option is to provide subsurface detention storage, which would need to be located in multiple areas most likely under the parking areas. This can be done when the area is redeveloped or when the northern parking lot is repaved. Projects could be done in phases controls on the north or south sides are not dependent on each other.

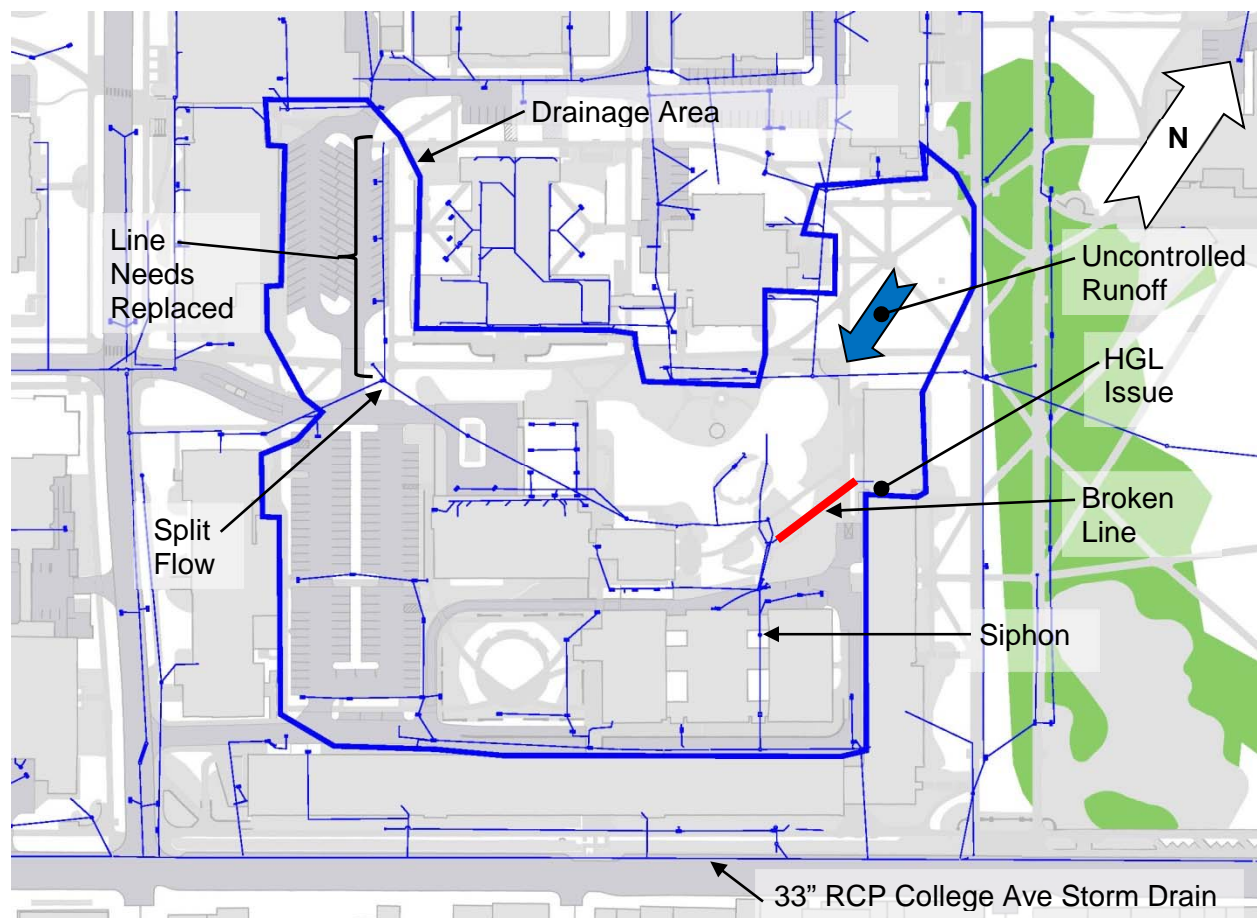
In 2013, the University attempted to develop designs to route a new storm drain on the west side of the Sackett Building towards the 33" RCP in College Ave, thereby bypassing the siphon and the broken line. It was determined that too many utilities (electric and telecom, etc.) were in the way physically preventing such a route. In 2015 a sump pump was also installed inside the door at the bottom of the stairwell, which is flooding.

Figure 6.n. Stormwater Issues Around the Sackett Building

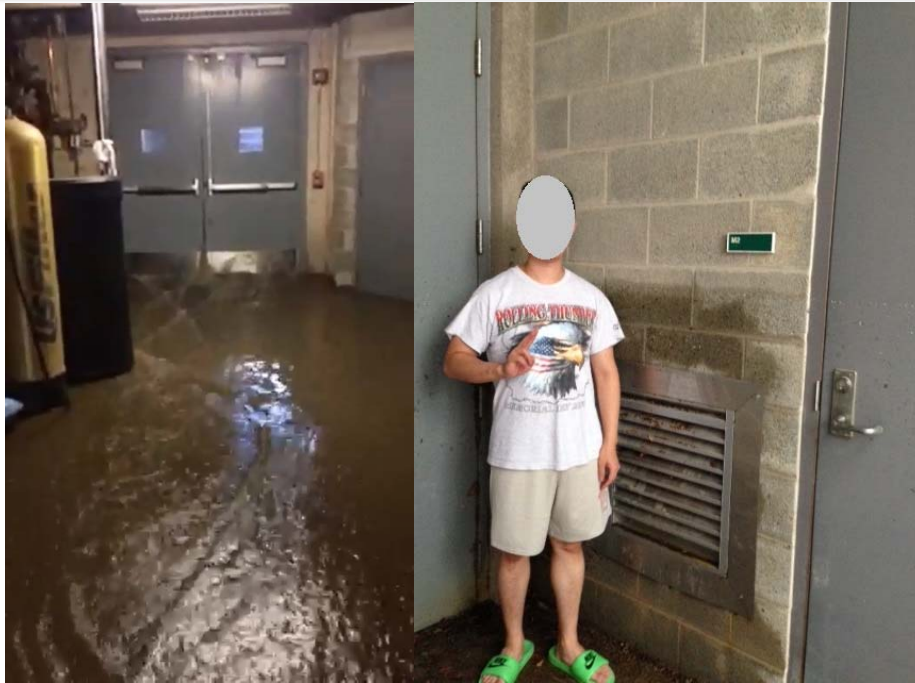
Figure 6.p. Flooding at Chandlee Lab on 8/3/2014

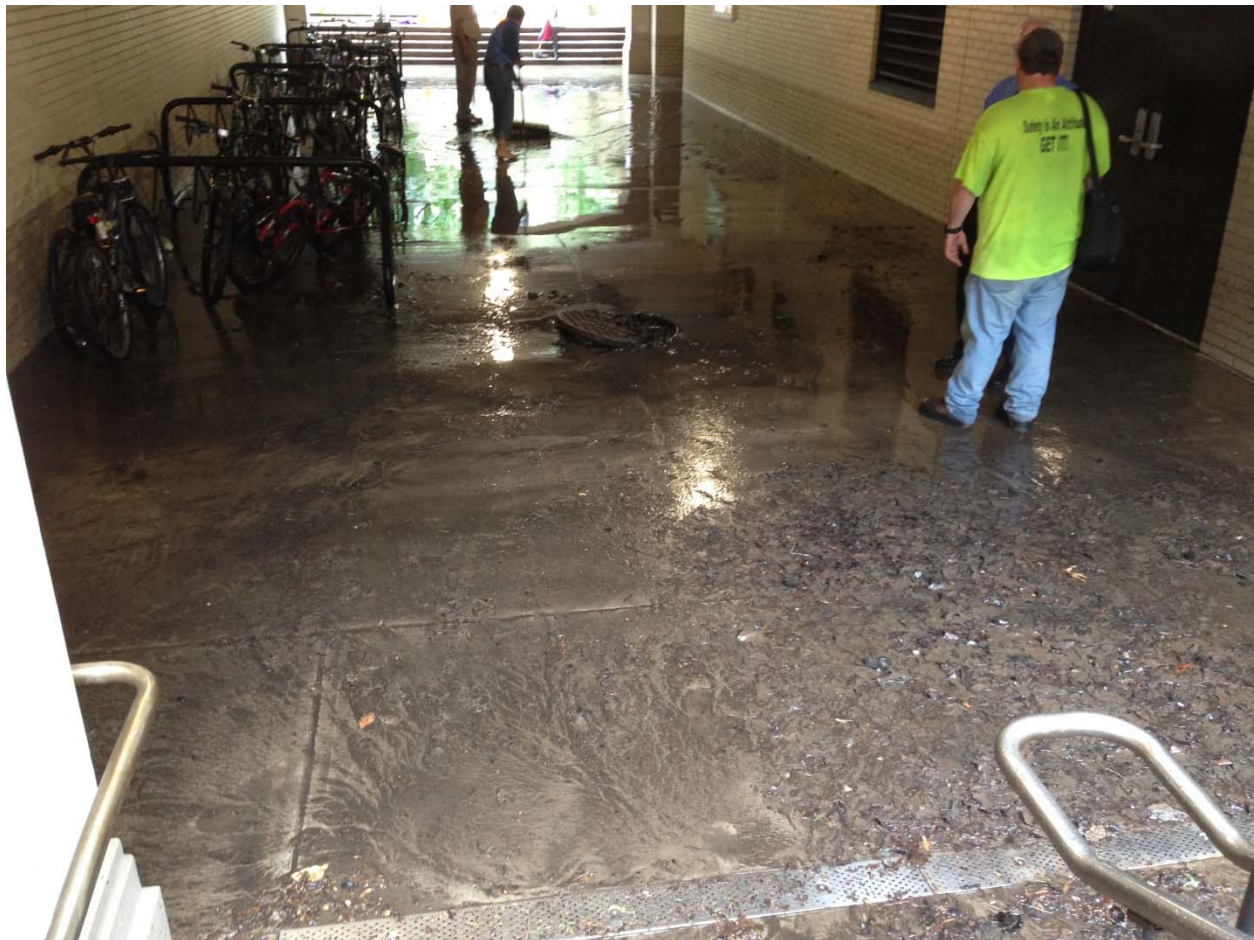
Figure 6.q. The Pattee Tunnel after Flooding 2 feet Deep on 6/25/2014

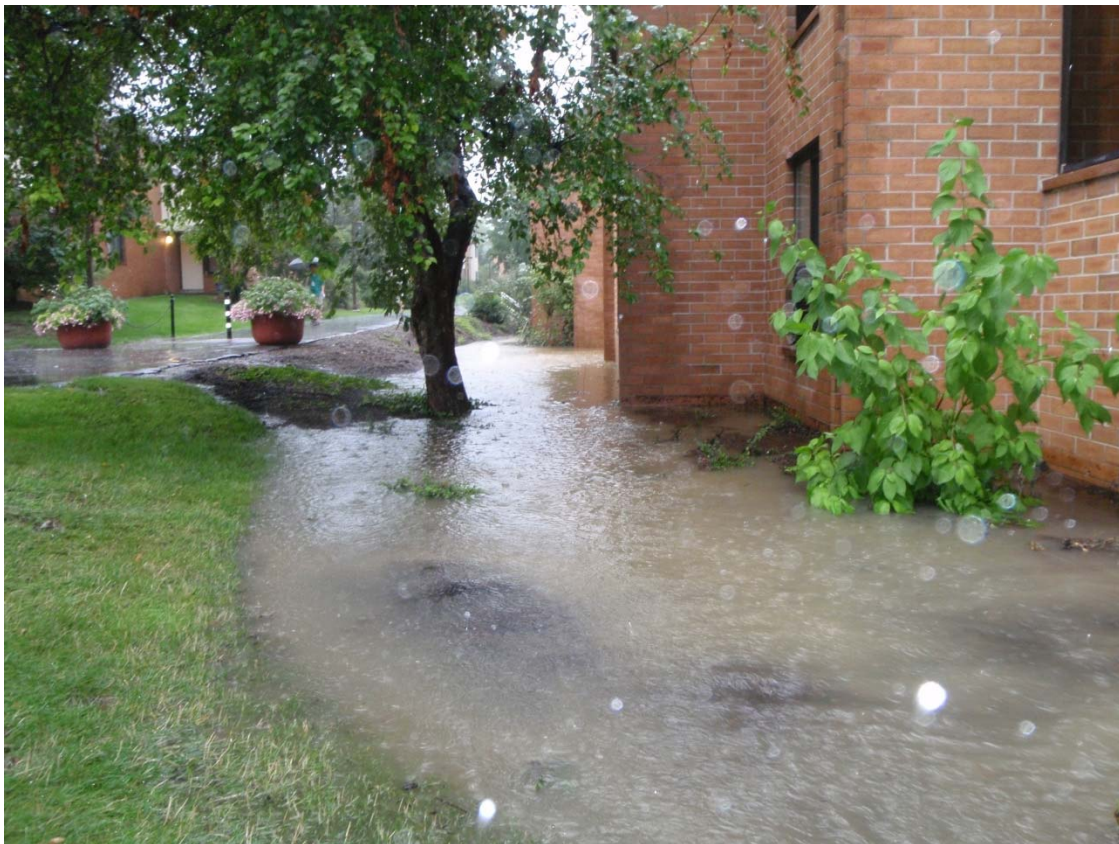
Figure 6.w. Flooding Along the North Side of Nittany 60

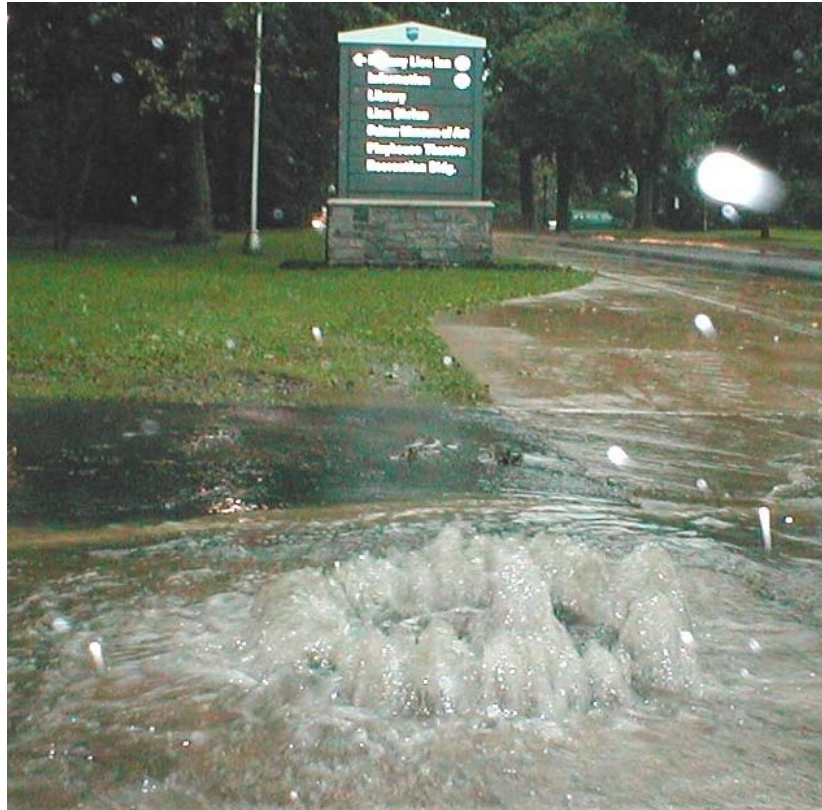
Figure 7.e. Surcharging at STMH125 along Park Avenue

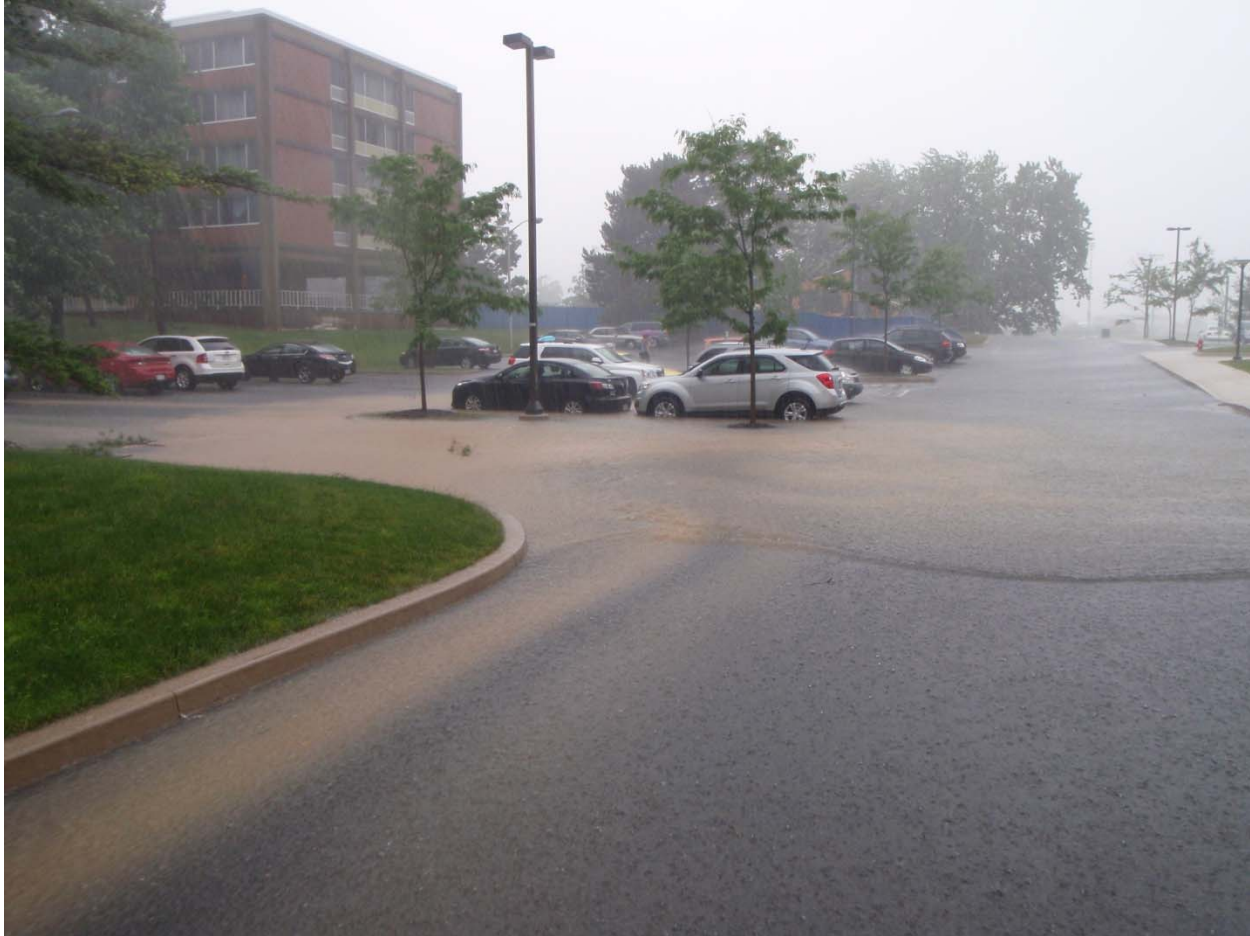
Figure 7.i Flooding of Parking Lot Between the Softball Facility and Snyder Hall

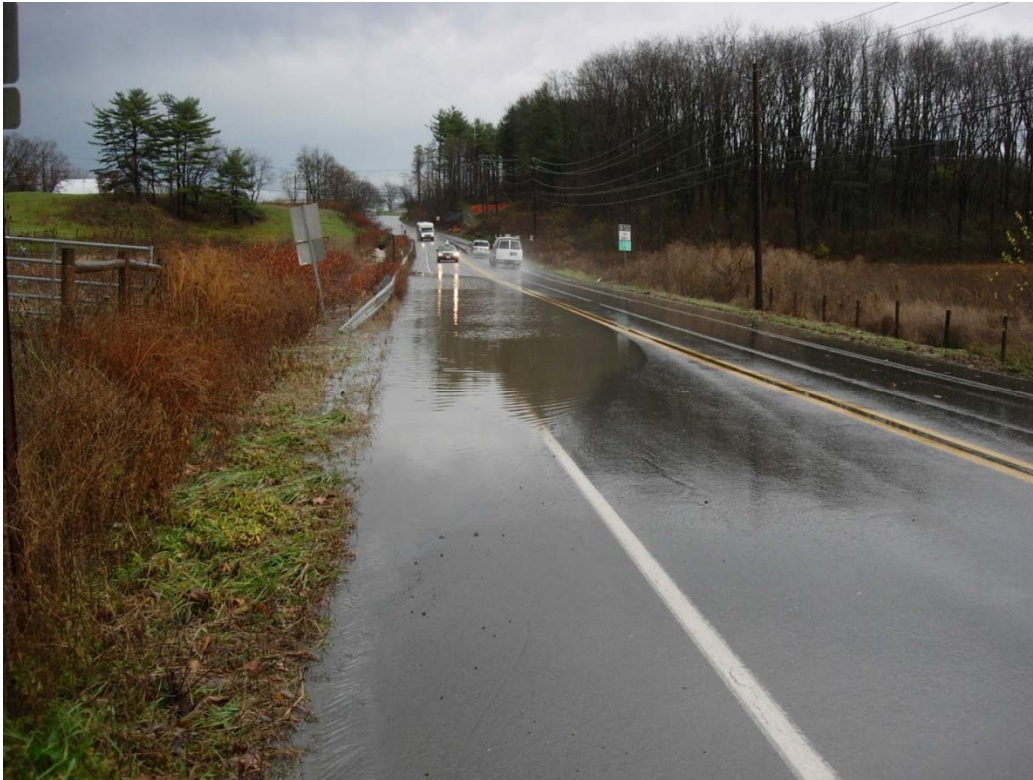
Figure 7.j. Flooding at the Sag in Fox Hollow Road During Overflow Conditions

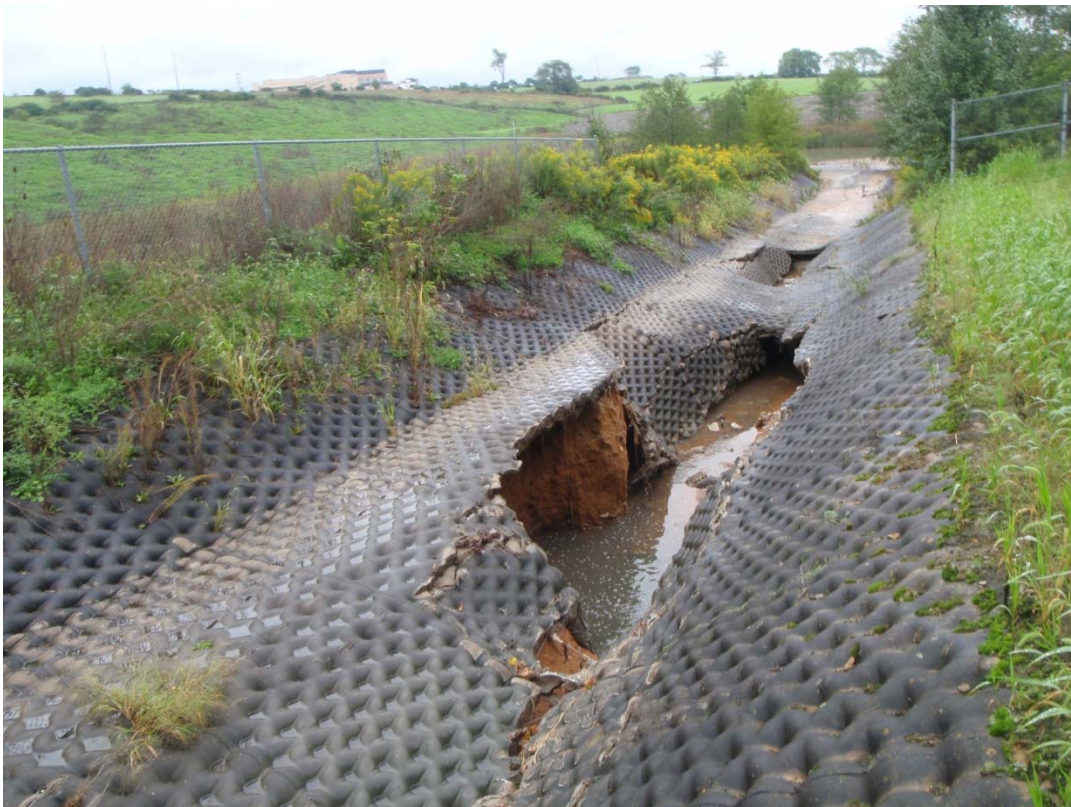
Figure 8.d Sinkhole under the Inflow Fabri-Form Concrete Channel
