York

Campus Exterior Architectural Plan November 2006

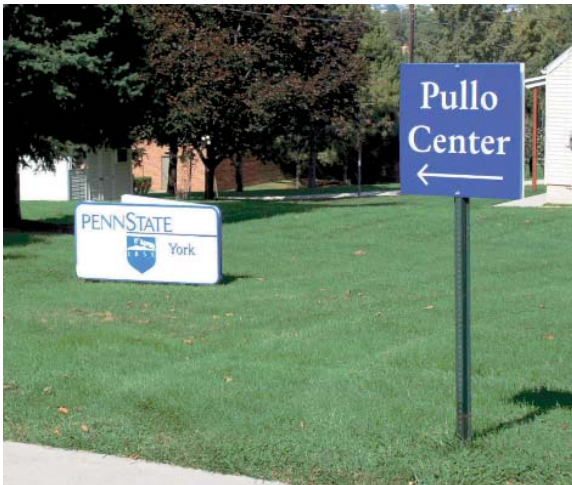
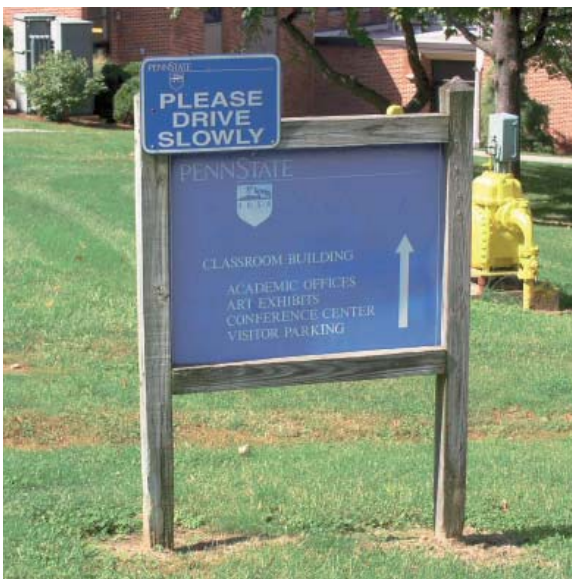
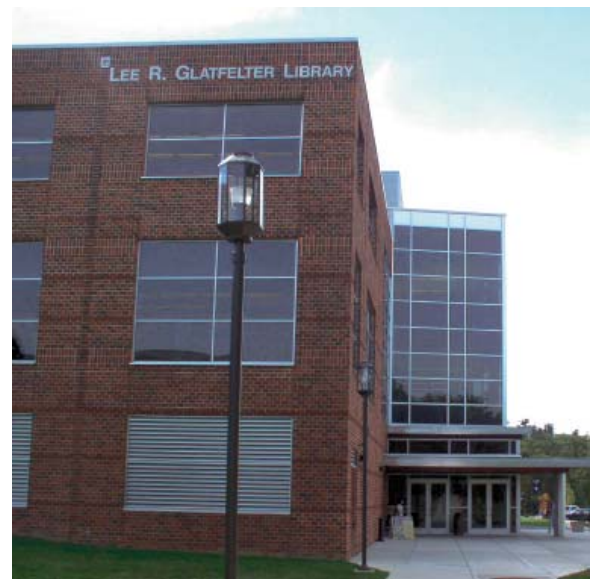
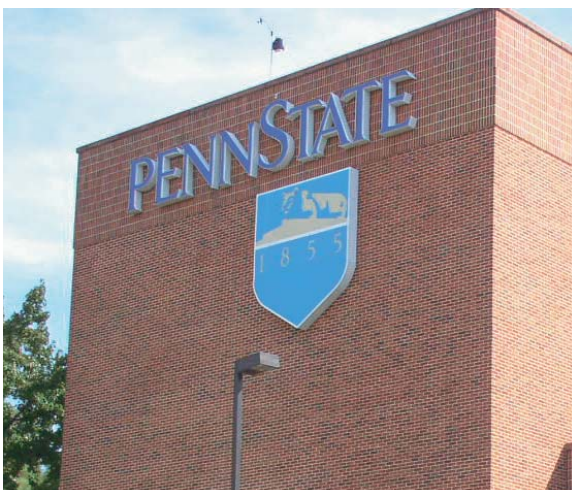
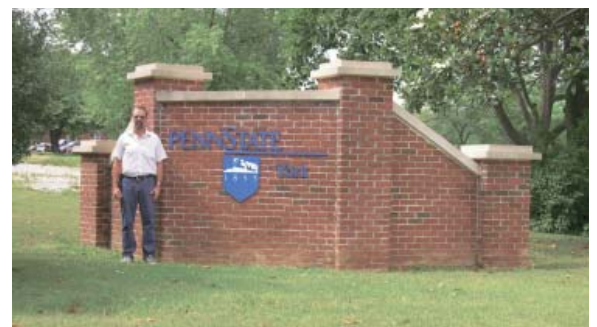
Campus identification and wayfinding signage is inconsistent stylistically with respect to copy, color, size and detailing. Deviations from PSU signage standards exist. Campus maps to direct pedestrians to various buildings are absent.

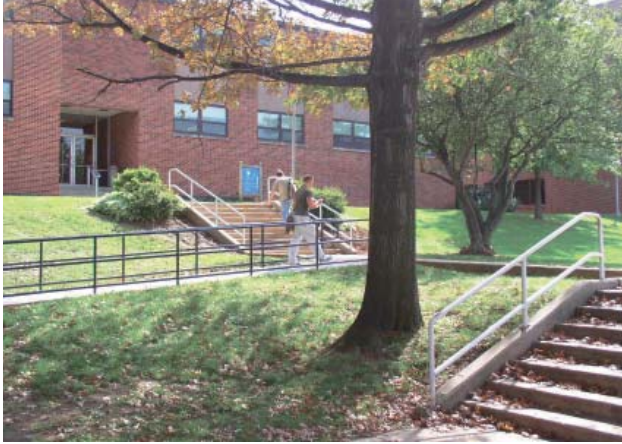
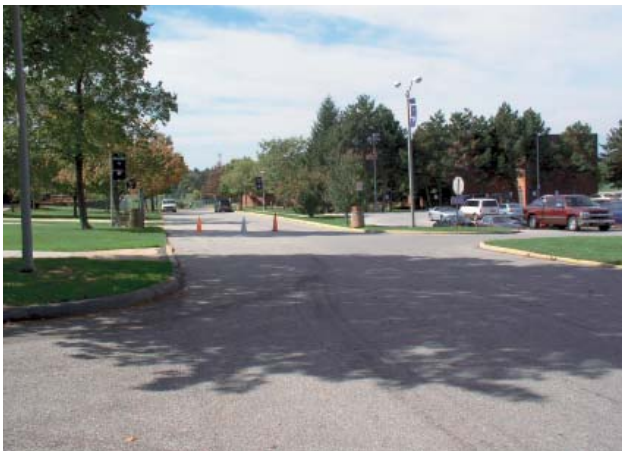
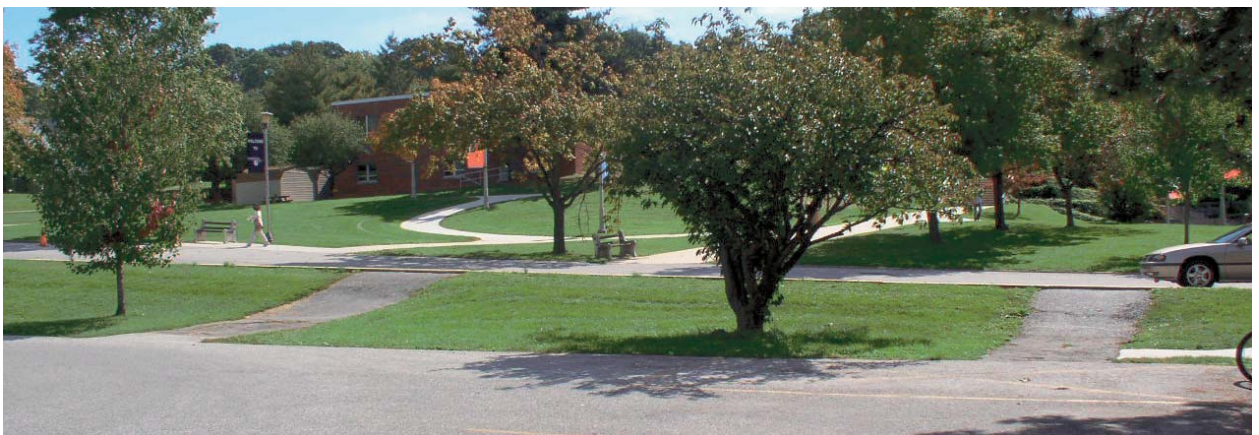
ADA compliant pedestrian circulation is and will always be a challenge on this campus due to the topographic condition. Suitable walkway connections are absent in some locations. Expansive unused asphalt surfaces exist. Handrail design is inconsistent across campus.

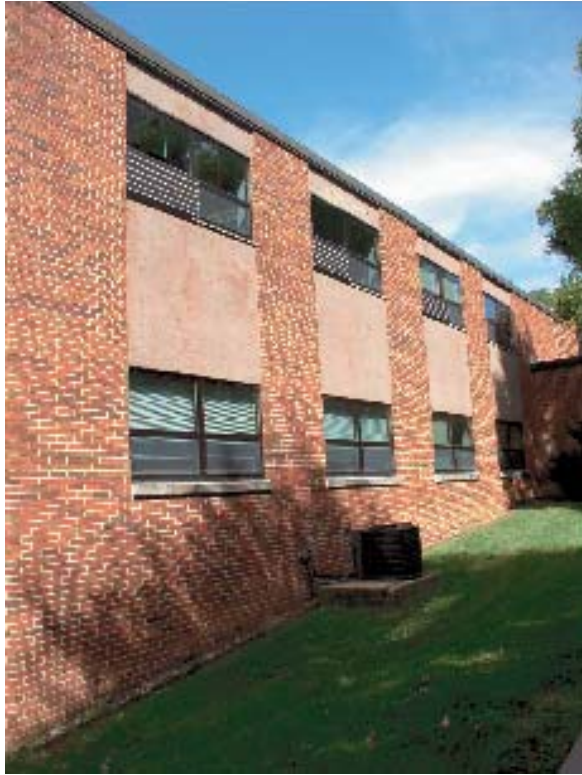
1a

Parged finished panels on Main Building are in need of repair or replacement. Inspect, repair, replace and repaint.

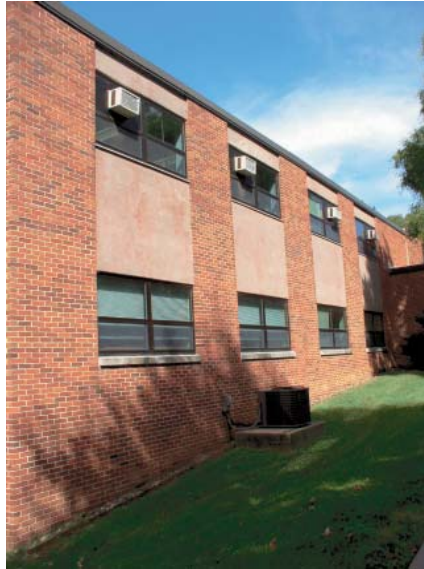
1b

Air conditioning units protruding from windows are unsightly. The marketplace offers new, efficient window units that are housed primarily on the interior of the room with a more integrated exhaust grill. Installation of this type of unit will improve the aesthetics of the building.

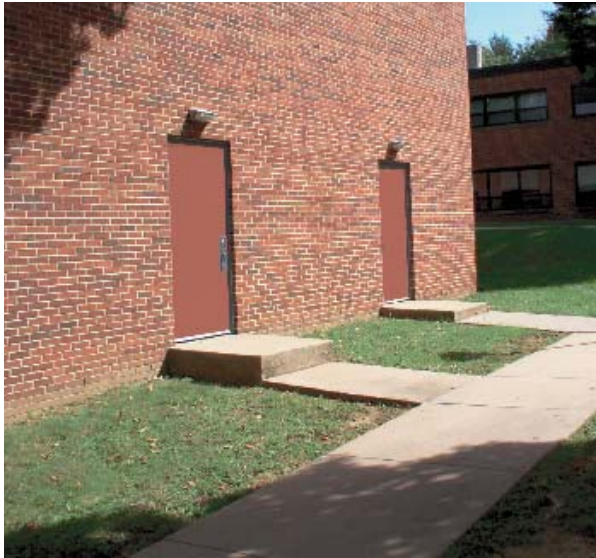
1c

Color of painted exterior doors should be consistent with other trim elements on the building.

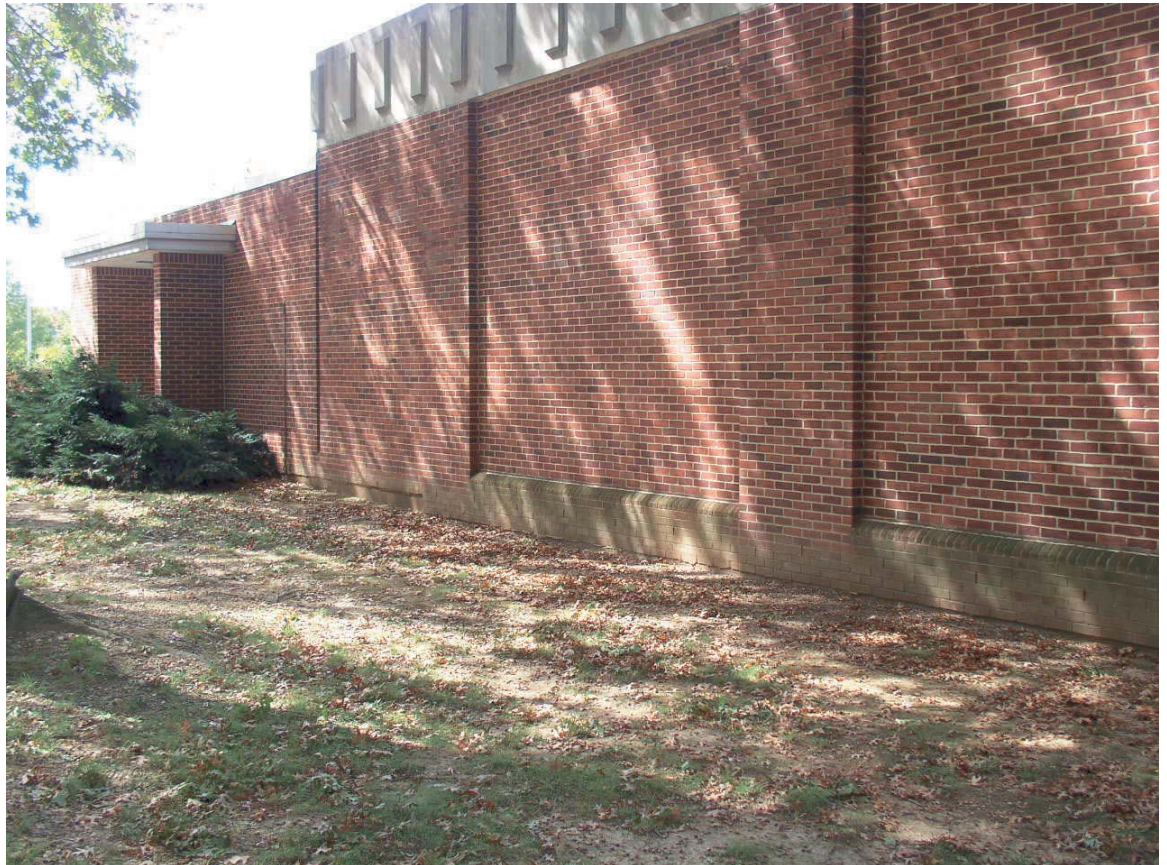
1d Pressure Wash

Inspect exterior masonry surfaces for dirt, mildew and other discolorations. Power wash to remove. The foundation perimeter of the Multi-Purpose Building (shown) as well as cast concrete window sills on the Main Building have been noted in particular.

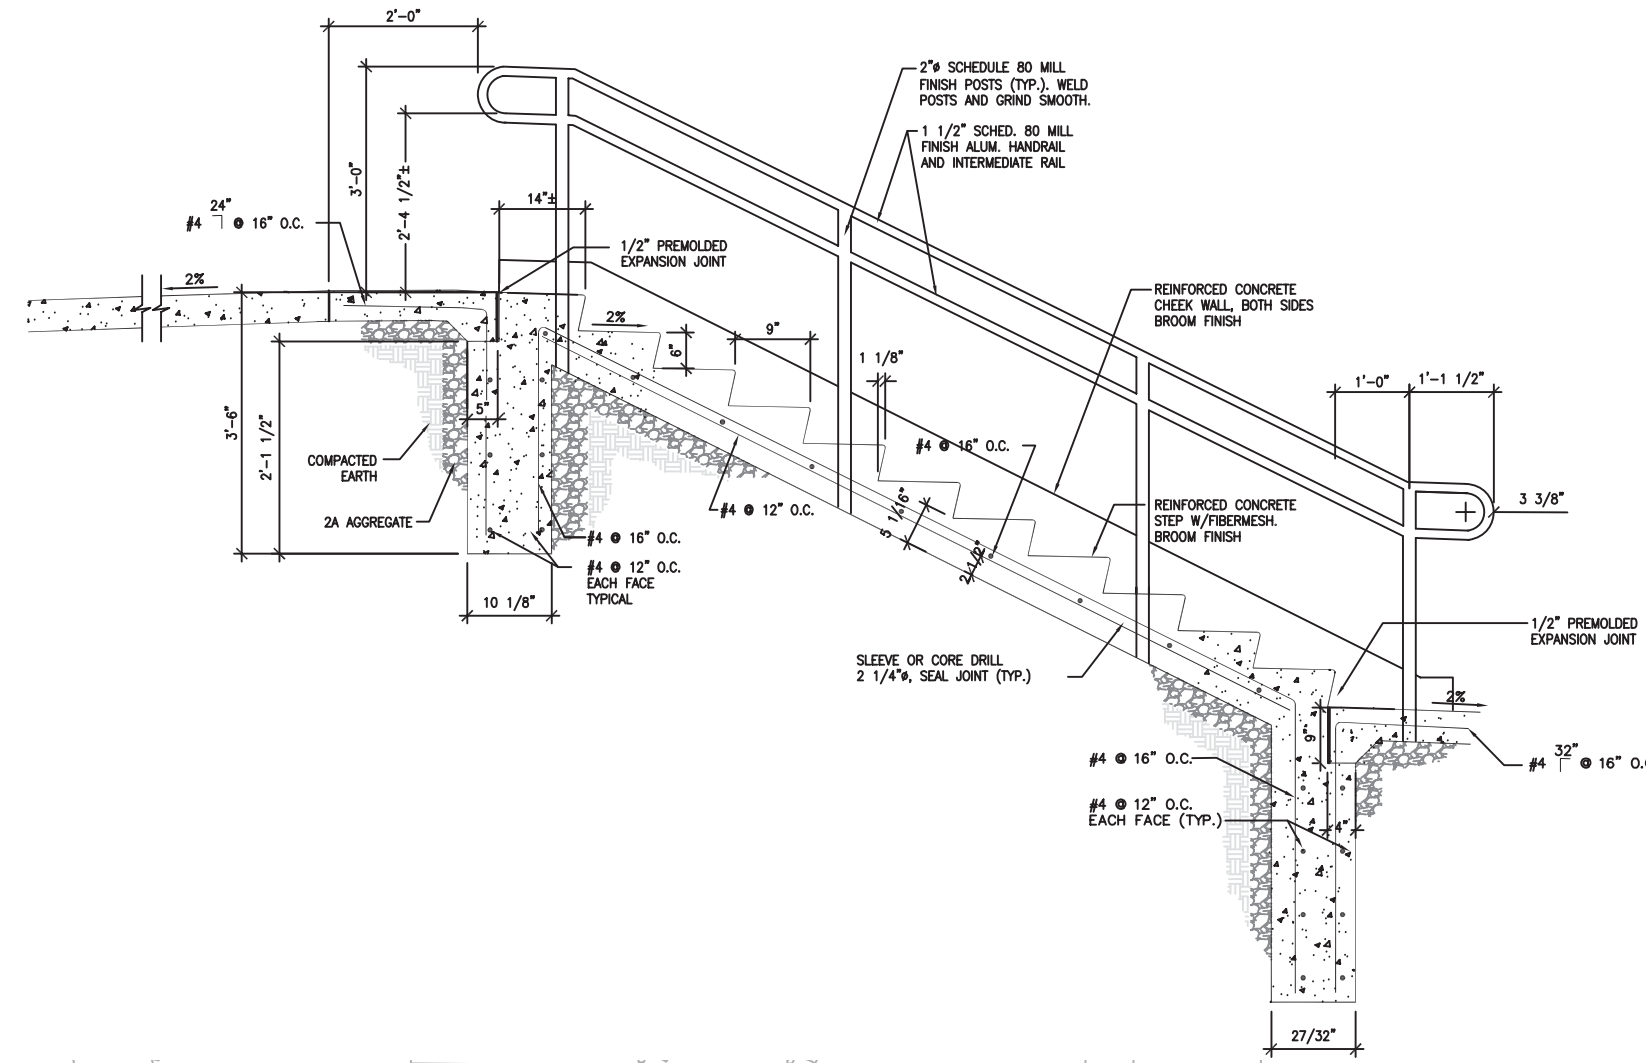
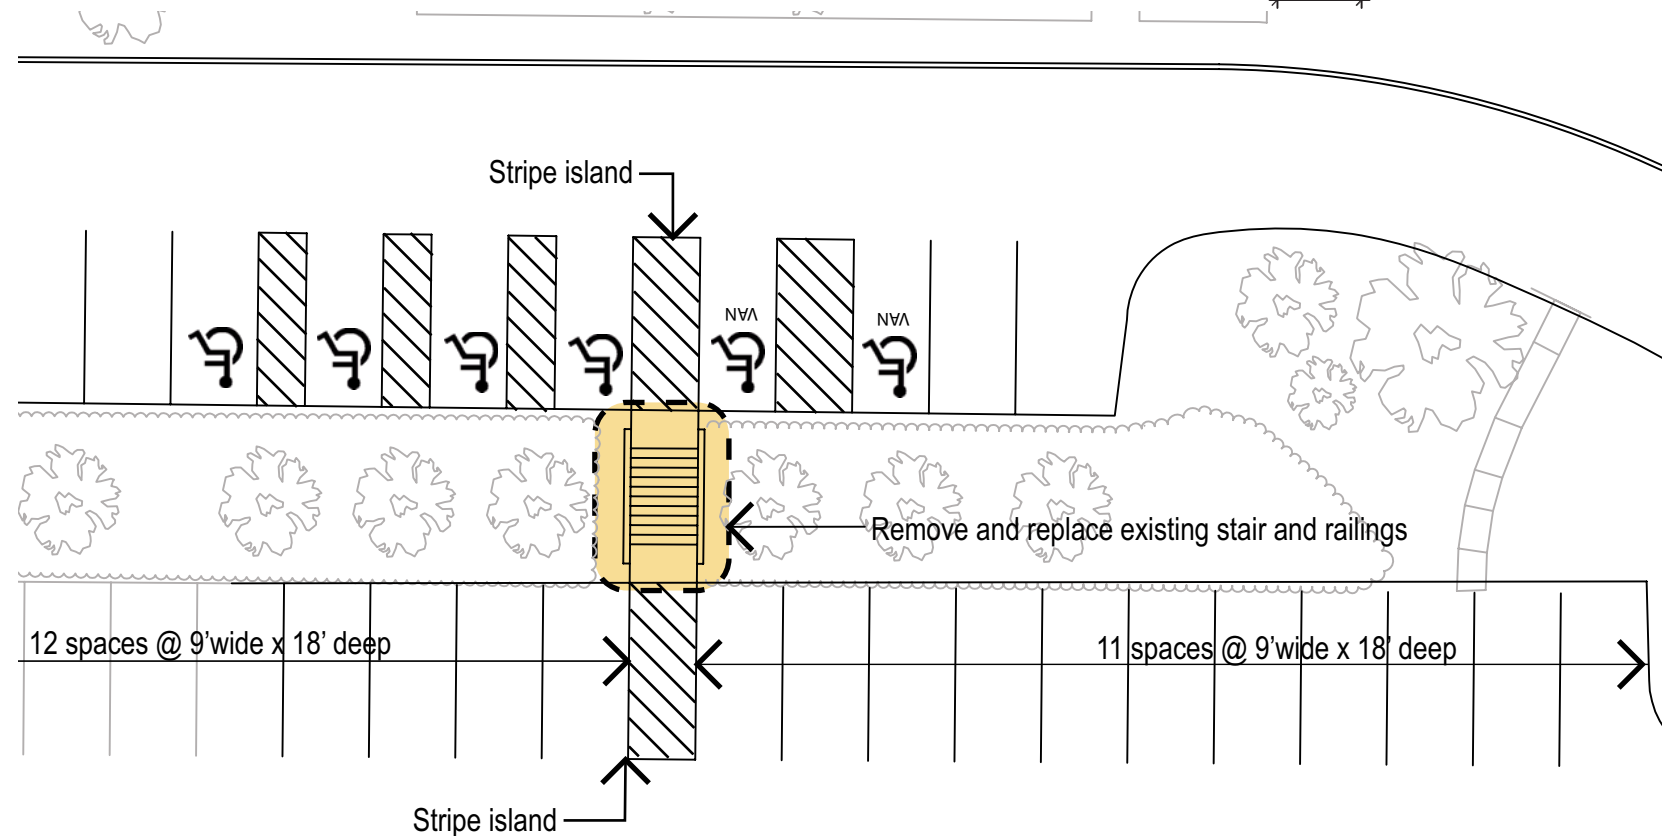
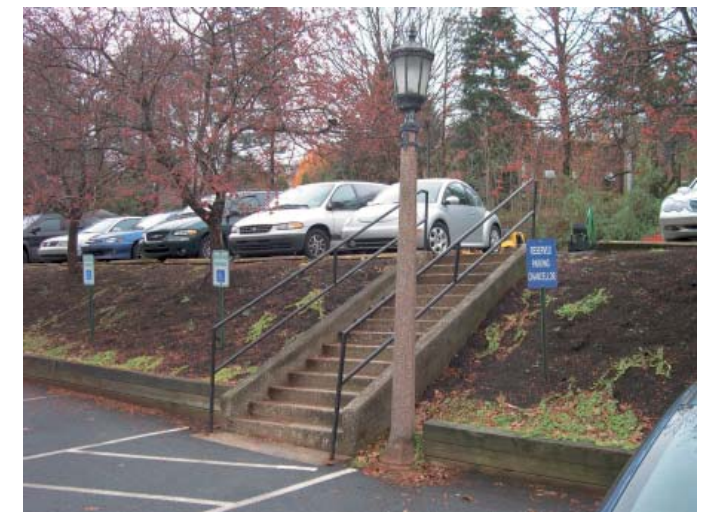
2d

The existing stairs and railings between the faculty/staff and visitor parking lots to the south of Main Building are in disrepair and require replacement. Parking stall striping should be reapplied and pedestrian islands created.

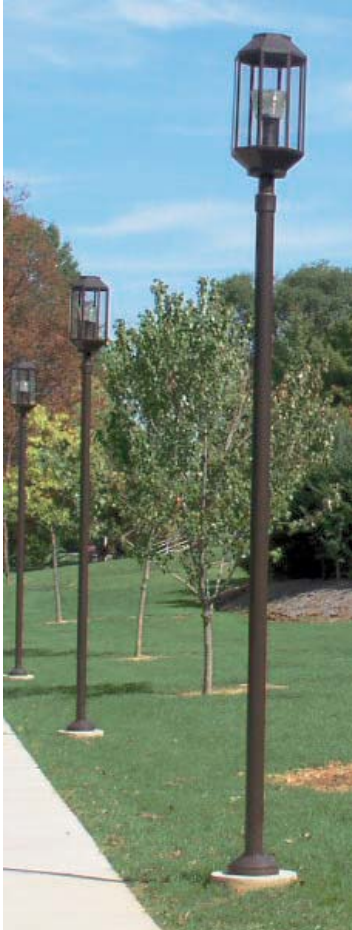
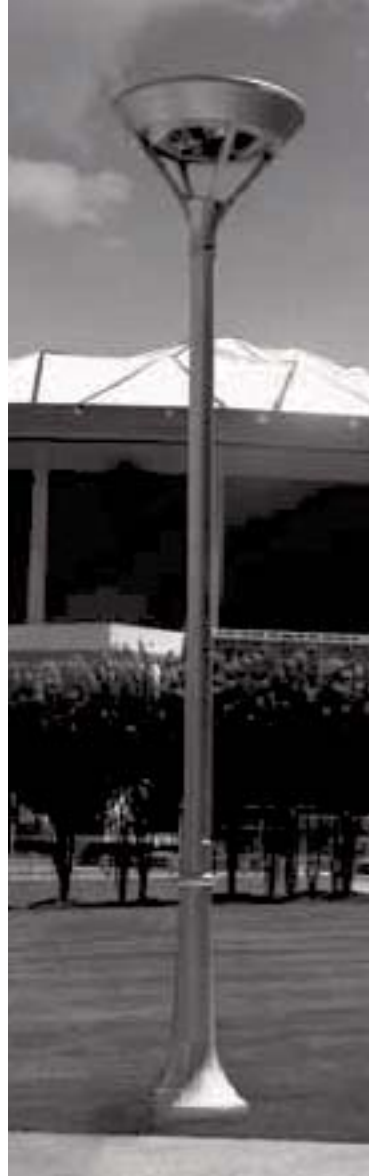
4 Lighting

Plan for phased replacement of any antiquated, inefficient pedestrian walkway lighting. Propose the use of metal halide lamps in cut-off luminaires mounted to poles. It has been noted that at the time of this assessment the campus has recently installed a significant quantity of the non-cutoff fixture shown at the far left. An inquiry with the fixture manufacturer indicates that retrofitting the design to a cutoff standard is not presently possible. Prior to replacement of existing lights with a different style it is recommended that an attempt be made to modify the existing fixture to achieve cutoff compliance.

Avoid the use of bollards due to vulnerability to snow removal operations and vandalism.

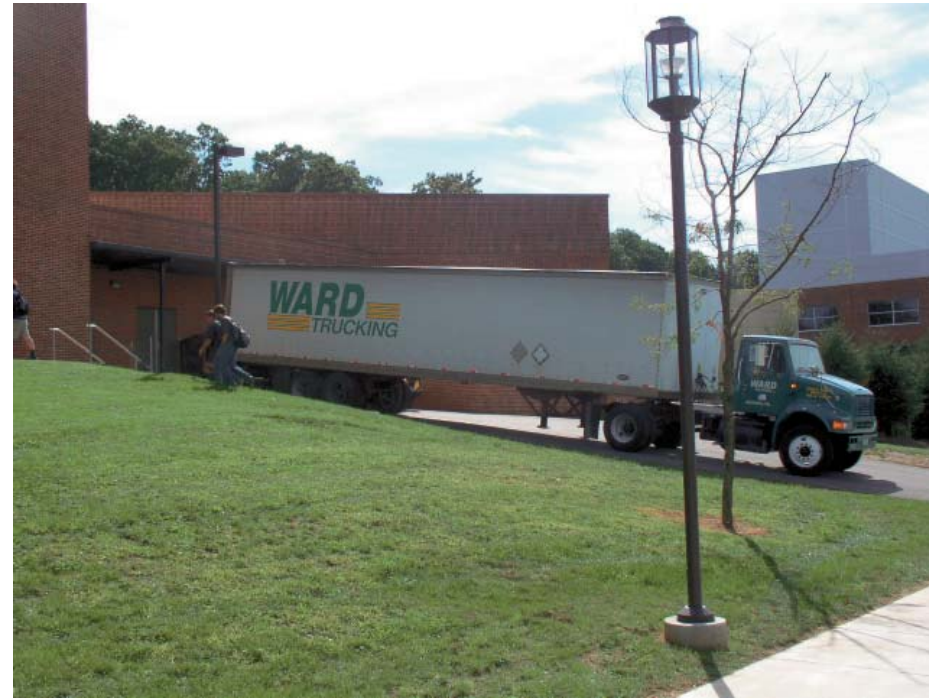
1 -Screen service area

Opportunities exist across the campus, to screen utilitarian functions from view. Supplemental landscape plantings will not only obscure views but will add interest and beauty to the campus.

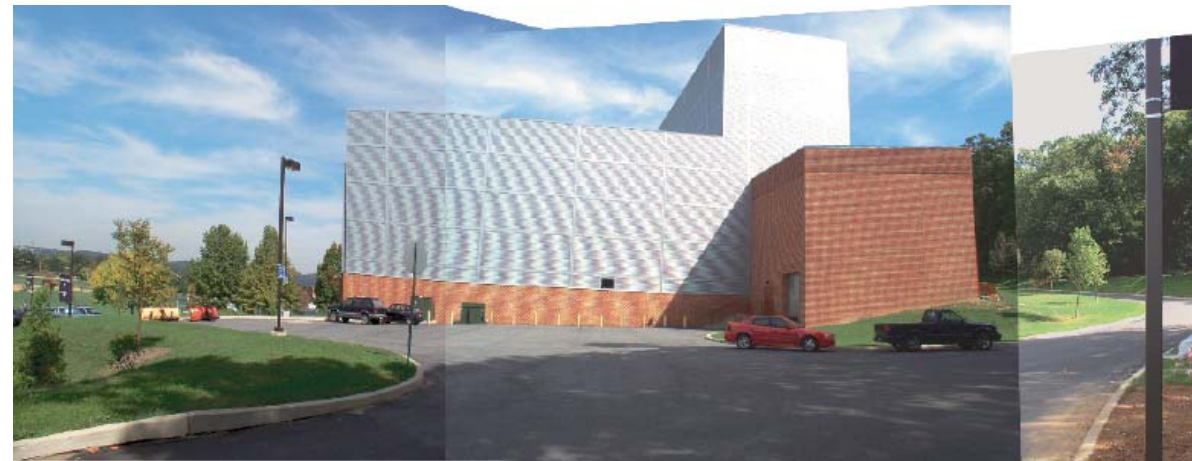
1 - Pullo Center / Library from entrance drive

The service area/loading dock area of the Pullo Center and Glatfelter Library Building is prominently visible upon entering the campus along the new entry drive. Landscape plantings needed to soften and diminish the scale of the building are absent or underplanted. Graded slopes currently planted with high maintenance turf should be replaced with trees, shrubs and groundcovers. The lower level pedestrian entrance from the parking lot is ill-defined and unremarkable.

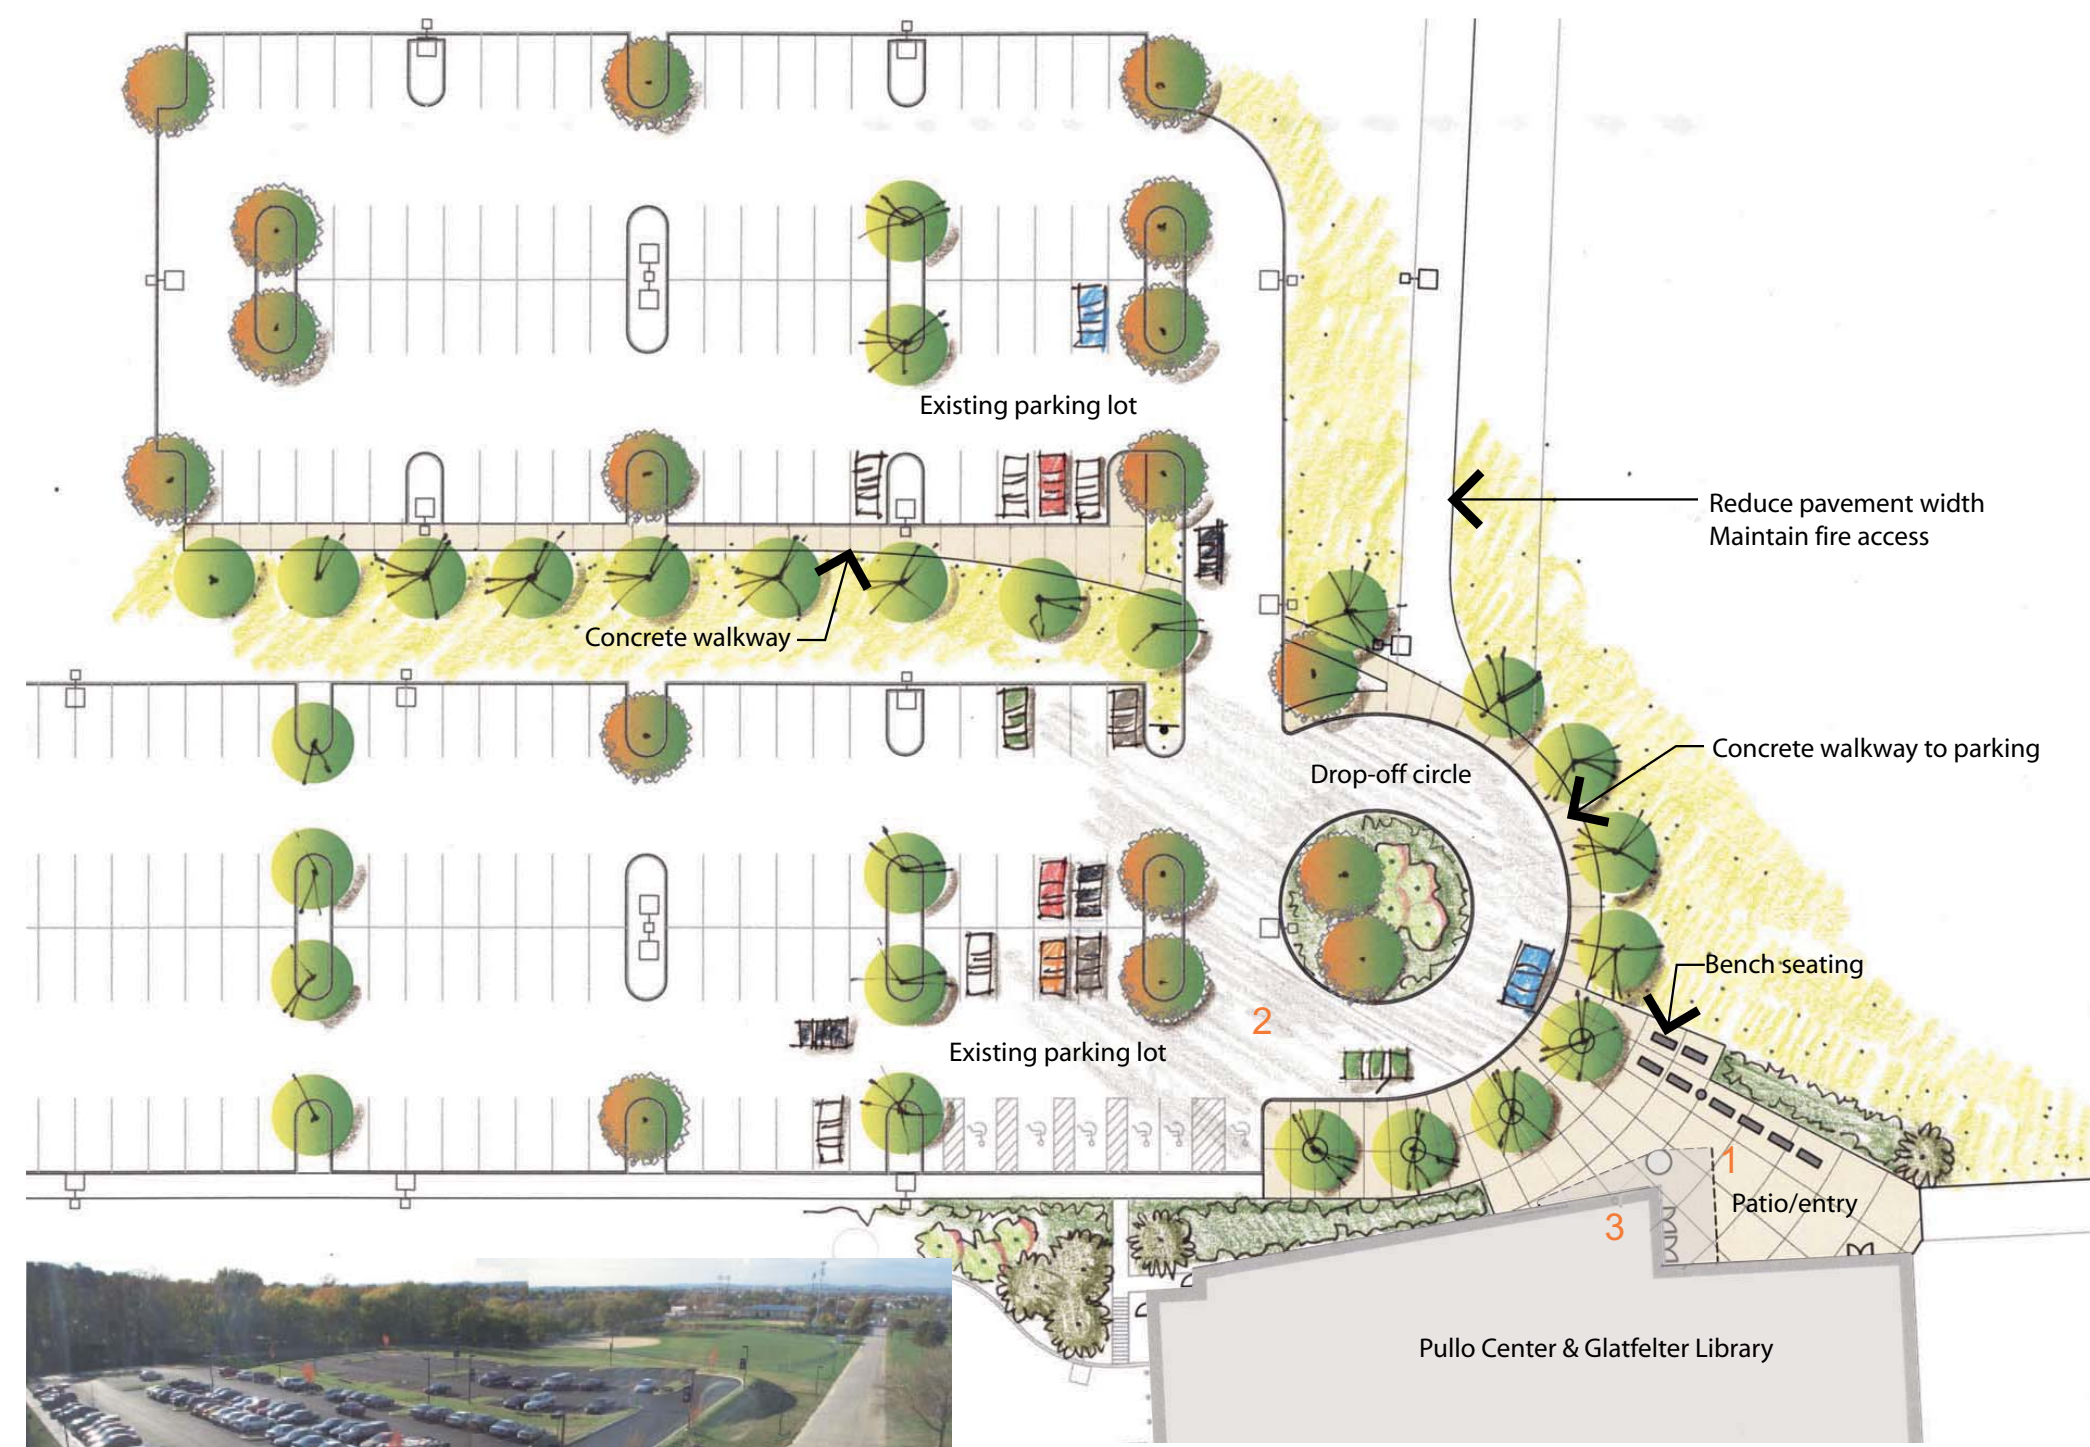
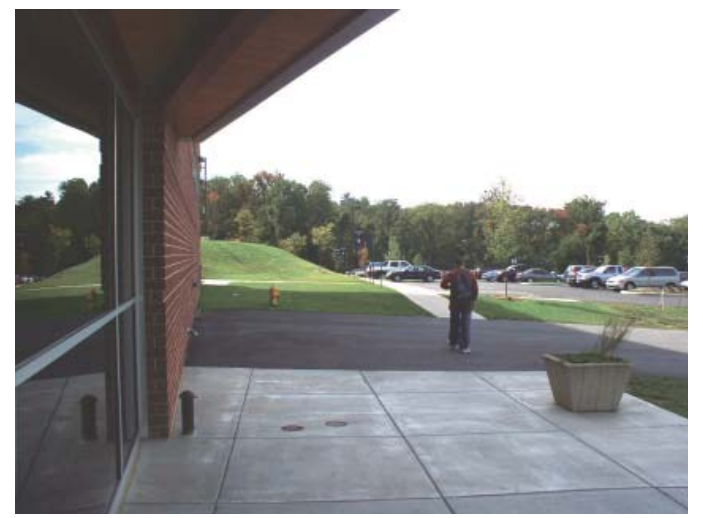
Library Entry

The pedestrian entry experience from the Library/Auditorium parking lot is inadequate with respect to walkways and aesthetic quality. Propose the development of a drop-off/turn around and supplemental sidewalks. The new patio area should be furnished with bench seating and waste receptacles. The "soapbox derby" track is excessively wide. Propose the narrowing of the asphalt road while maintaining the required fire access to the building.
