Campus Exterior Architectural Plan
April 2009

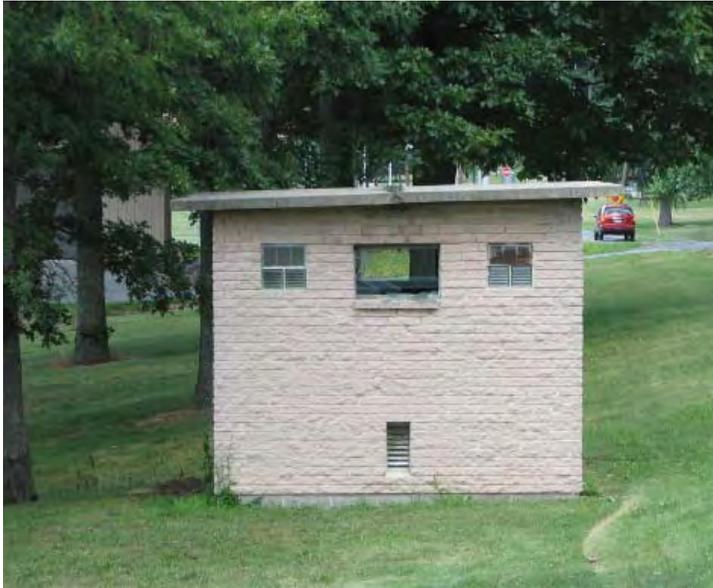
1A Remove Abandoned Building

The Penn Gate Gas Building located along Slabtown Road is no longer used.

Recommend the removal of the structure and conversion of the site to lawn.

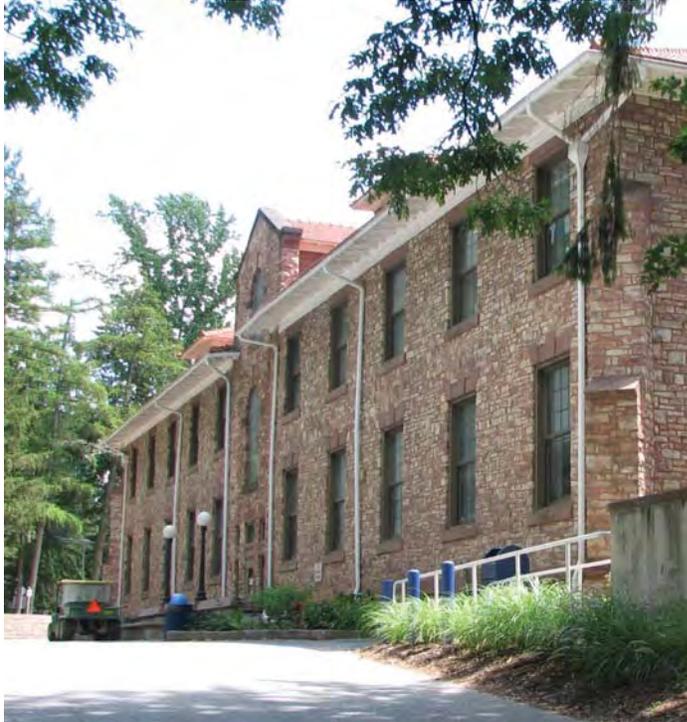
Conklin Hall 1B

The white gutters and down spouts on the long facades of the building detract from the beauty of the architecture.

Recommend that the downspouts be reconfigured, reduced in number or eliminated altogether. If they must remain, changing the color to one that's less contrasting to the masonry would diminish the visual impact.

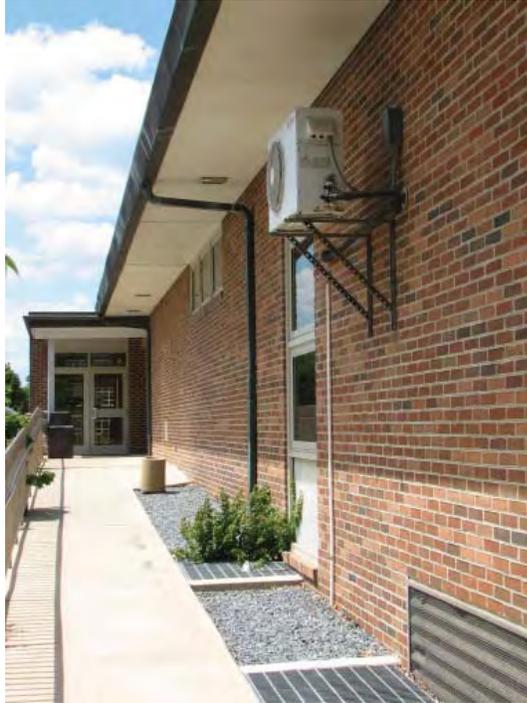
1c

The Millstream Cafe entrance walkway is only partially paved. The existing AC unit and mounting bracketing is unsightly.

Recommend that the AC unit be lowered to sidewalk level and the gravel voids in the walkway surface be paved with concrete.

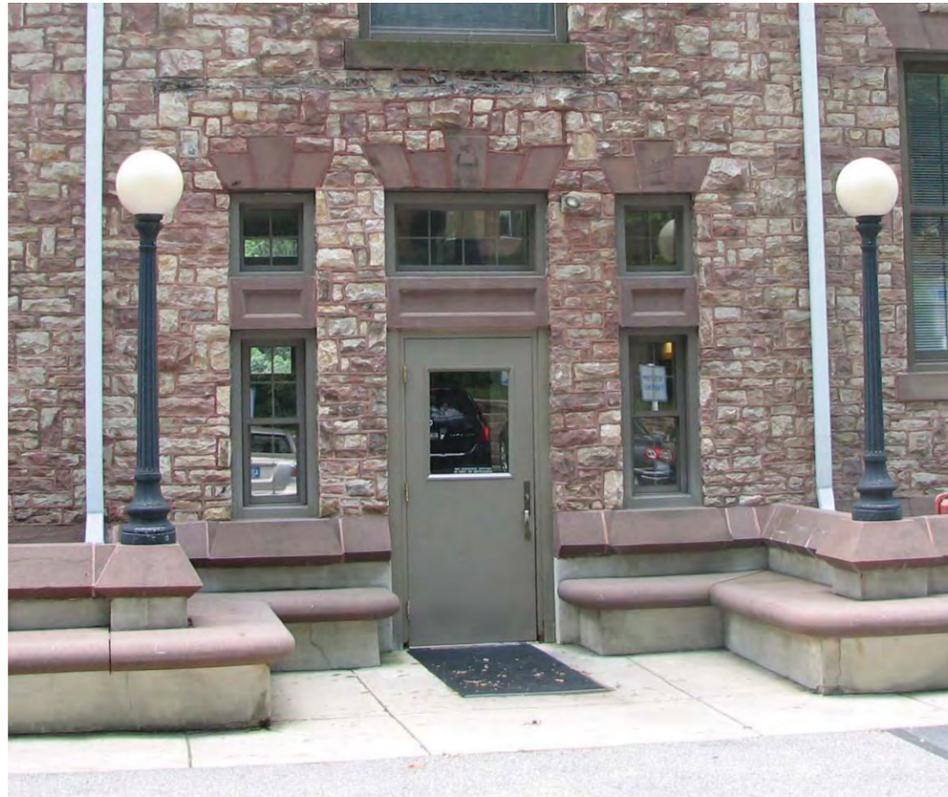
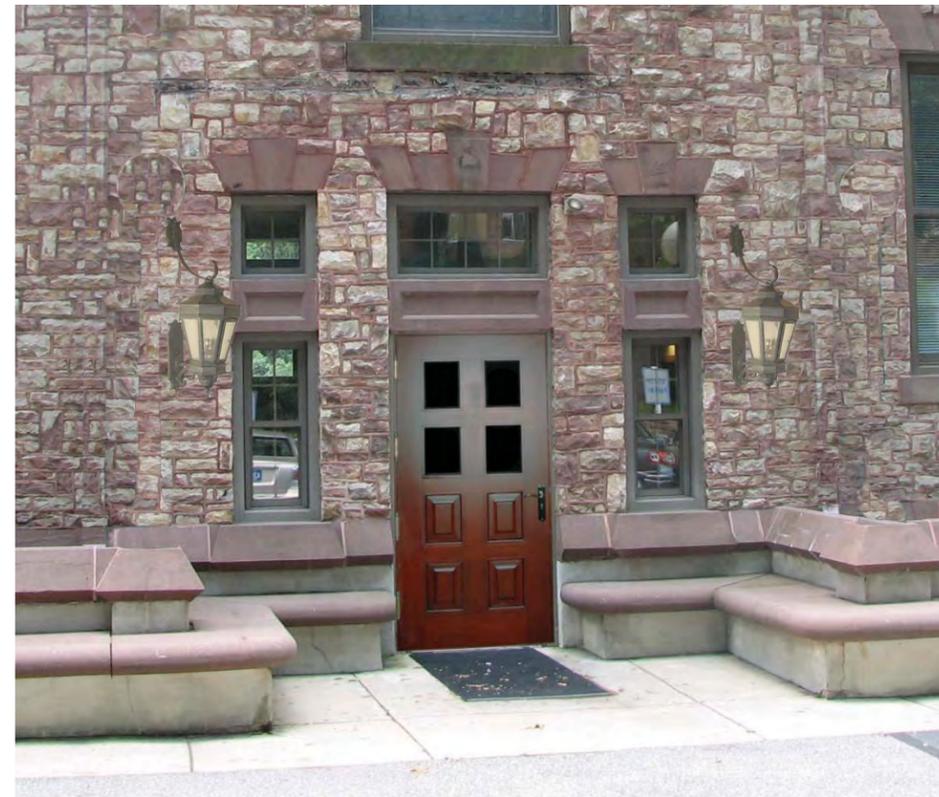
Entry Enhancements

Previous renovation projects have not always respected the architectural integrity of campus buildings.

The two examples at left illustrate alternative door designs that compliment the architectural character of the building. Note also that stylistically appropriate light fixtures and site furnishings improve the aesthetic quality of these important campus locations.

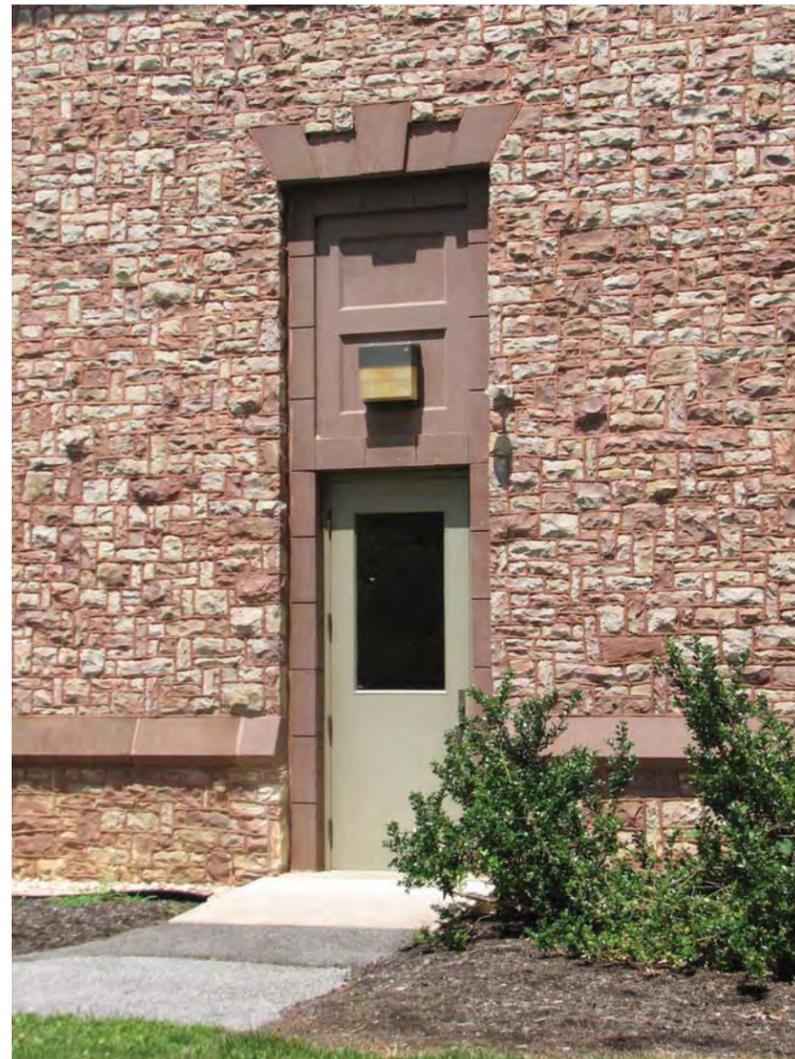
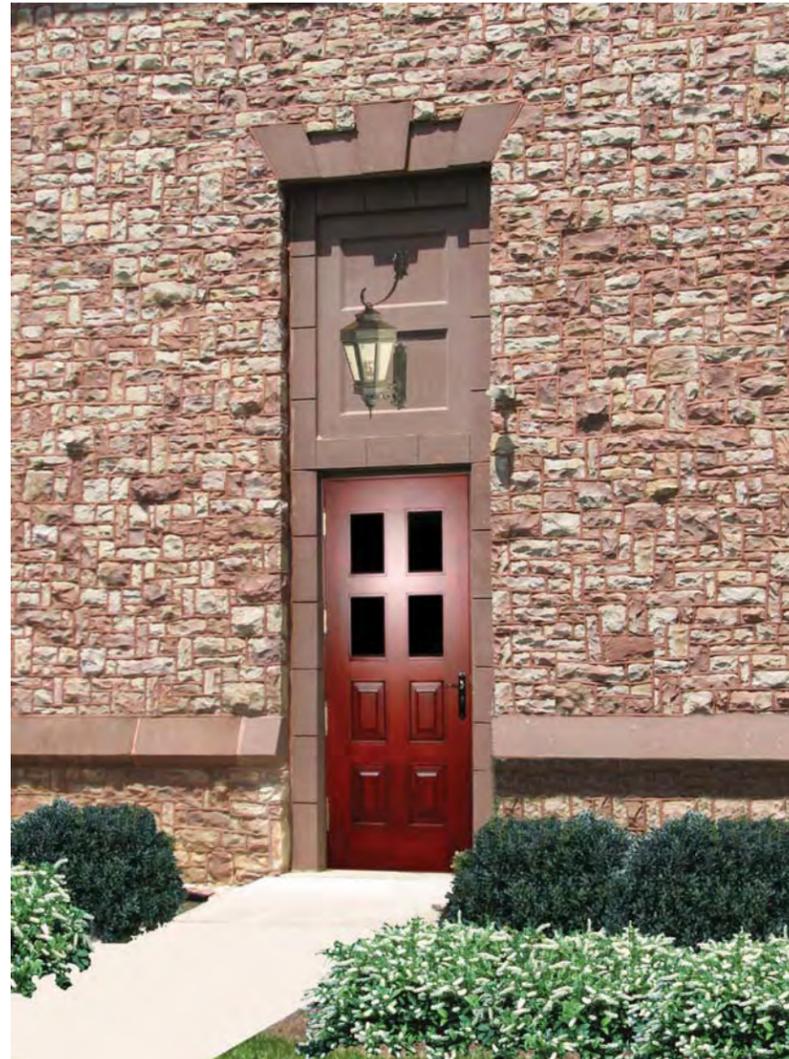
1D Conklin Hall Entry Enhancements

Conklin Hall is a beautifully detailed architectural landmark of the campus. Previous renovation projects have not respected the design integrity of the building resulting in inappropriate updates.

Recommend the replacement of existing steel doors with stylistically appropriate ones, replacement of "wall pack" light fixtures with period lantern fixtures and landscape planting enhancements to welcome users into the building.

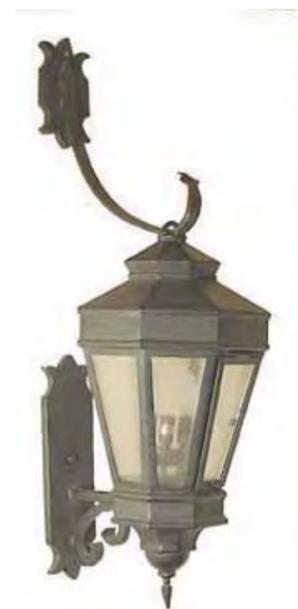
Architecturally appropriate period lantern fixture

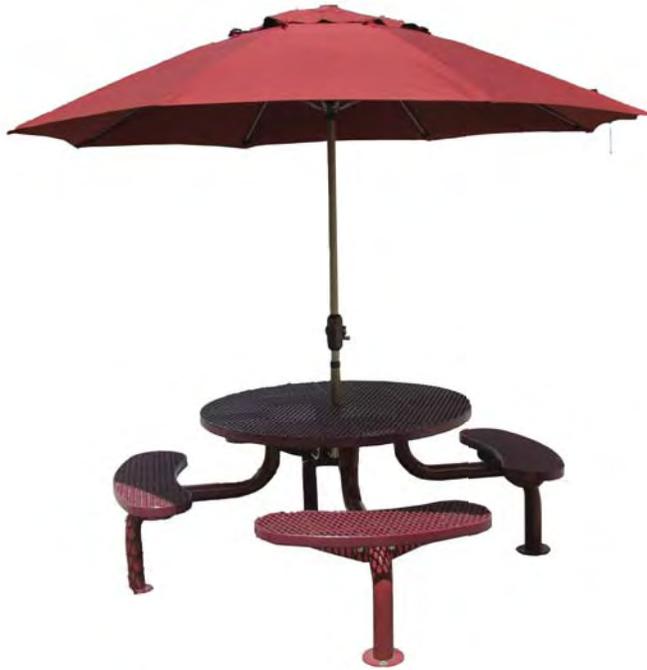
2

Site furnishings designed in a style “family” are aesthetically unifying. The umbrella table shown here exists on campus in the burgundy color. Generally it’s best to avoid colors because they stand out visually and can appear dated over time. Since existing installations are relatively new and are limited to the patio at Wiestling Hall and the Library they should remain.

For benches and trash receptacles along walkways and other common areas it is important for the style and color to be more conservative. In lieu of free standing ash receptacles in the landscape, purchase receptacle mounted units and strategically locate away from building entrances.

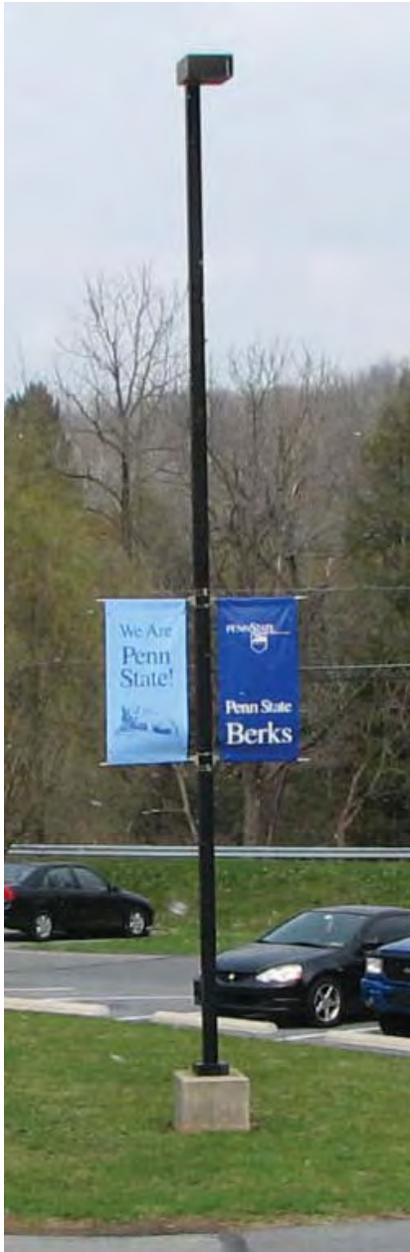
3 Lighting

Typical Parking Lot/Roadway Light

Site Light

"Utility style" fixture to be avoided

Replacement of any antiquated, inefficient pedestrian walkway and parking lot lighting is recommended. Metal halide lamps in cut-off luminaires mounted to poles are recommended for pedestrian walkways. High pressure sodium lamping is acceptable for parking lot lights. Color/finish for all fixtures should be consistent campus wide. Avoid the use of bollards due to vulnerability to snow removal operations and vandalism. It is also recommended that wall mounted "utility style" fixtures be avoided.

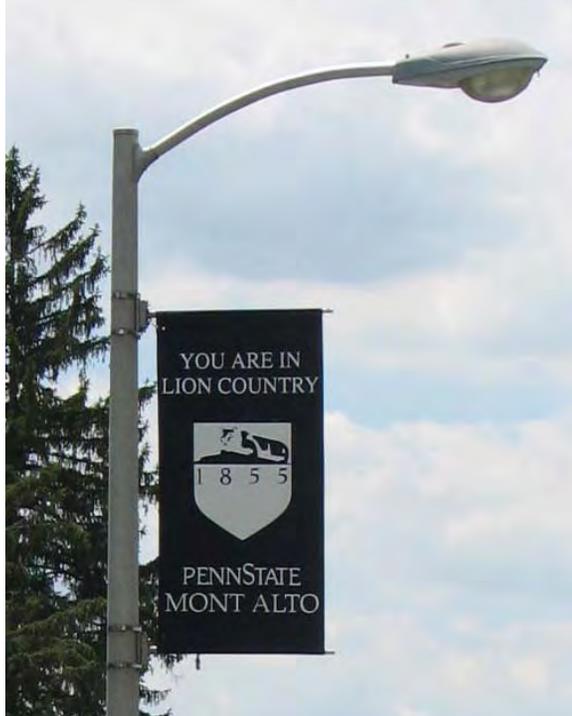
Existing banner with incorrect reverse image of the Penn State Mark

Guidelines for use and graphics are published on the following web site:

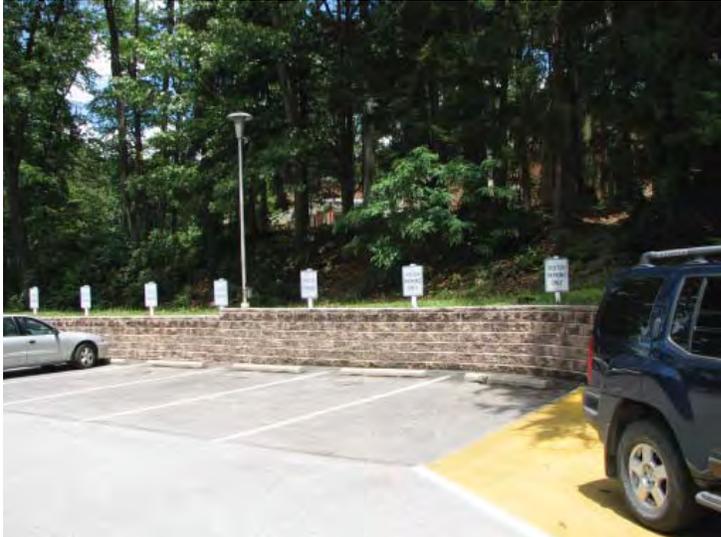
Before

The positive aesthetic effect of relocating pole mounted parking signs to the face of the existing masonry wall is evident in the photo simulation at left.

Note also that colored parking stall designations should be limited to perimeter markings instead of in-filling the entire space.

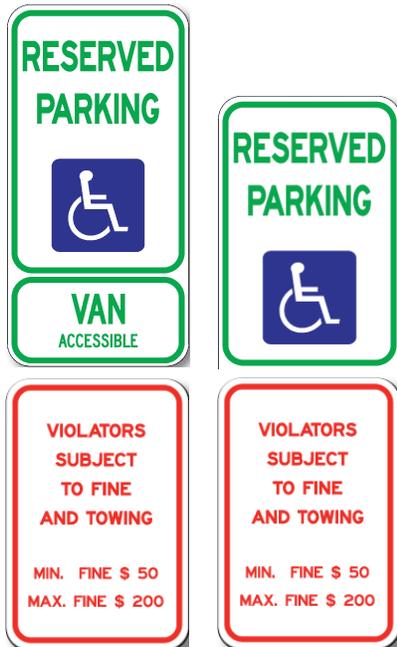
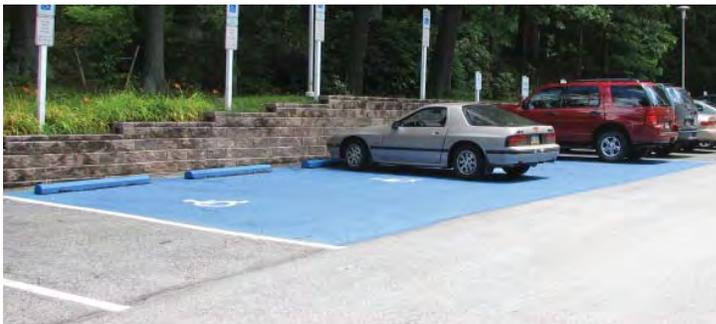
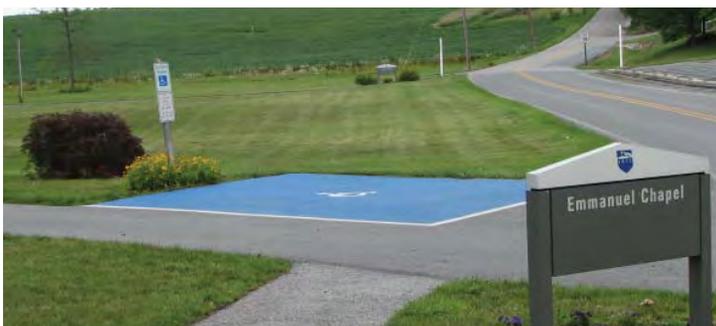
4C HC Stall Marking

Painting the entire surface of specially designated parking stalls attracts undue visual attention. Accessibility guidelines require only the placement of the standard signs shown at left.

Examples of Existing Condition

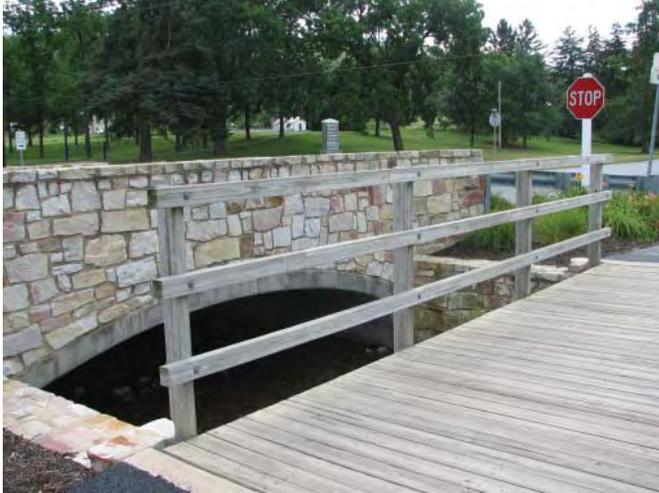
Before

The footbridge across Antietam Creek is a unique feature of the campus.

There is an opportunity to strengthen the visual appeal as well as safety of this crossing by rebuilding the existing rail. The design of the rail system should compliment other entrance treatments at this important campus vantage point.

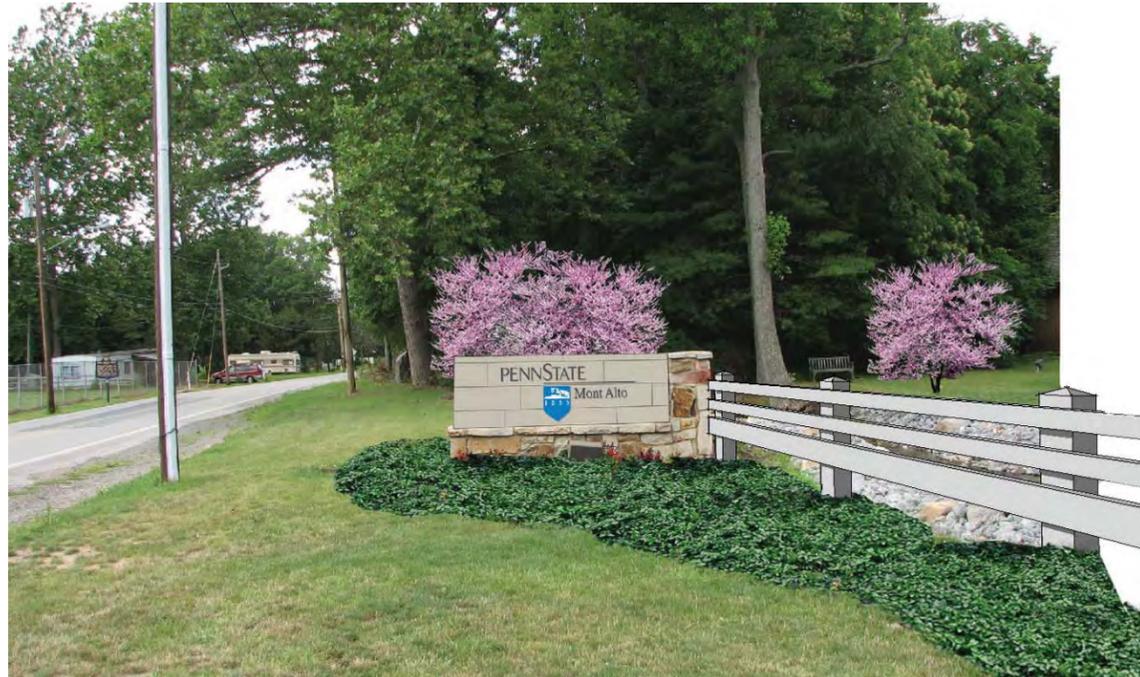
Campus Entrance Enhancement

The existing entrance monument sign along Park Avenue (Rt. 233) and the surrounding landscape could be enhanced to create a more pronounced and significant campus identity.

The stone base of the existing sign is attractive and well built. Replacement of the panel sign with a masonry and pin letter signature mark will upgrade the sign and give it a more permanent and solid appearance.

Supplement and expand foundation plantings using shrubs and groundcover. To further enhance the visual presence of the entrance, a fence rail using the same design, material and scale as is proposed for the bridge abutments and footbridge rail could be installed.

The combined effect of all the components of this treatment would be an entrance theme that extends beyond the sign itself to include the bridge and possible masonry entrance markers.

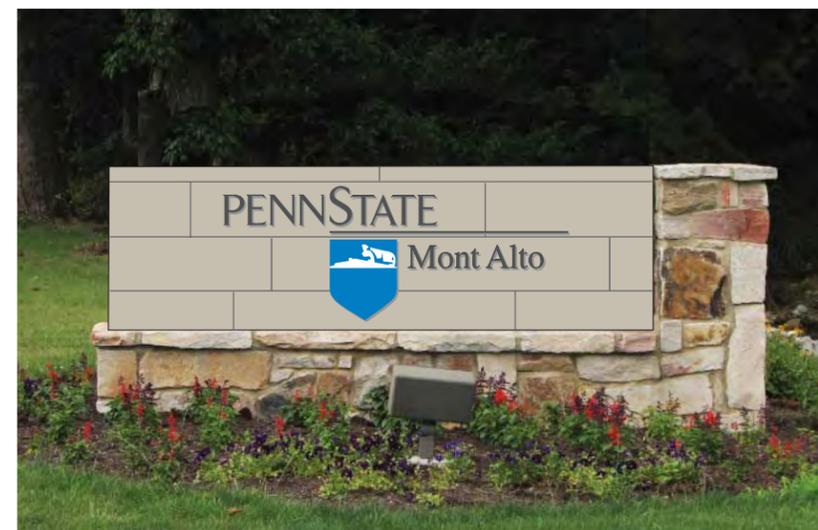
Updated Entrance Sign on existing stone base

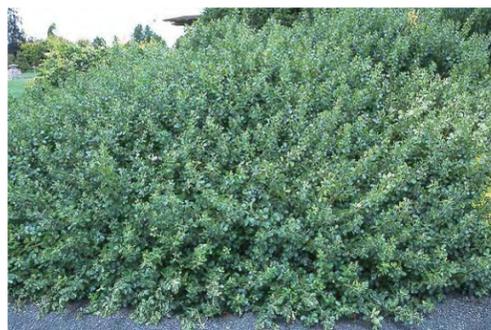
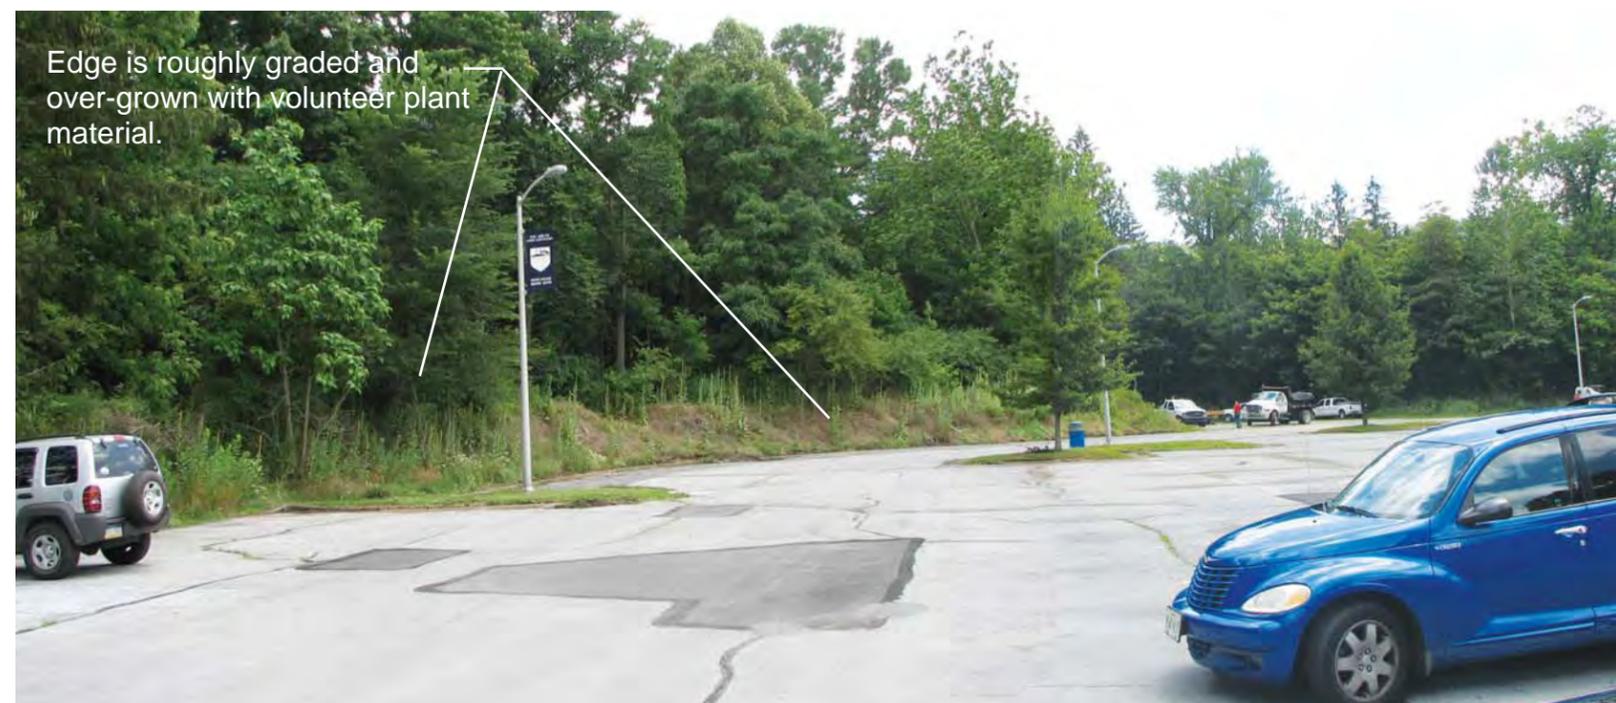
5D

The edge of the existing parking lot going into the woods looks unfinished and rough.

Recommend that the transition slope be graded and planted with a shrub groundcover. Additional tree plantings in existing parking lot islands are also suggested.

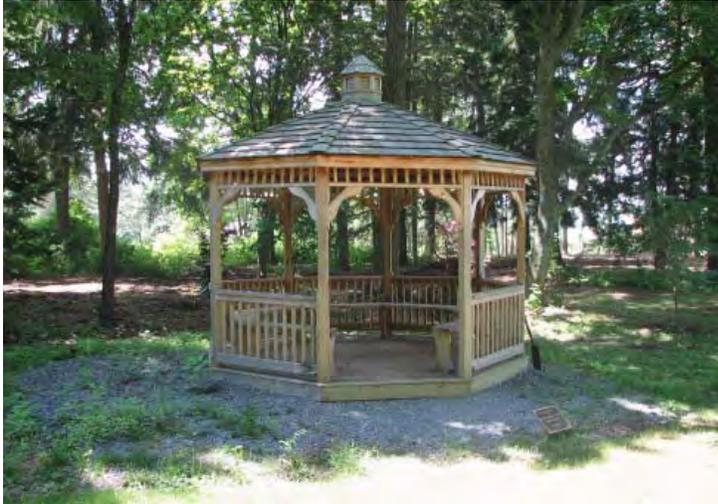
5E Auten Gazebo

The quality of the space around the existing gazebo could be improved through the installation of suitable trees, shrubs and groundcovers. The interior of the structure could be made ADA compliant by eliminating the step at the entrance.

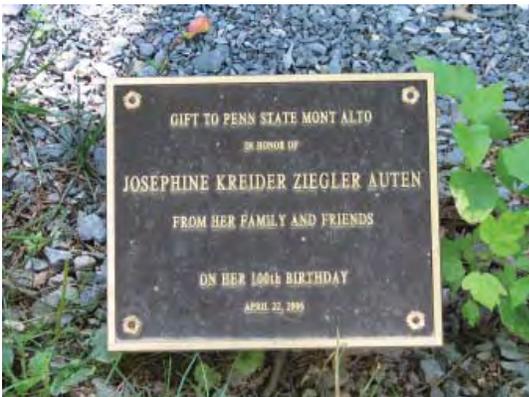
Landscape ^{5F} at Gazebo

The quality of the space around the existing gazebo could be improved through the installation of suitable trees, shrubs and groundcovers. The interior of the structure could be made ADA compliant by eliminating the step at the entrance.

A paved access walk and new site furnishings will give the use a finished character.

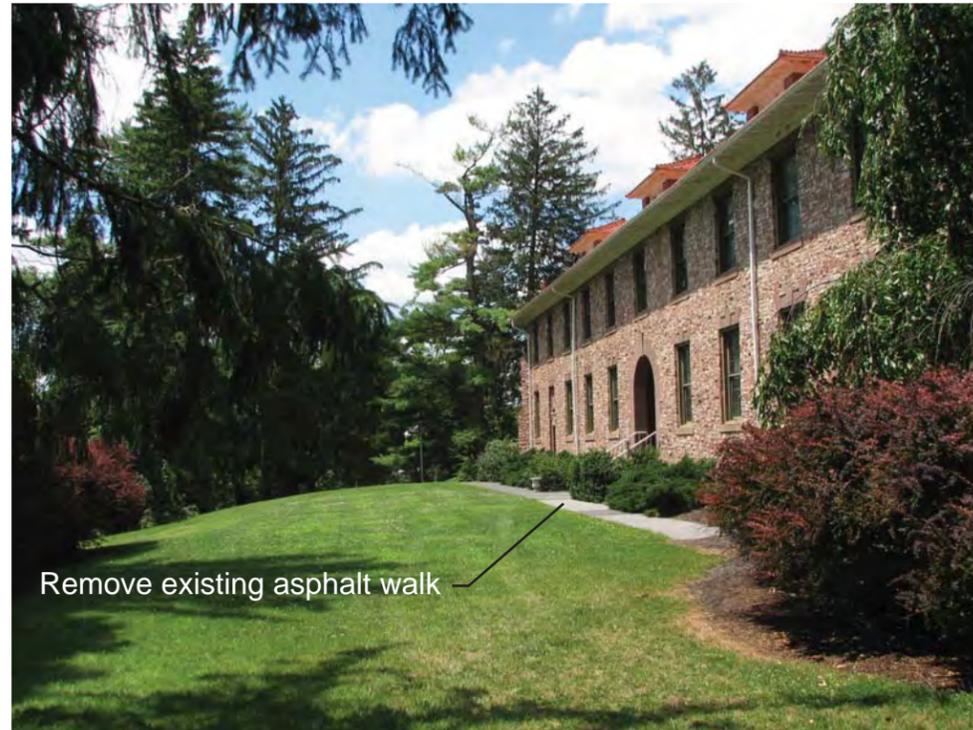
Conklin Hall 5G Landscape Enhancement

Conklin Hall is the administrative center of the campus. It sits prominently above a grassy slope leading to the woods that offers pleasant views of the woods to the south. The north side of the building is dominated by the access road and parking lot. The pedestrian walkway along the south side of Conklin Hall is narrow and overgrown. It does not tie into other pedestrian routes to the east.

Recommend the placement of new sidewalk, supplemented landscape plantings and seating opportunities as shown.

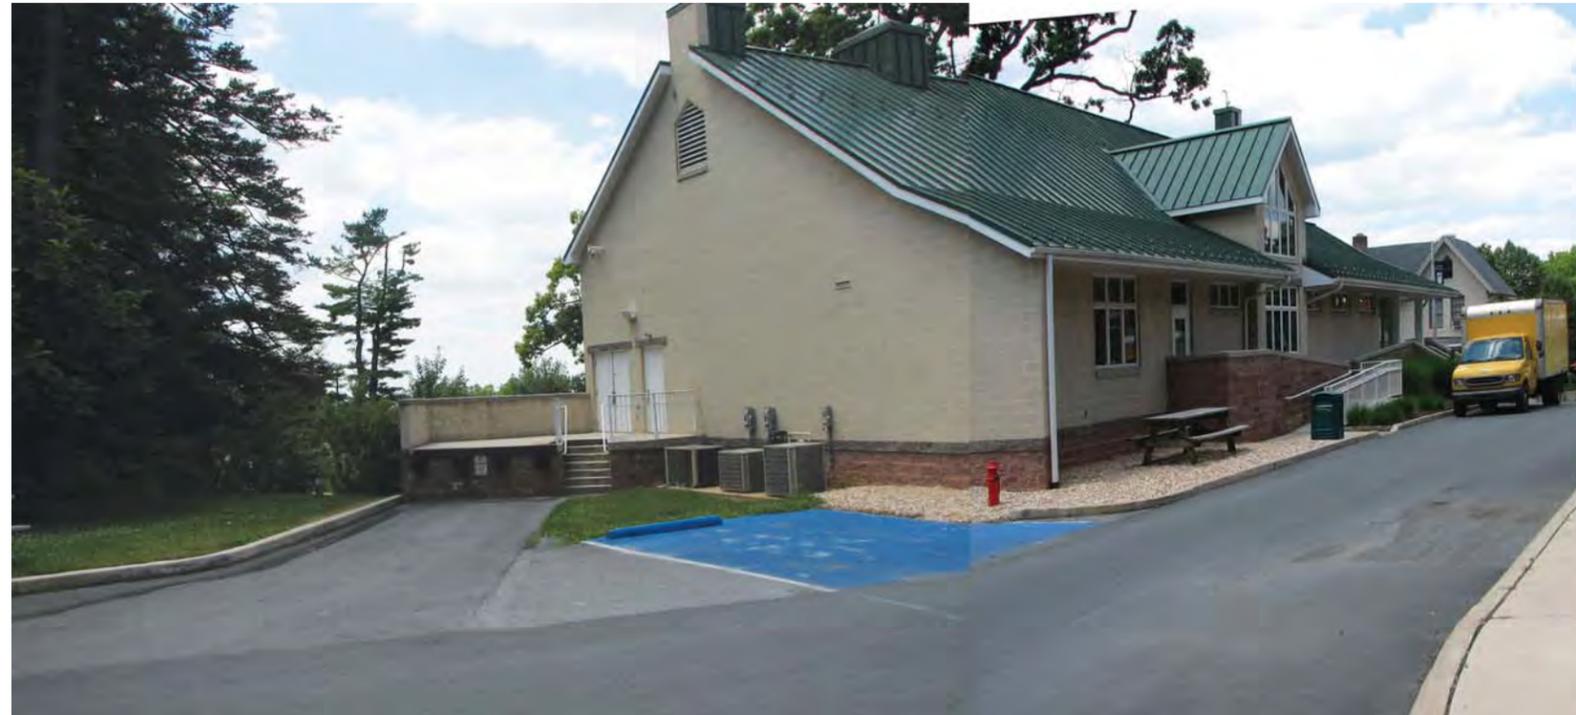
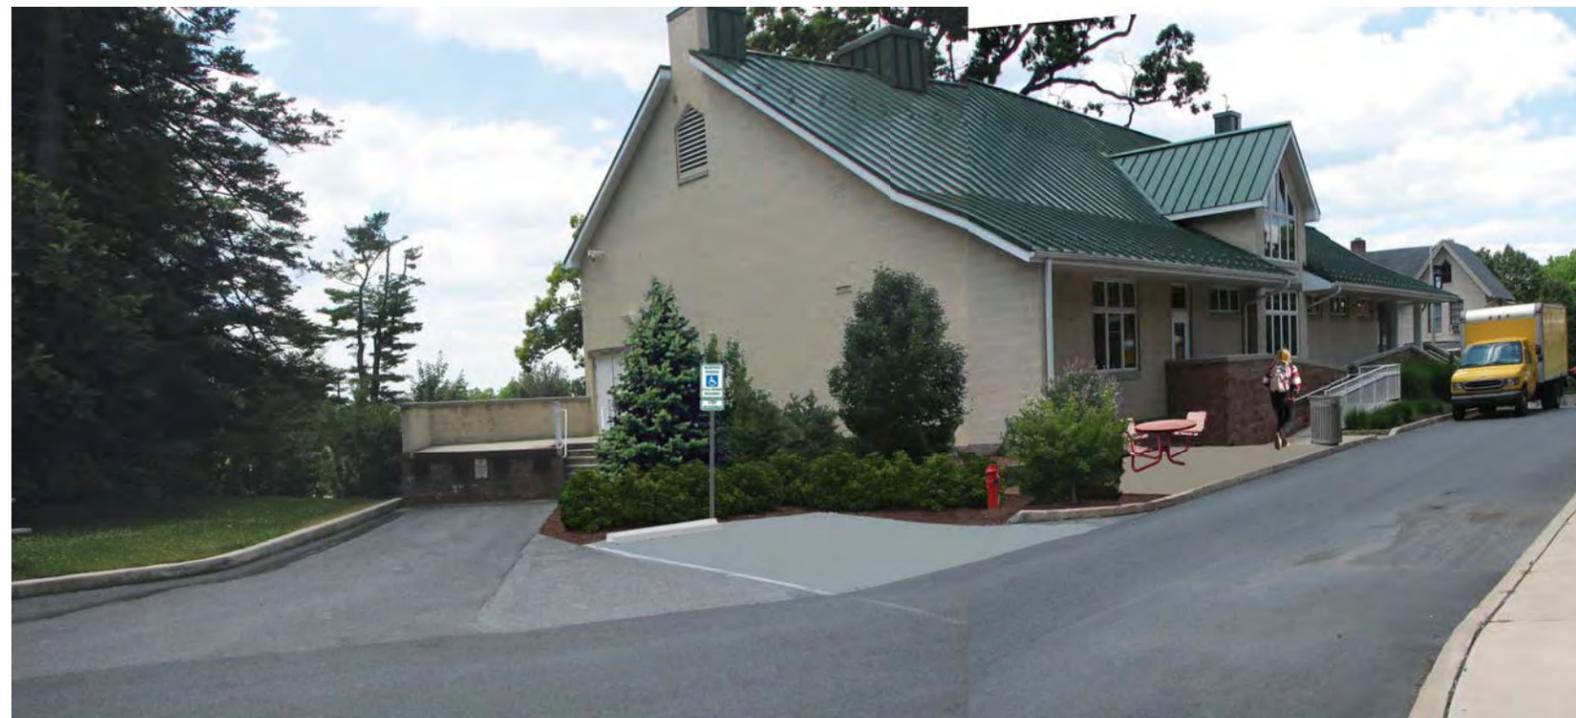
5H

The service function and mechanical equipment for the bookstore are exposed to view. Non-standard site furnishings on a gravel surface characterize the outdoor gathering space at this important campus hub.

Recommend that the corner be landscaped to screen the service and mechanical equipment. Pave the seating area and furnish with campus standard table and trash receptacle. Cover bright blue paint on pavement surface and provide handicapped stall signage.

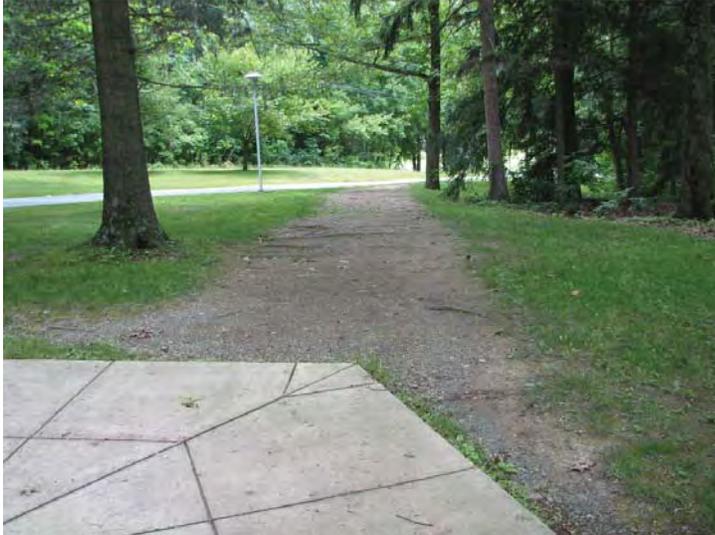
6A

The pedestrian route from the student parking lot to Mont Alto Hall is well established as is evidenced by the trail at left.

To facilitate this pedestrian flow it is recommended that the pathway be paved and the edges stabilized.

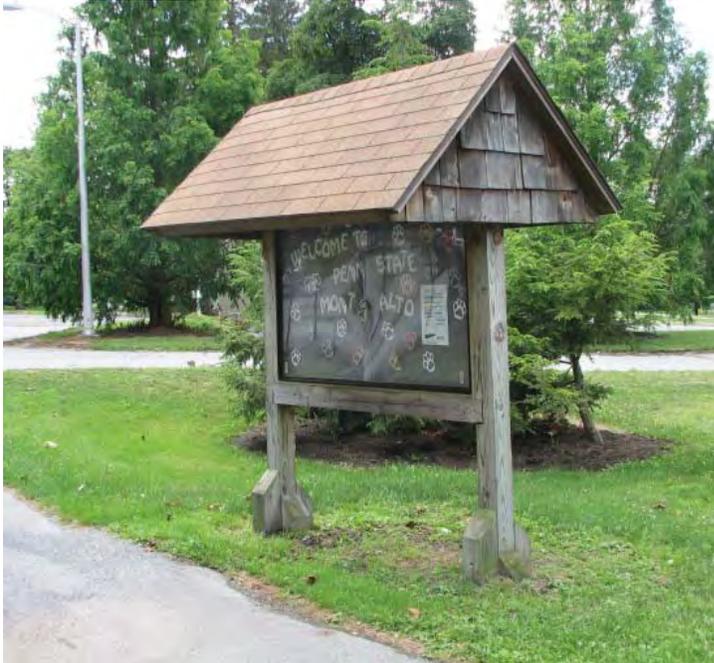
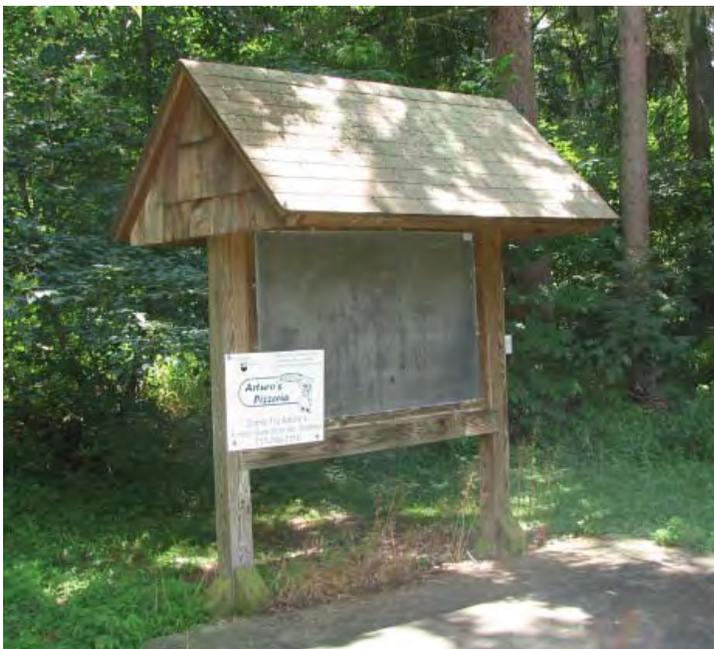
6B Post Boards

The rustic character of lumber and shingle style exterior post boards is not compatible with the image of quality and permanence of a Penn State campus. Management of content on post boards is often inconsistent.

It is recommended that the existing exterior wooden post boards be removed from campus.

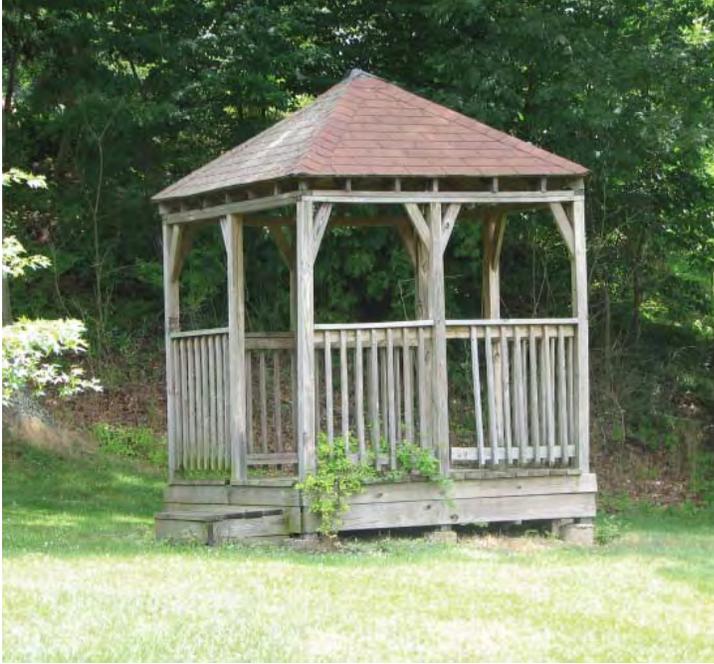
6c Gazebo

This existing wooden gazebo in the landscape is in disrepair. If it has no significant value to the campus then it should be removed. If it holds value then restoration is required.

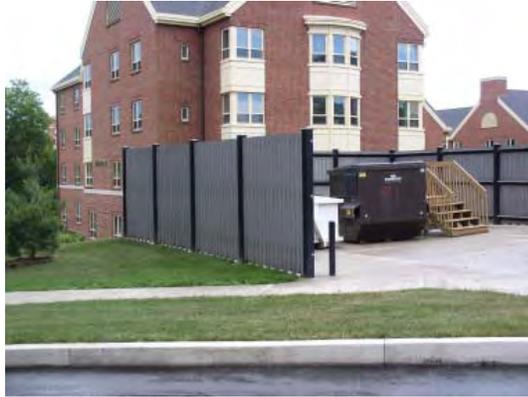
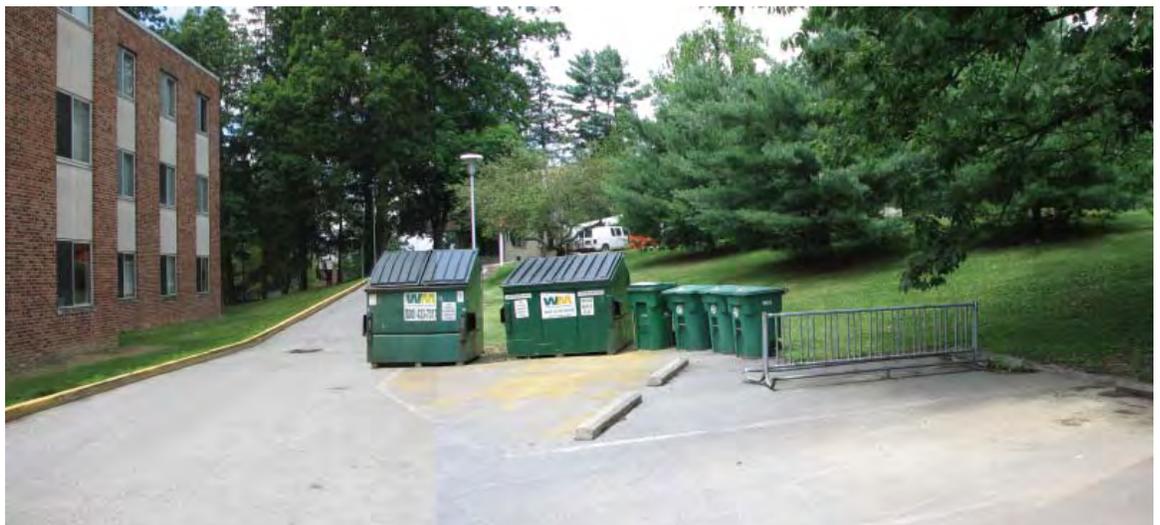
6D Dumpster Enclosure

Creating organized and efficient waste and recycling dumpster screening is necessary in order to present the best face of a campus. Success has been realized at University Park Campus through the use of wood or synthetic lumber enclosures.

Existing Condition

In addition, visual impact can be minimized by simply painting the dumpsters a neutral color that matches the enclosure.

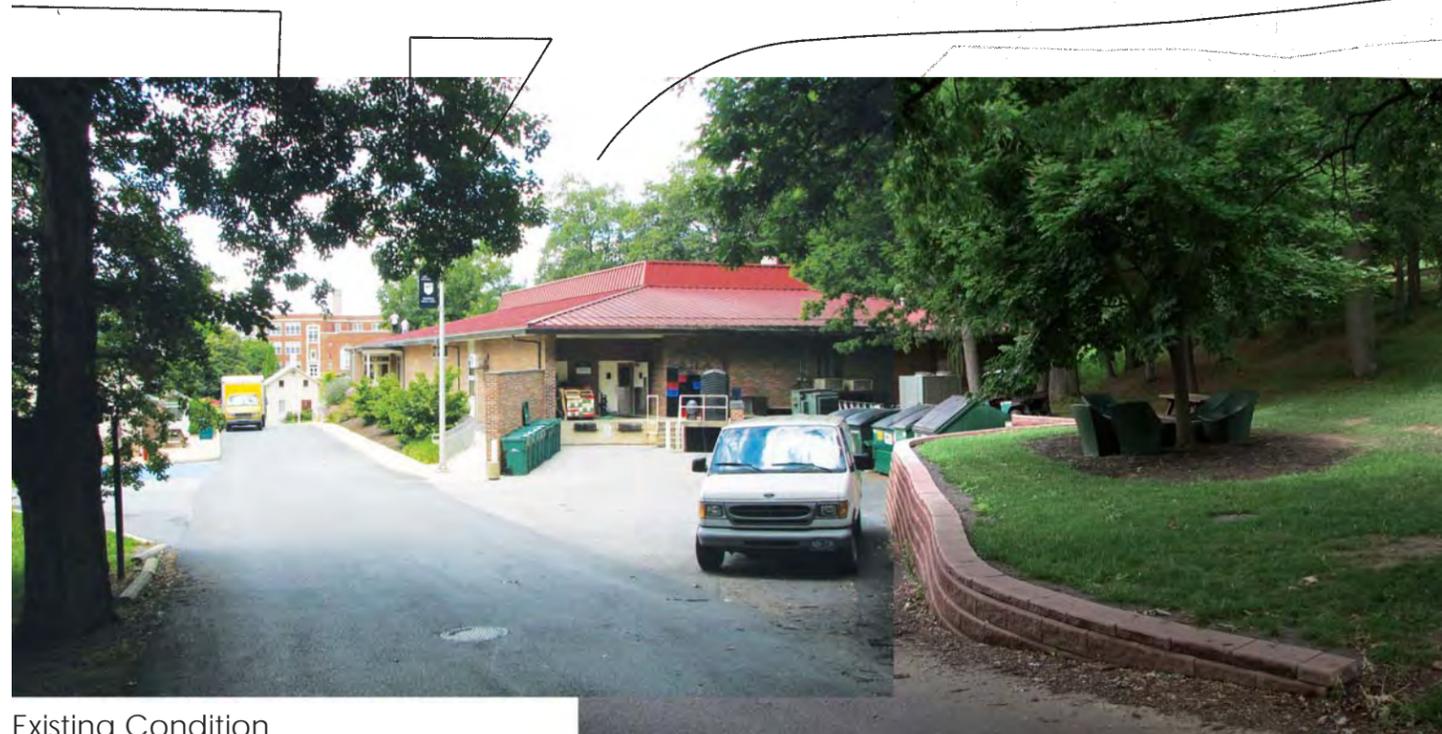
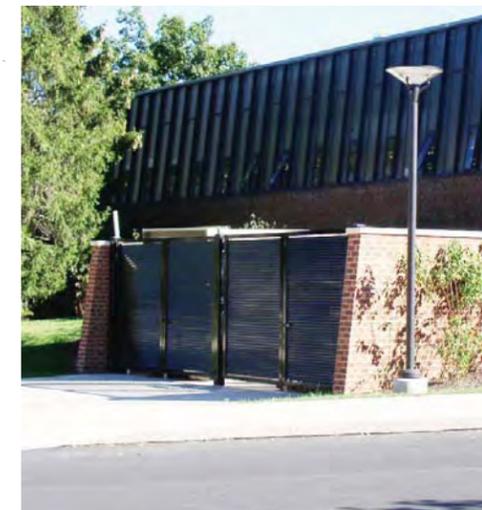
Foods Building Dock 6E

Service access to the Foods Building at its current location is necessary despite its unsightly appearance.

Existing Condition

One way to mitigate this aesthetic challenge while maintaining the functionality of this area is to screen with swinging gates.

Example of dumpster enclosure with view screening swing gates.

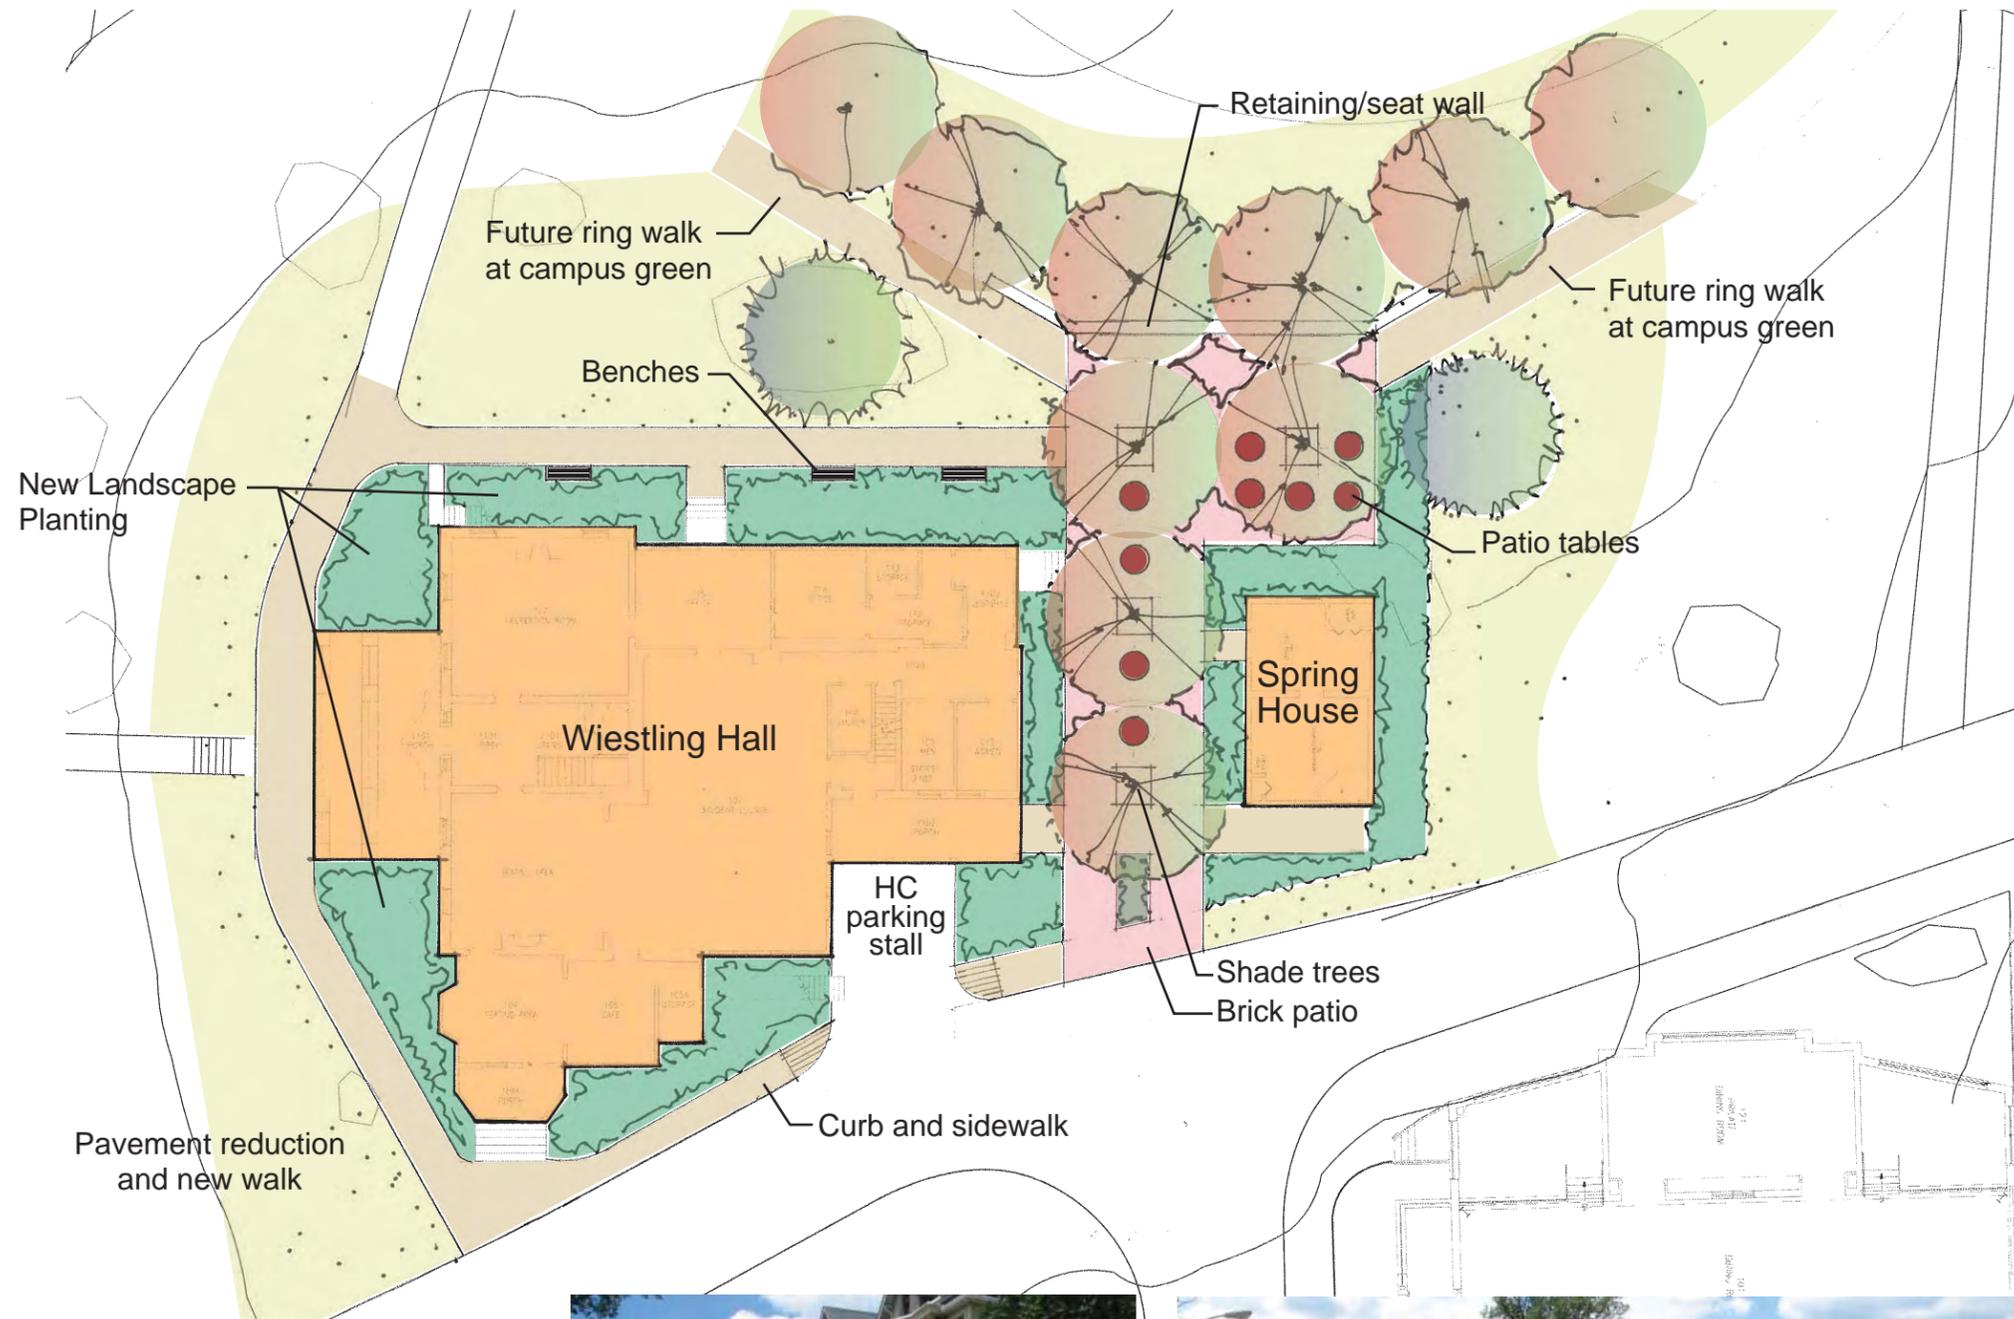
6F Wiestling Hall Patio and Landscape

Wiestling Hall is a primary student centered facility in the very heart of campus. Vehicular encroachment into the open space surrounding the building has been dramatically curtailed to the credit of the campus.

This concept drawing illustrates a truly pedestrian space with enhanced paved surface, dedicated table seating areas, reduced pavement and landscape enhancement.
