Penn State Berks

Campus Exterior Architectural Plan
July 2007

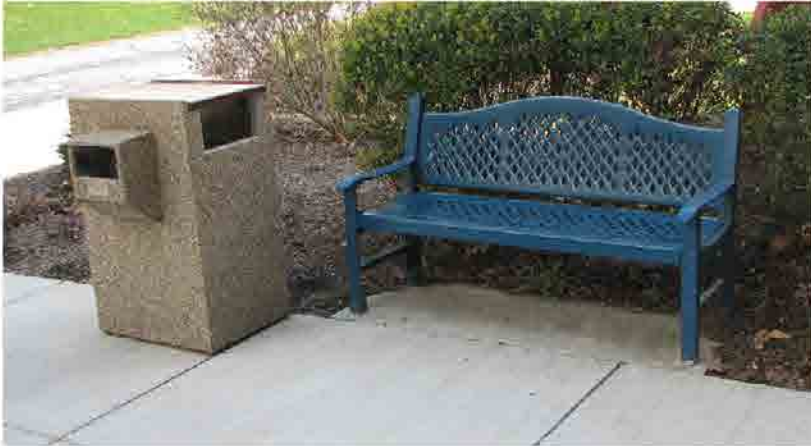
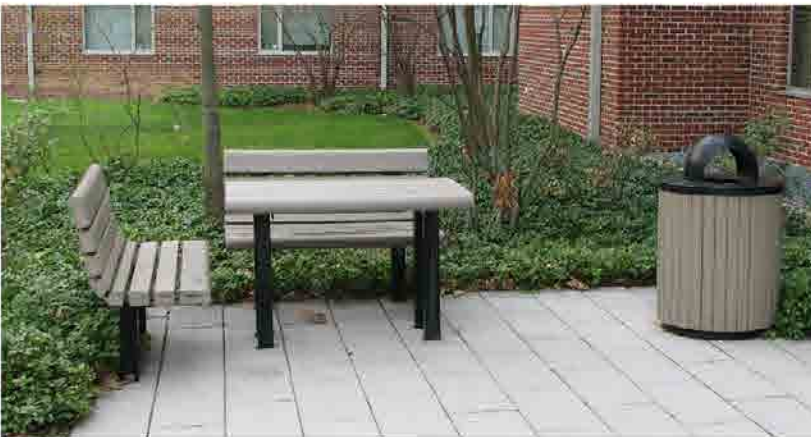
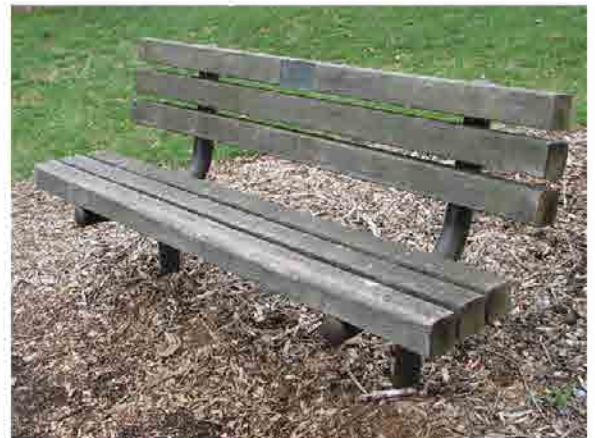
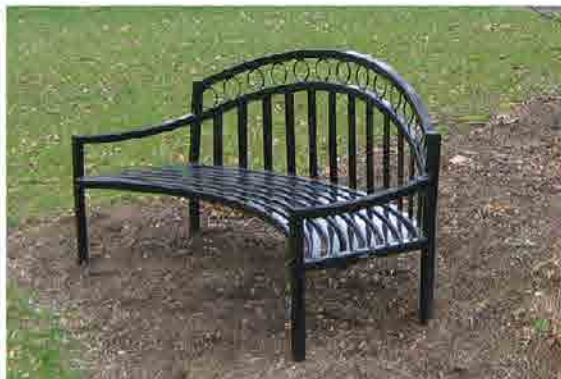
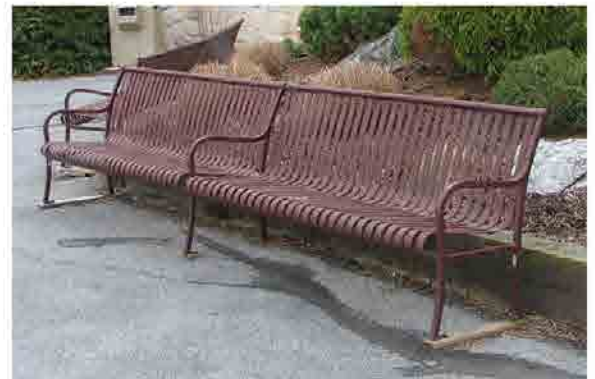
Benches and trash receptacles across the campus are varied in design, color and material. Furnishings are in good repair on the whole. It is recommended that a standard design for furnishings be selected that will aid in unifying the campus aesthetic.

In addition to aesthetic appropriateness, the longevity and maintenance of site furnishings should be considered when specifying.

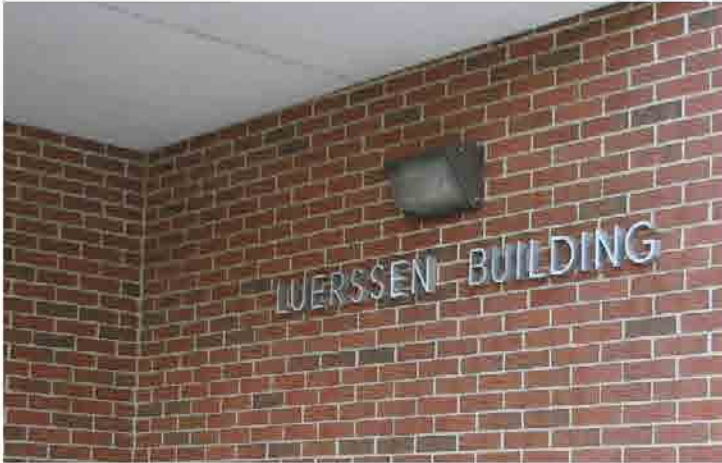
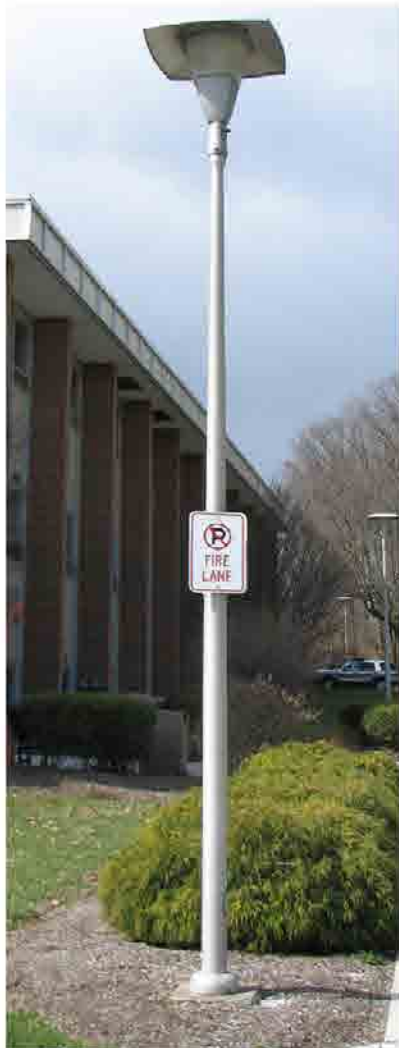
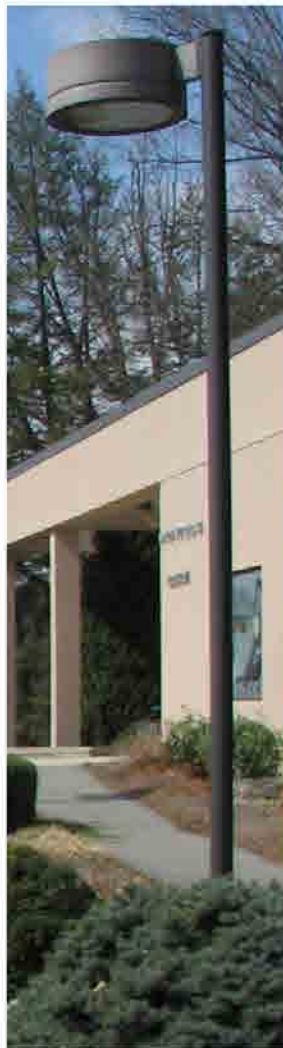
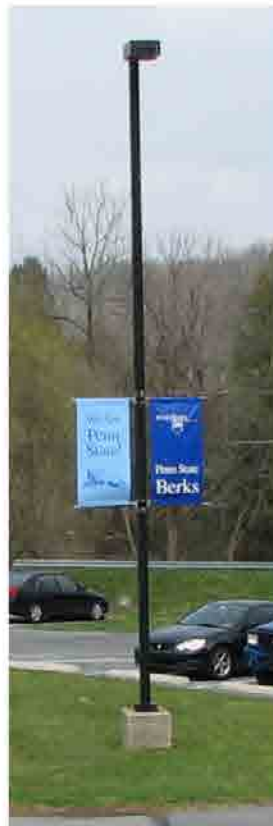
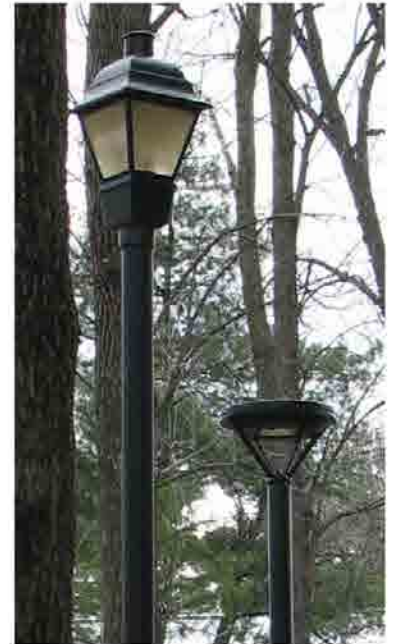
A variety of exterior lighting fixture types are present on campus. As with site furnishings, it is recommended that design standards for parking lot/roadway and pedestrian site lighting be identified and implemented across campus. Full Cut-off luminaires that mitigate light pollution should be used. Metal Halide lamps on pedestrian walkways is recommended.

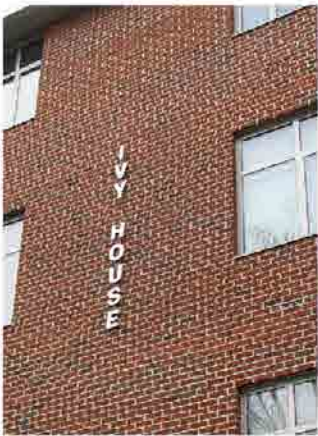
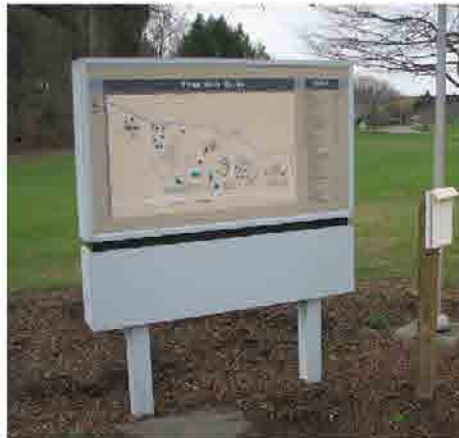
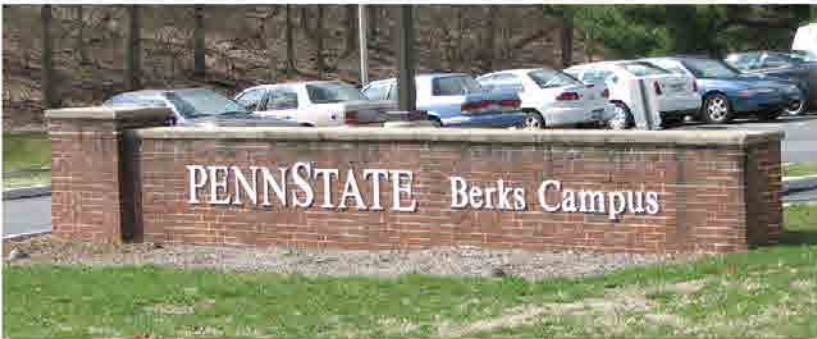
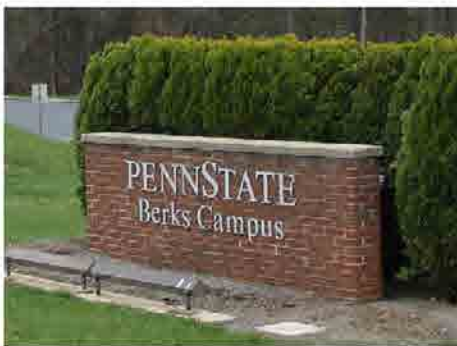
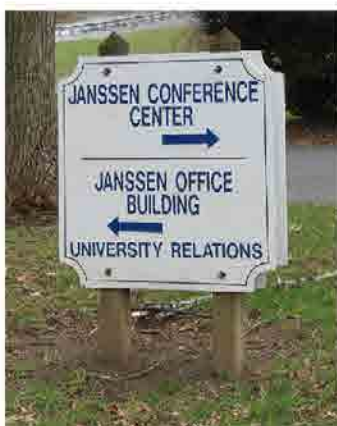
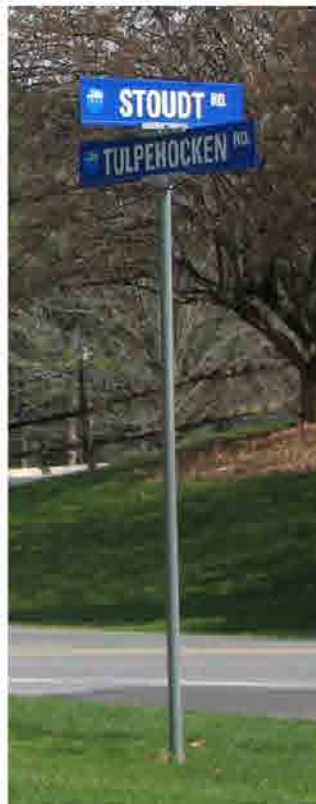
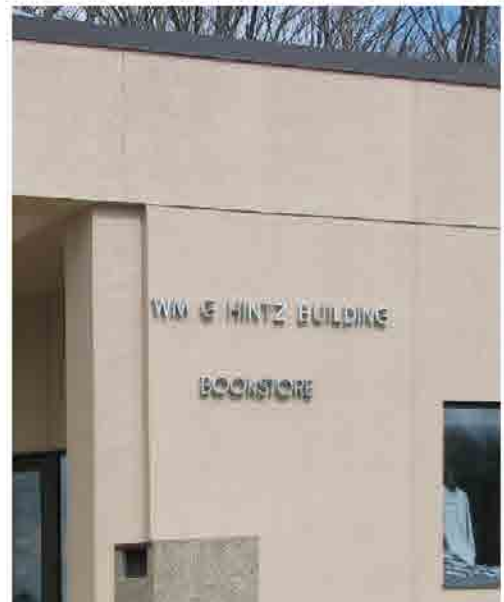
Consistent design and placement of signage is key to a unified aesthetic as well as an intuitive and clear means of way finding. Campus maps are present and partially conform to the University standard. Building identification signs are consistent stylistically though difficult to read in some cases.

Entrance signage should be upgraded to reflect the campus mark and establish a clear entrance.

It is recommended that the PSU sign standards be implemented at the campus.

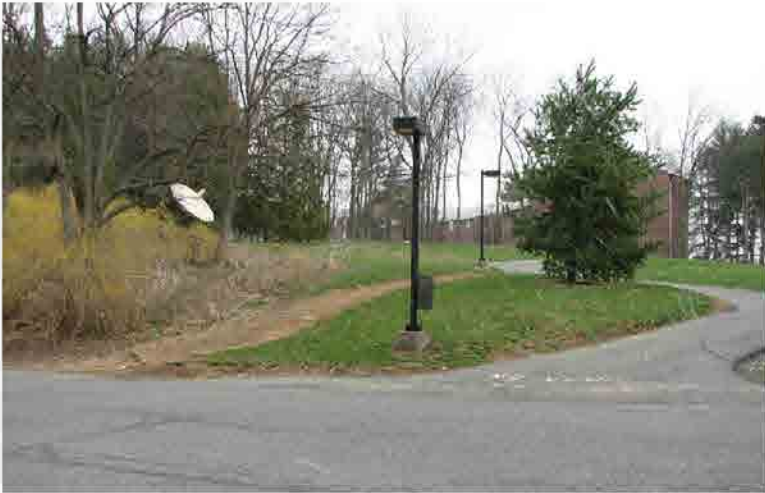
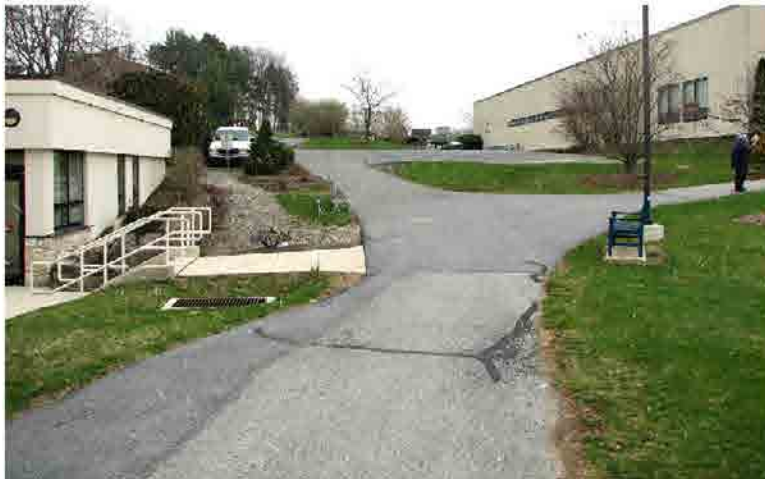
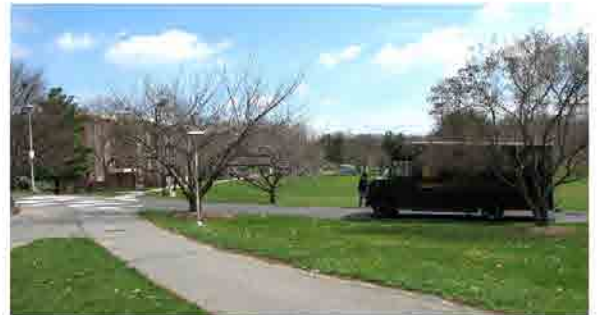
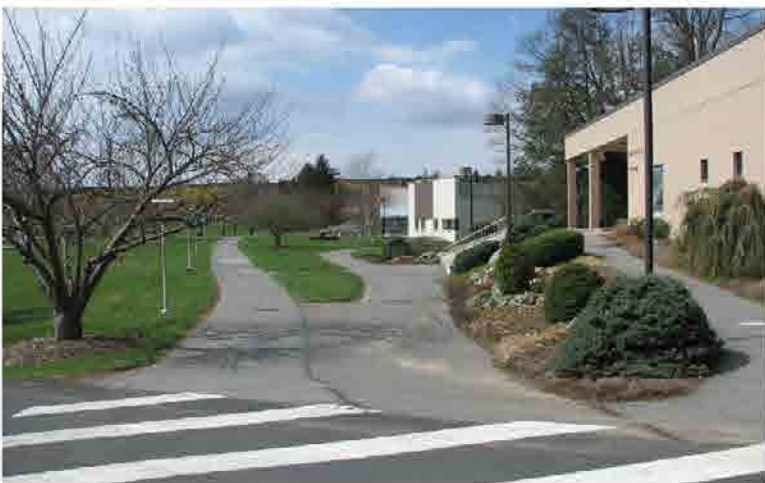
The system of pedestrian walkways through and around campus appear to have evolved based on pedestrian desire. There are redundant walkways in some areas and absence of improved walks in others resulting in "cow paths". The use of concrete in lieu of asphalt for walkway surfacing is recommended. Conflicts with vehicular circulation are noted.

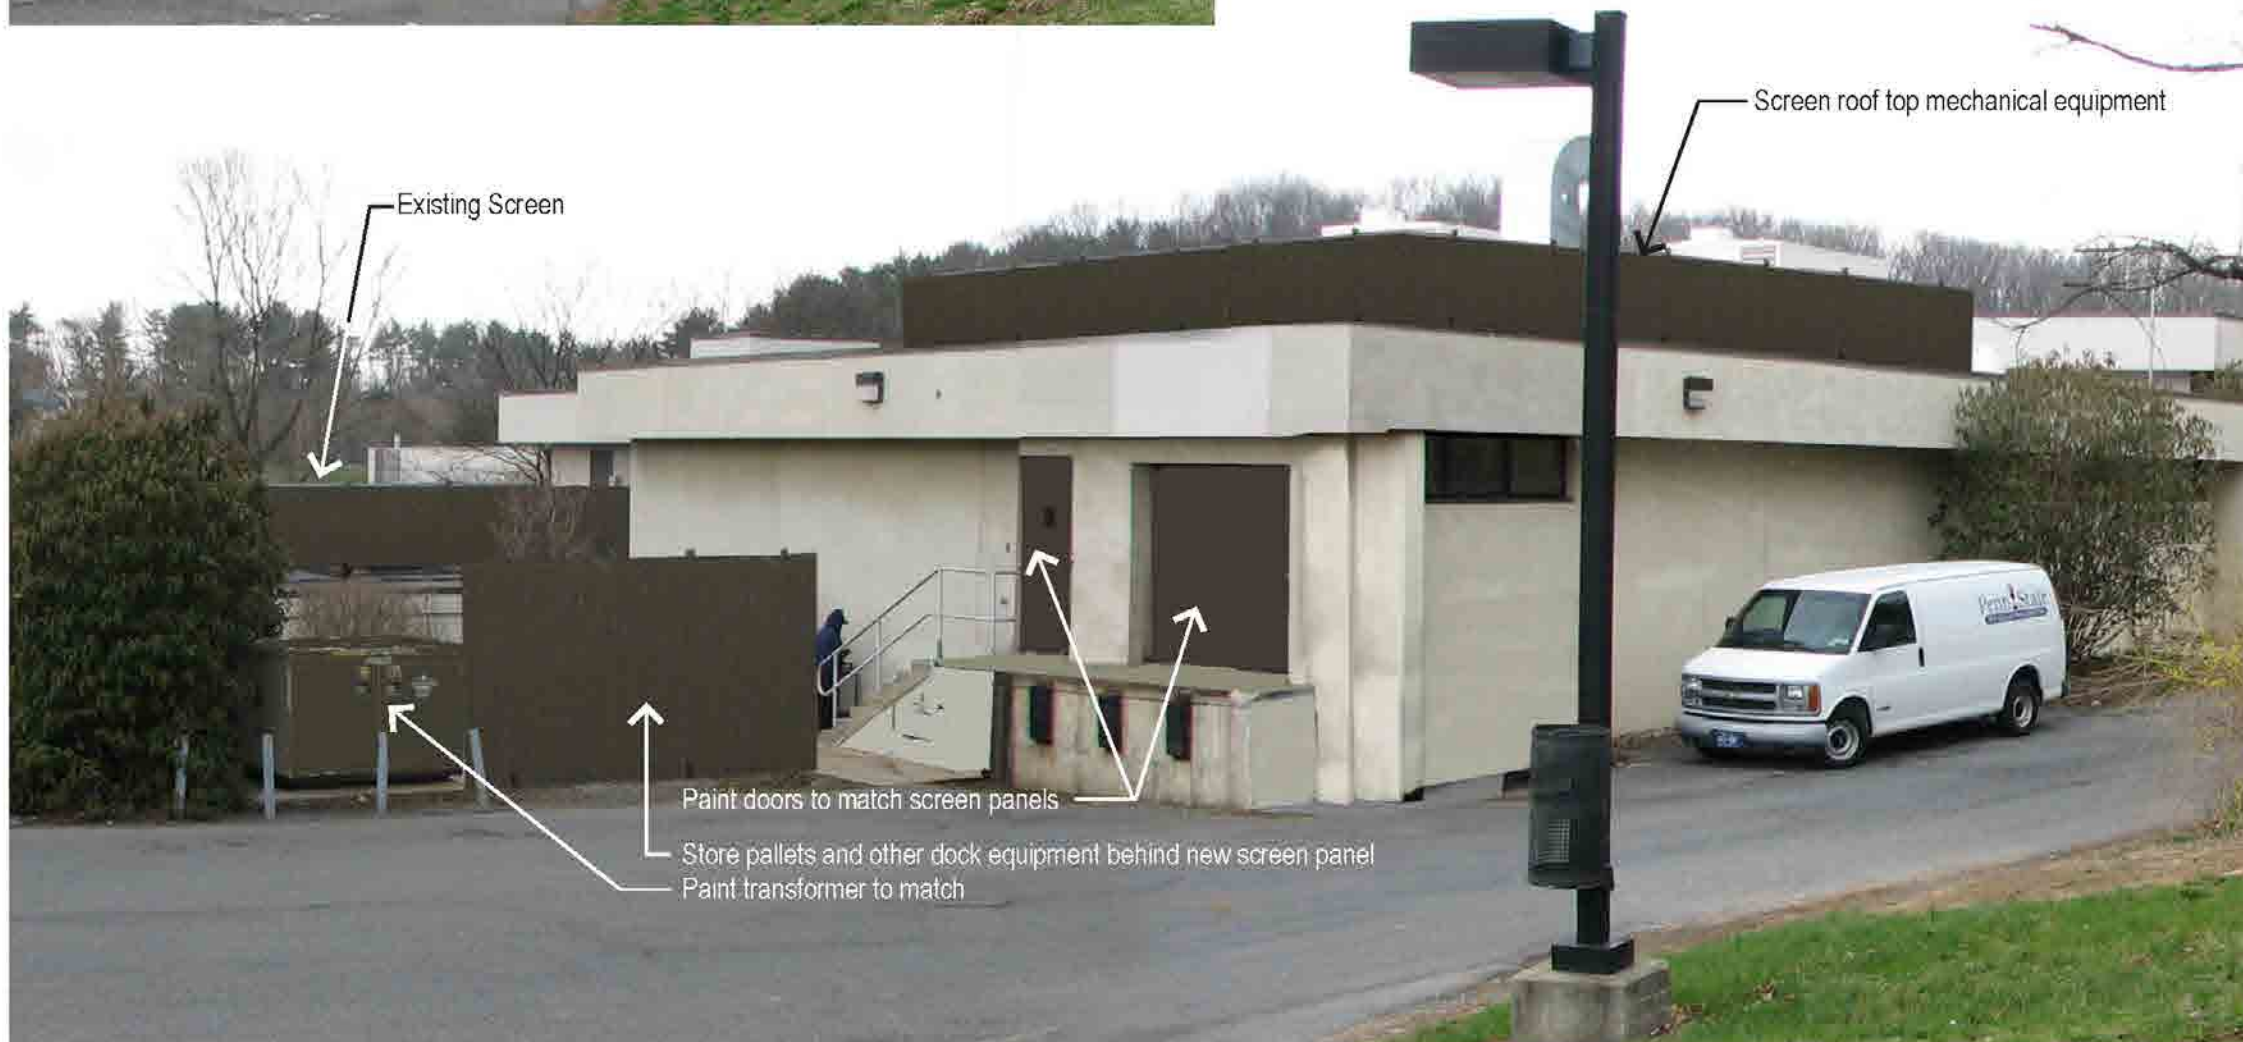
Existing Screen

Screen roof top mechanical equipment

Recommend that the equipment be screened like other equipment on the west side of the building. In addition, a screen panel could be erected at the dock to hide other unsightly utility equipment as well as providing a place to store temporary delivery paraphernalia. The existing electrical transformer and building entrance doors should be painted to match the screen panel.

- Paint doors to match screen panels
- Store pallets and other dock equipment behind new screen panel
- Paint transformer to match

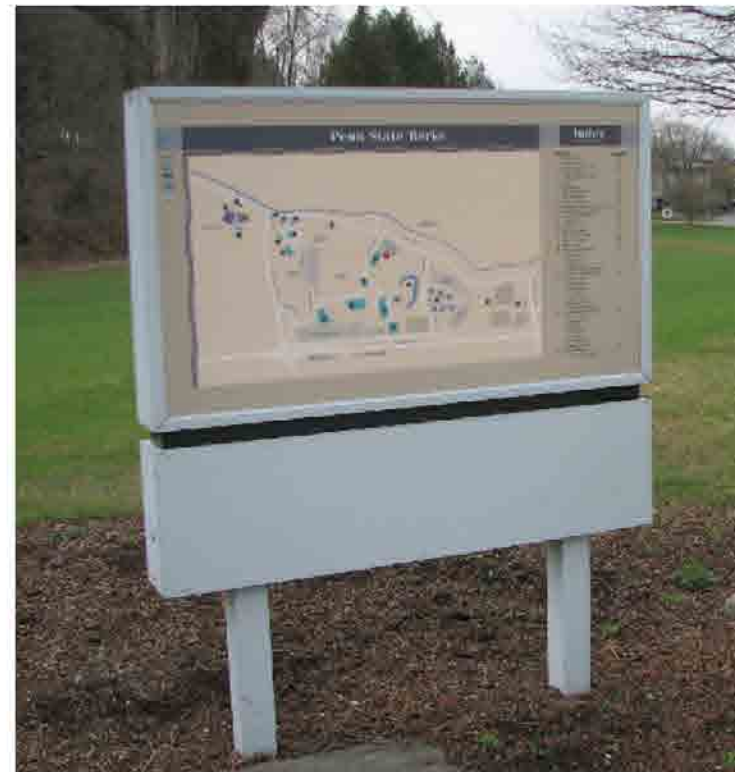
Existing Campus Map

- Existing parking regulatory signage is difficult to interpret and may be unenforceable.
- Recommend a comprehensive parking lot signage upgrade to clearly delineate regulated areas.
- Parking regulation signs should be removed from primary campus entrances.
- Location, size and design of campus maps should be included in the signage assessment.

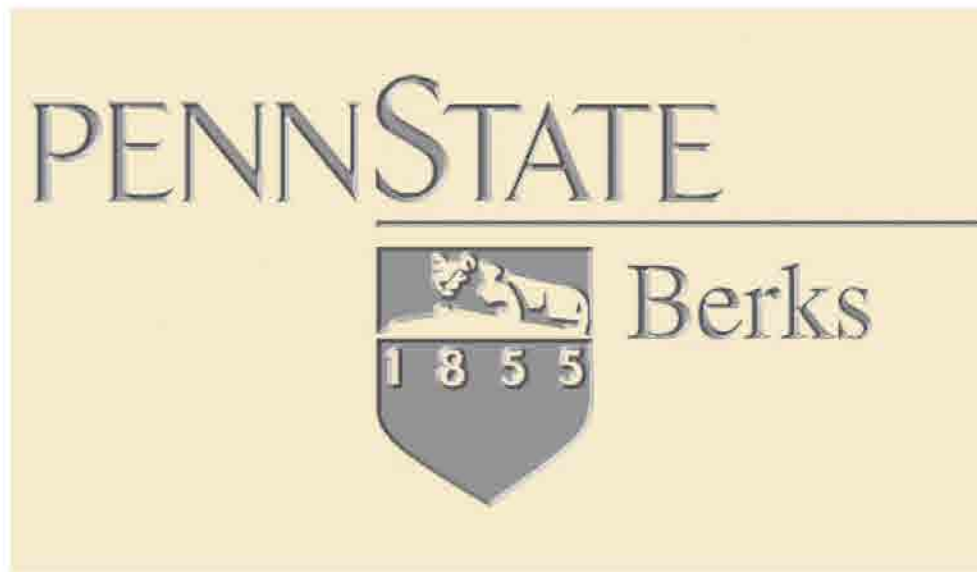
Existing Campus Sign

The primary campus identification sign at Broadcasting Road is insufficient in size, scale and quality to appropriately announce the campus.

Propose the development of a new monument size such as the one illustrated herein. The Berks campus identifier is shown in its correct proportion and graphic style.

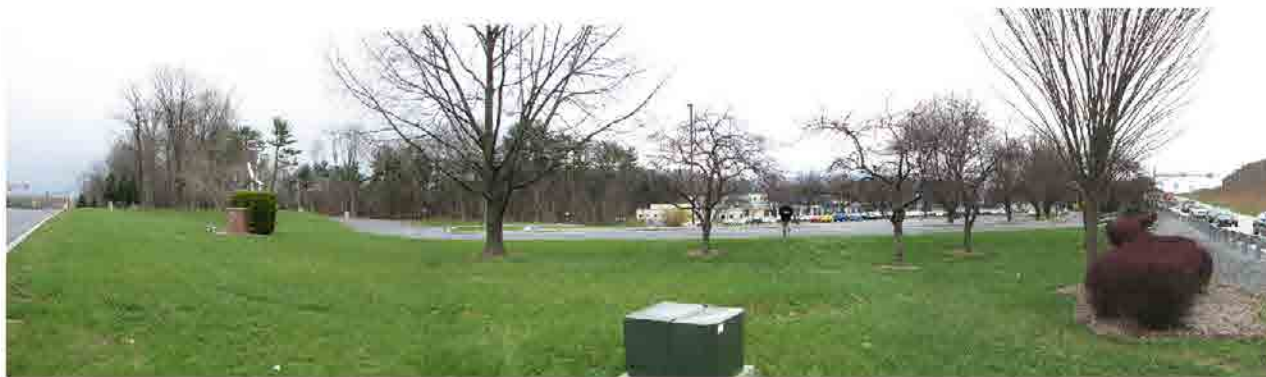
Existing view of campus from Broadcasting Road

The landscape character of the main entrance to campus is unembellished and sparse. Roadways and parking lots constitute the first impressions of campus. Positive impact at this front door to the campus requires supplemental landscape plantings including trees and shrubs (evergreen and deciduous). Careful integration of new campus identification and directional signage is also a primary objective of this enhancement.

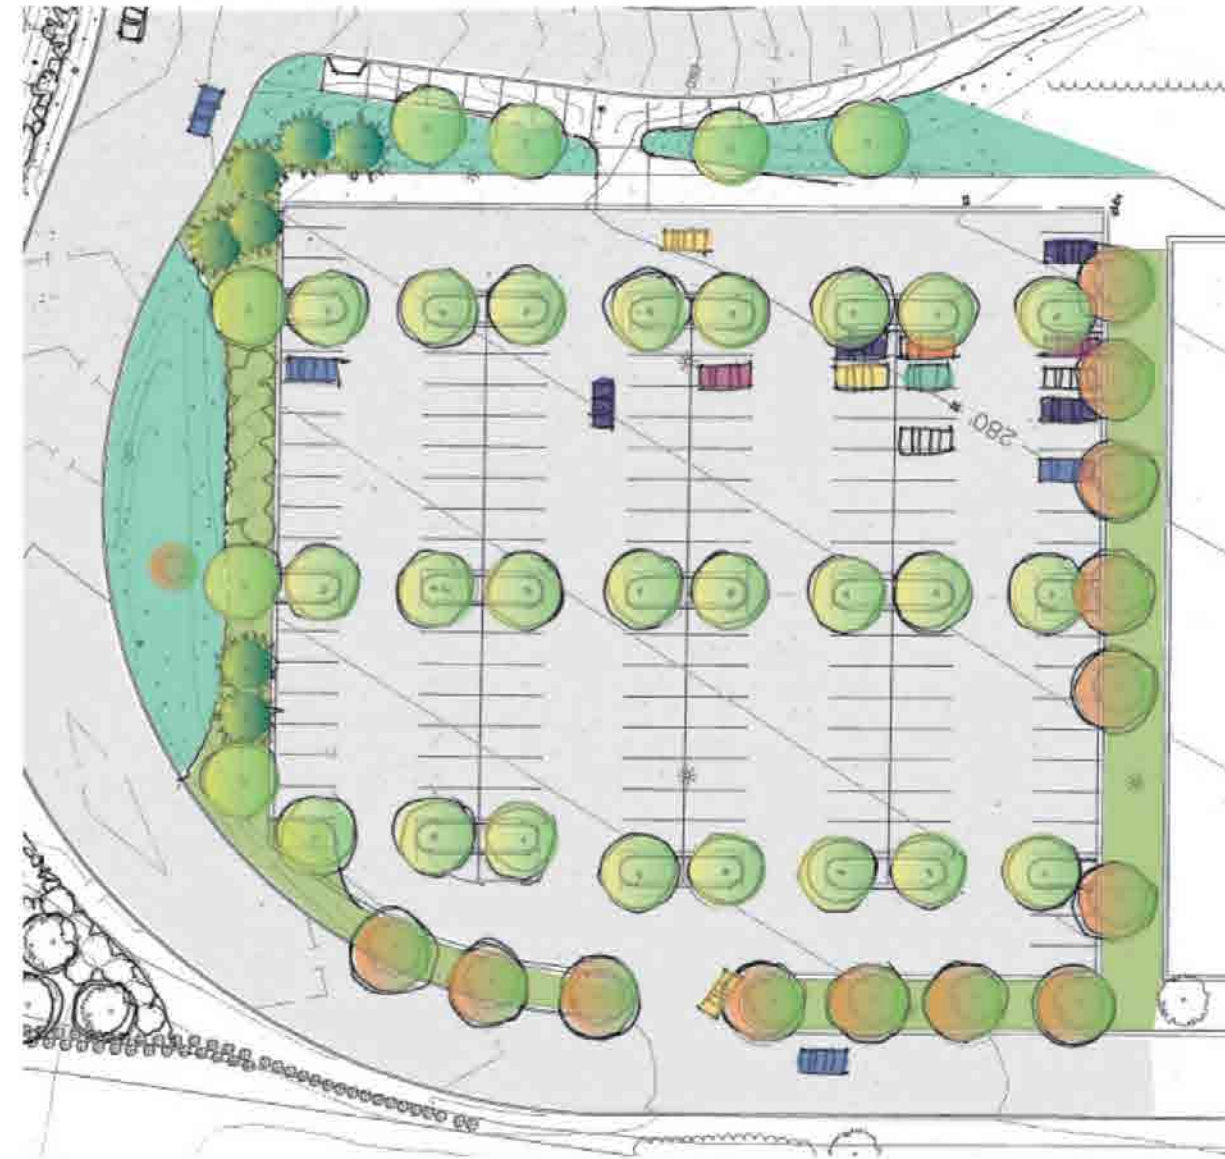
Existing Parking Lot at the campus entrance

Parking lots at the front door of campus are vast and unattractive. Visual quality can be improved through the installation of perimeter plantings and islands within the lots.

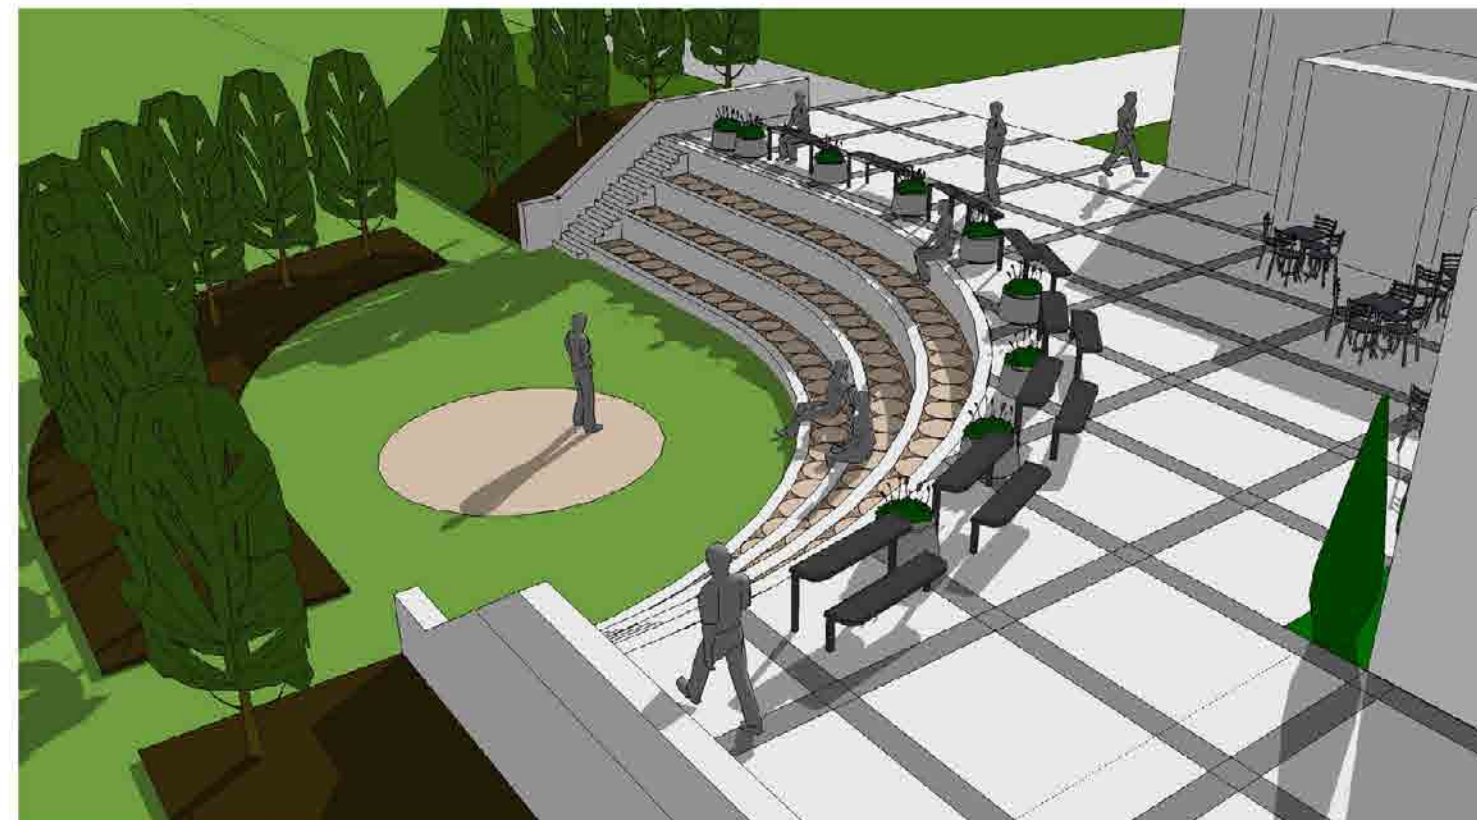
Existing Amphitheater

The vertical drop at the uppermost edge of the amphitheater is unprotected which could result in a fall. Recommend the installation of bench seats with tables to provide the necessary barrier as well as usable seating.

The focal point of the amphitheater is undefined. Recommend the installation of a hard surfaced stage from which to entertain or instruct. A visual backdrop to the stage area is necessary to define the focus of the amphitheater.

Recommend the replacement of turf seat steps with a paver that will provide a clean, supportive surface for seating as well as eliminating a high maintenance surface.

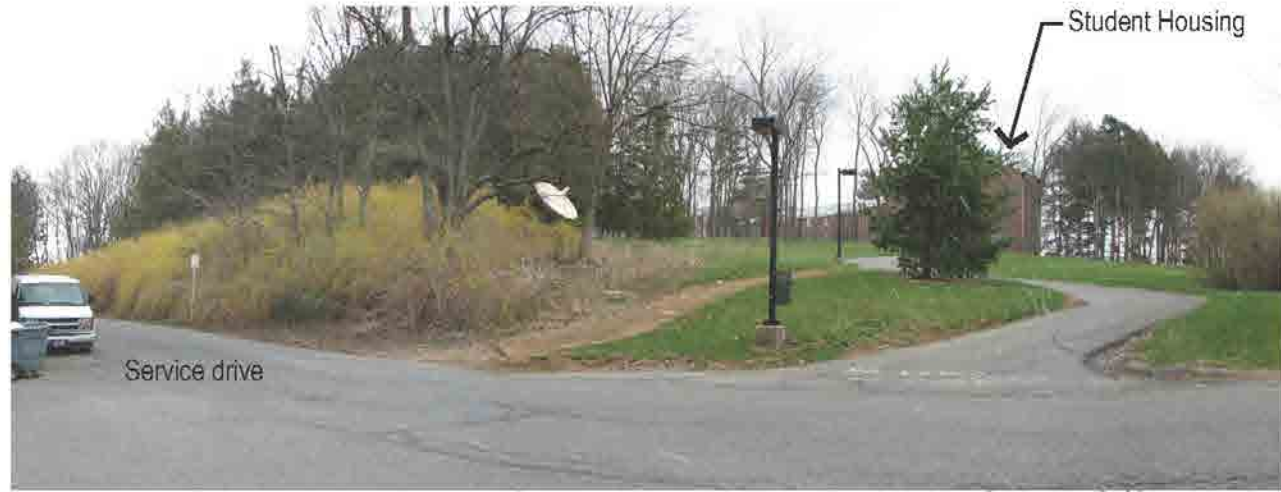
Existing

Pedestrian movement through planting areas is not a major problem at the campus. However in those instances where users require persuasion to utilize designated walkways it is recommended that a simple post and chain barrier be installed.

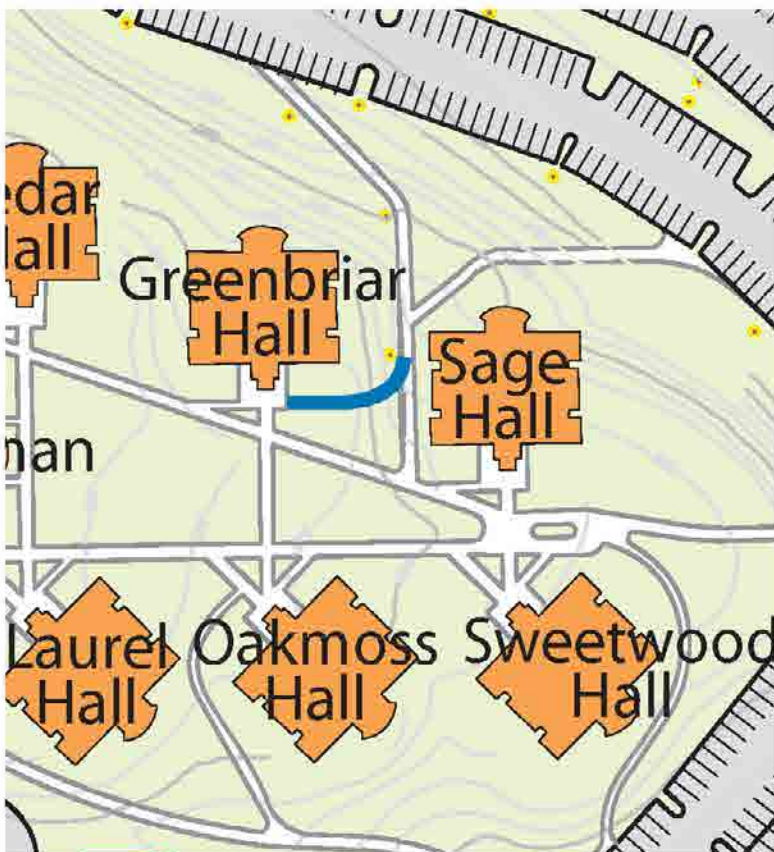
Existing Condition

The existing pedestrian circulation network between Greenbriar and Sage Halls inadequately accommodates movements between the commuter parking lot and core campus. It is recommended that a segment of walkway be constructed to eliminate the existing short-cut through the turf area.
