Penn State Schuylkill

Campus Exterior Architectural Plan
February 2009

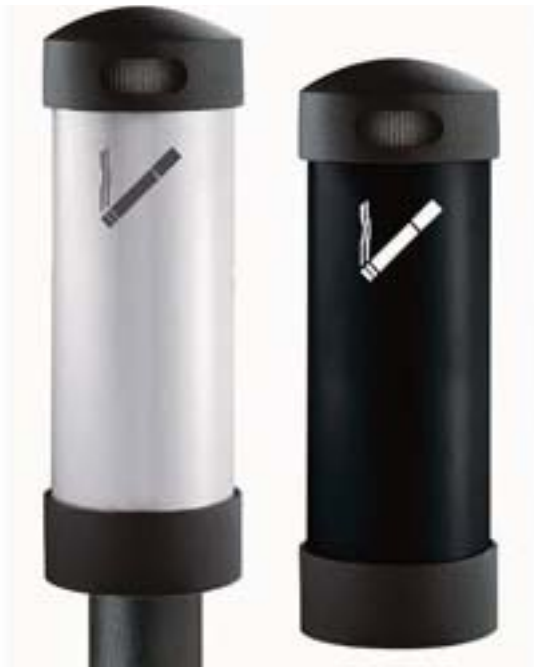
Existing

The existing cigarette ash receptacles should be replaced with a less conspicuous unit that can be pole mounted where needed, or attached to trash can receptacles. One option is shown below.

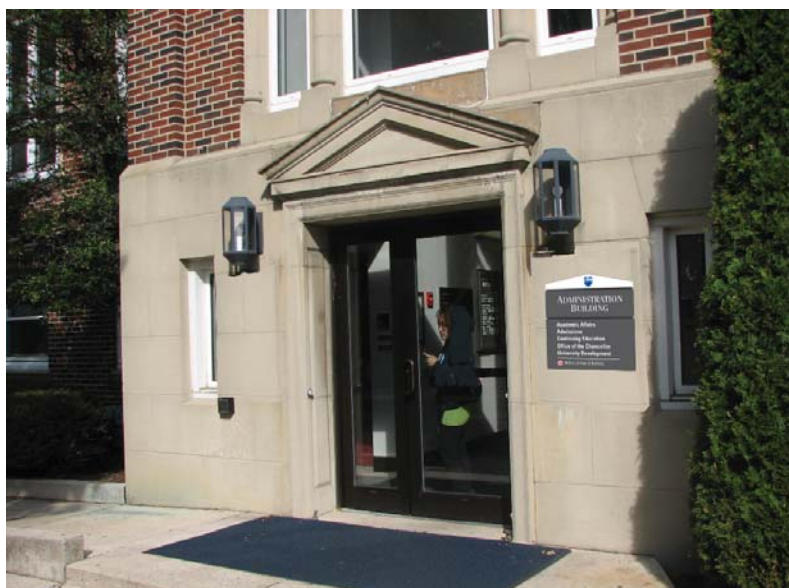
Existing

It is recommended that temporary posting cases be removed from the front of the Administration Building per the recently completed sign program.

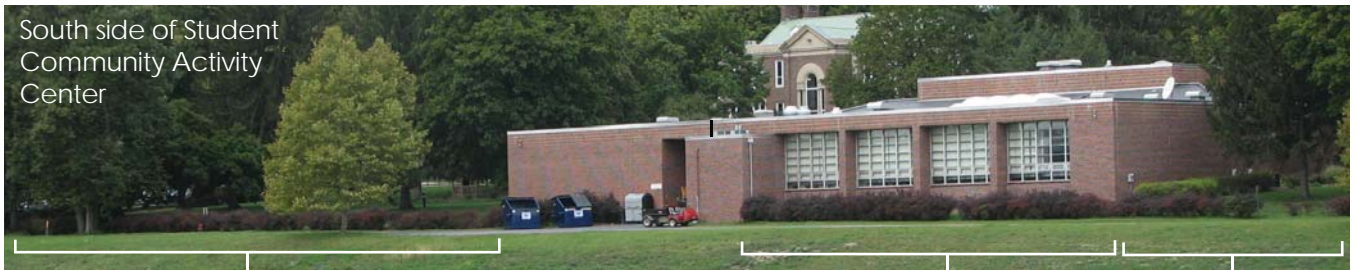
South side of Student
Community Activity
Center

Barberry is extensively used for hedging in the core of campus. Barberry forms dense stands in natural habitats and alters soil pH, nitrogen levels, and biological activity in the soil. Once established, barberry displaces native plants and reduces wildlife habitat and forage. The plant is spread into natural areas by birds that eat the plant berries. All barberry plants should be removed from campus and replaced, where necessary, with other forms of hedging and campus standard post and chain.

Hedges should be replaced with non-invasive plantings and post and chain where a physical separation is needed.

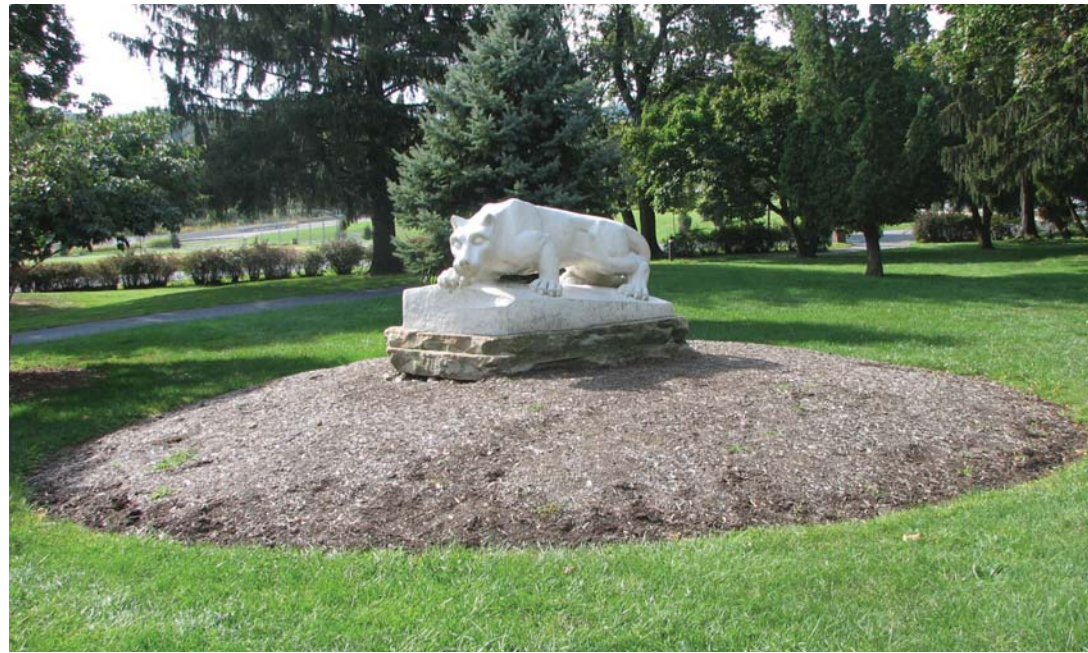
Existing Lion Shrine

Graduation day photos at the Lion shrine have become a Penn State tradition. The statue at this campus would benefit from some additional plantings to provide backdrop to the lion. Care should be taken not to obstruct views to the lion from the walkways on either side. May-blooming shrubs would provide color at the right time of year. The mountain laurels also relate the campus icon to its northeastern Pennsylvania setting by echoing the May-blooming shrub that covers much of the surrounding mountainsides.

The stone base of the lion statue itself needs to be repositioned to accurately depict the angle of the lion statue at the University Park campus.

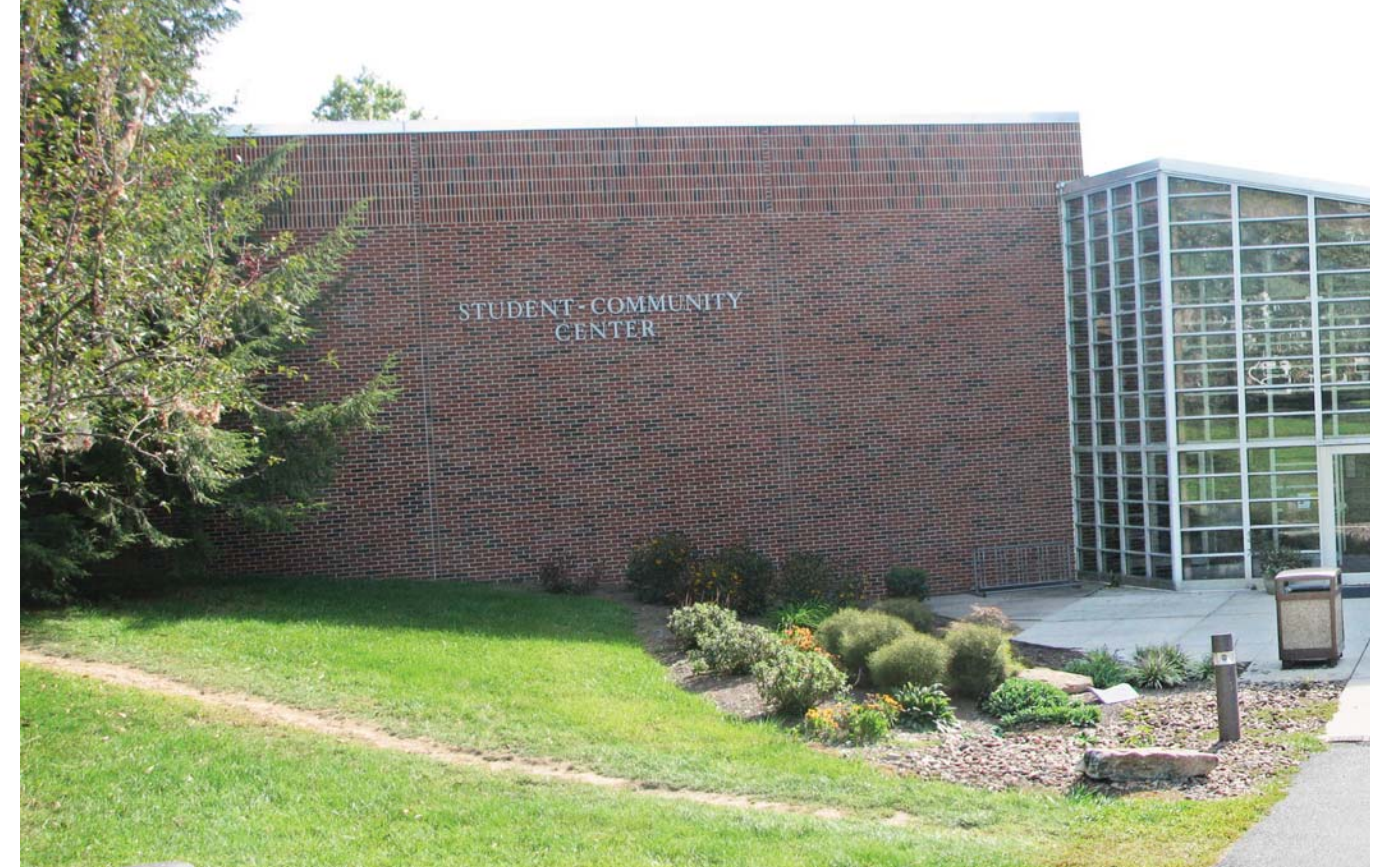
Before

The existing pedestrian circulation network between the mall and the west entrance to the Student Community Activity Center inadequately accomodates movements between these two areas. It is recommended that a segment of walkway be constructed to eliminate the existing short-cut through the lawn. Stairs would be required to negotiate the existing grade change.

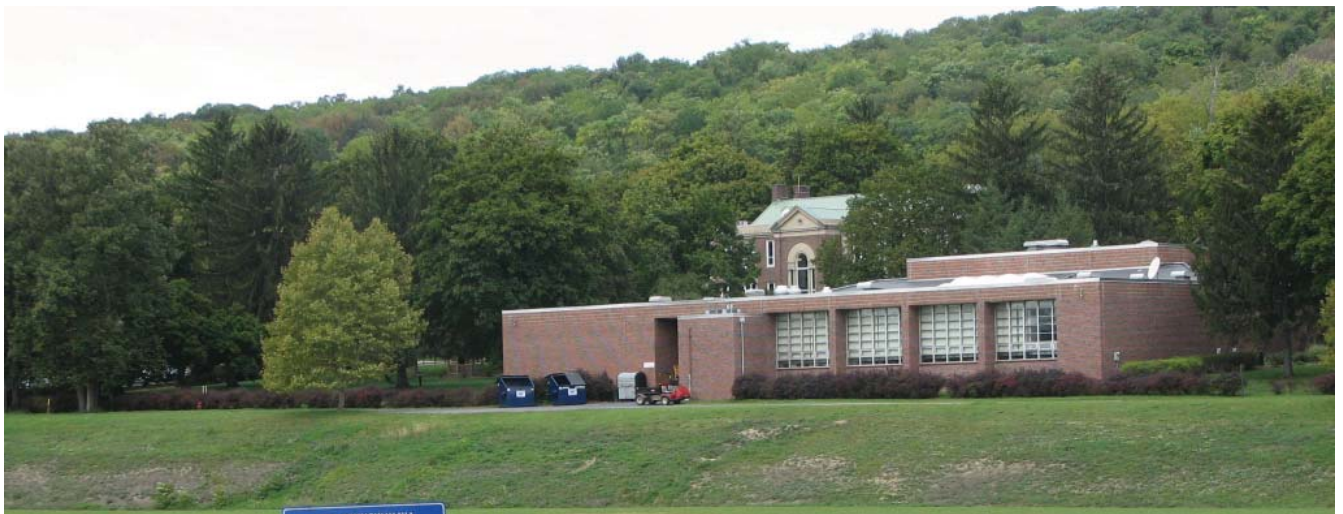
Existing

An opportunity exists to improve the view of campus from Route 61. The addition of trees on the bank on the north side of the athletic fields would soften this view and provide screening for the service functions and dumpsters behind the Student Community Activity Center.

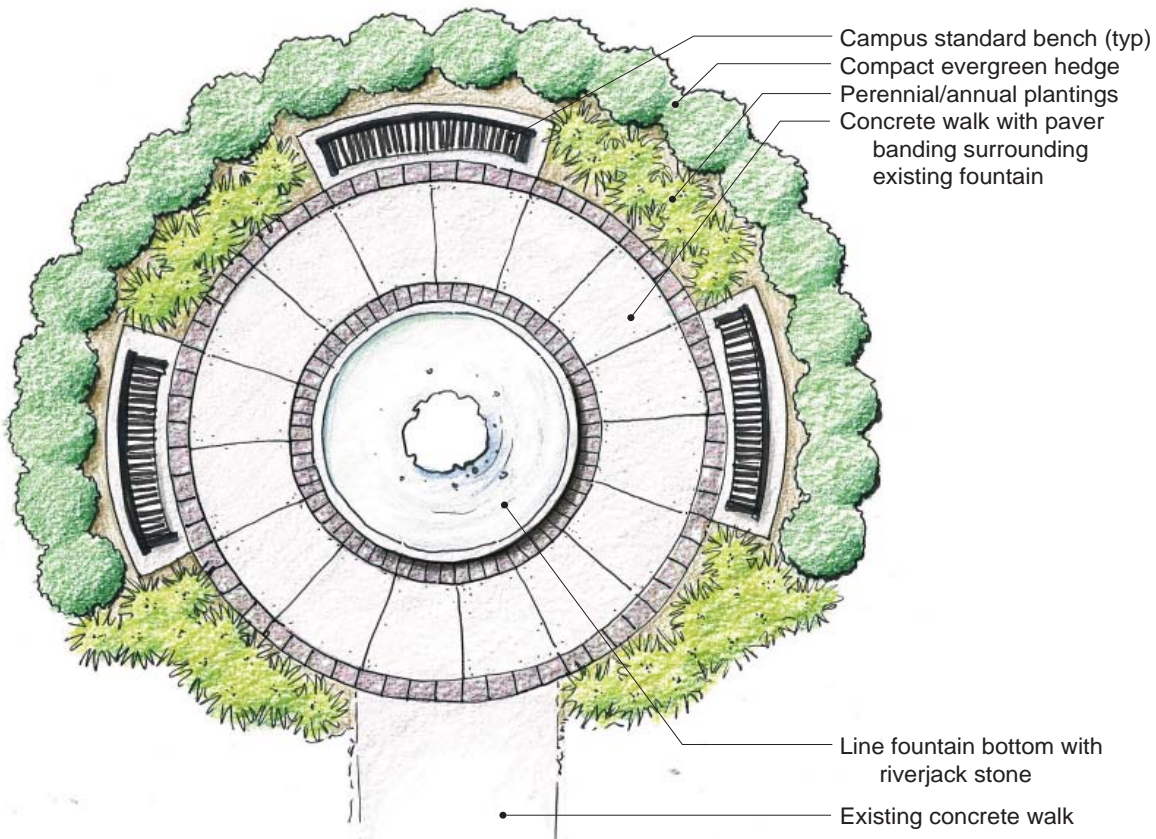
Existing

The existing fountain is a remnant from original property that was donated to the University in 1966. An opportunity exists to strengthen the visual impact of this central feature. A shallow layer of riverjack stone in the fountain pool to cover piping is suggested. A concrete walk surround is recommended as well as supplemental landscape plantings. Benches would accommodate users wishing to linger.

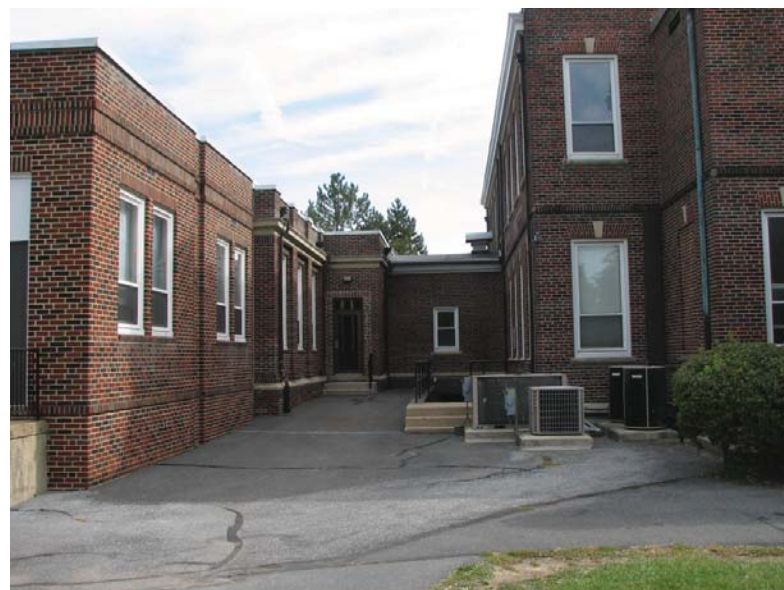
Existing main west entrance from parking lot

The path that leads to the main west entrance should be straightened and paved with concrete. It is recommended that all proposed sidewalks be concrete, not asphalt.

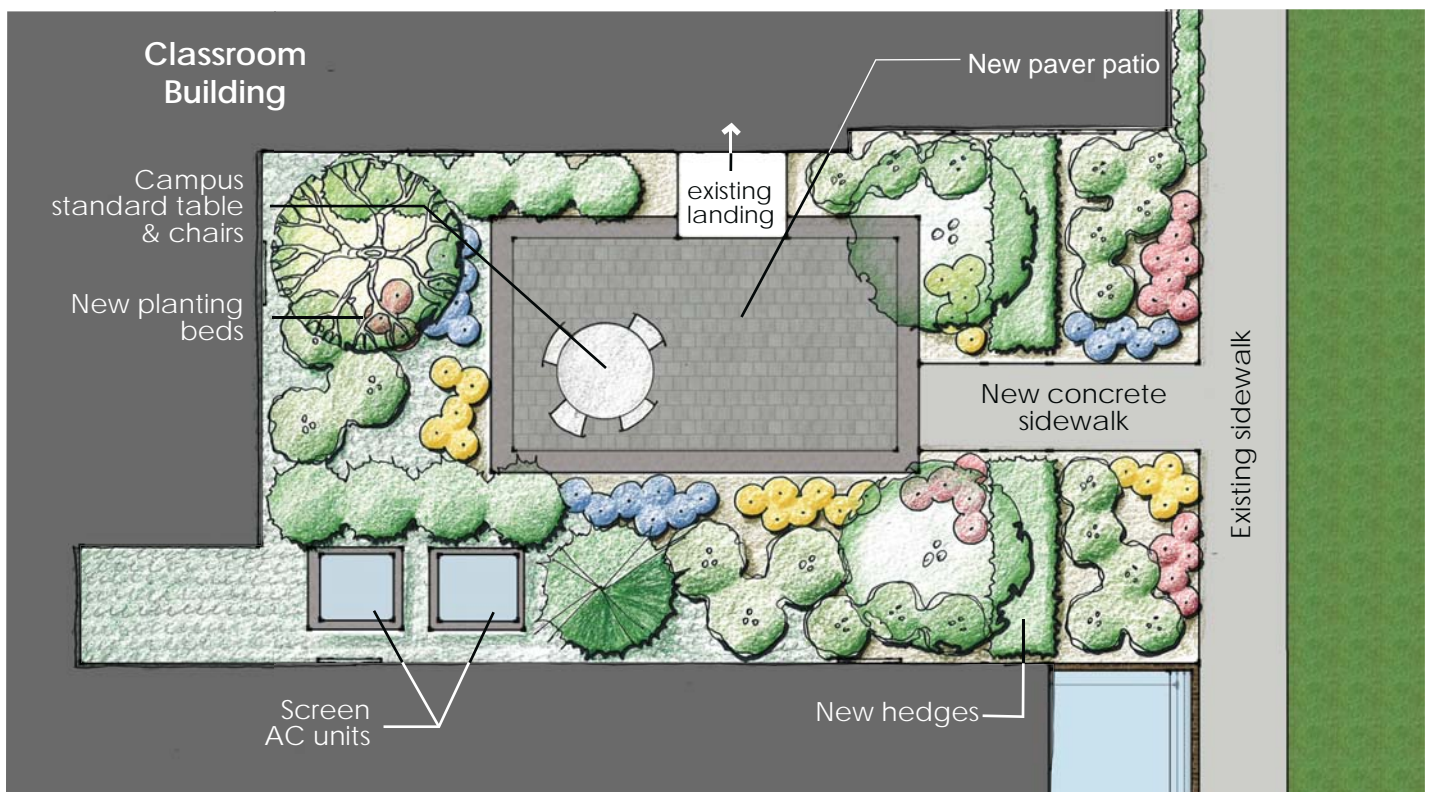
4R

The east frontage of the Classroom Building is punctuated by an undeveloped courtyard space containing AC units and a secondary entrance into the building. An opportunity exists to create an intimate seating space while structurally unifying the “missing tooth” in the building frontage with hedges.

Existing secondary entrance on east side of building

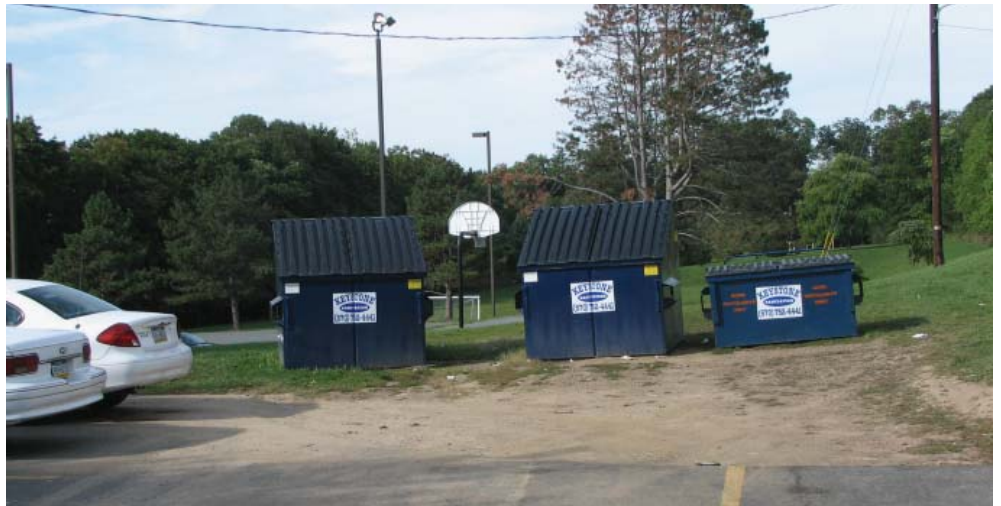
5A

Before

Screen enclosures block undesirable views, as well as contain the spread of dumpsters.

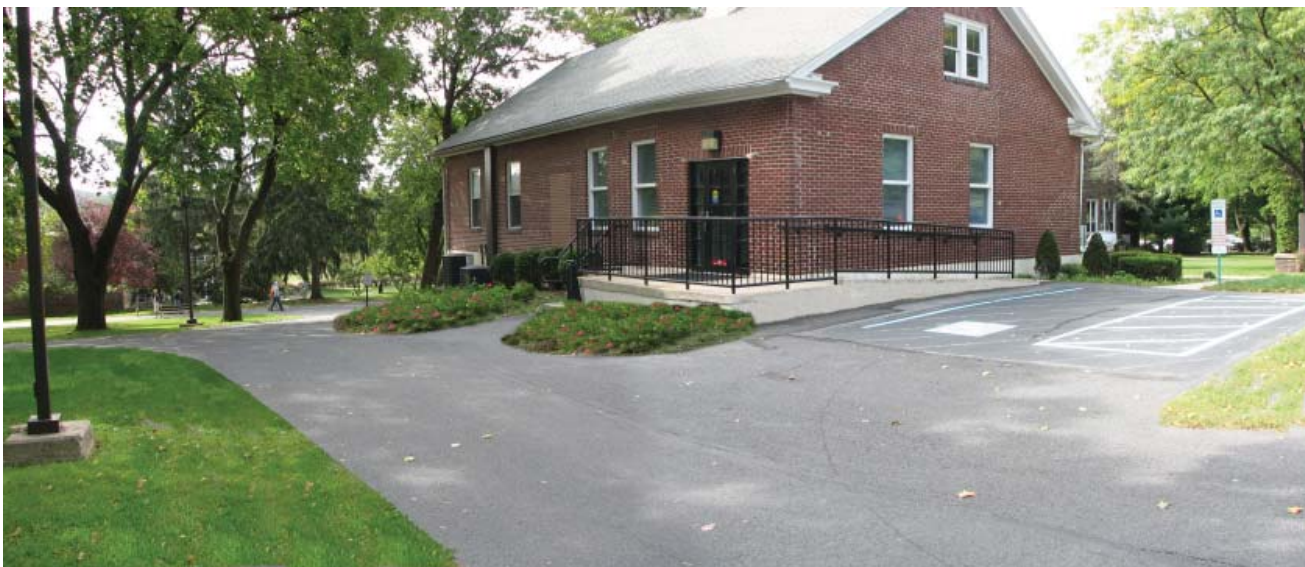
Before

The opportunity exists to reduce pavement. A minor vehicular cartway need be no more than 11' in width. The "after" photo below also shows a repaired and cleaned accessible ramp.
