York

Campus Exterior Architectural Plan November 2006

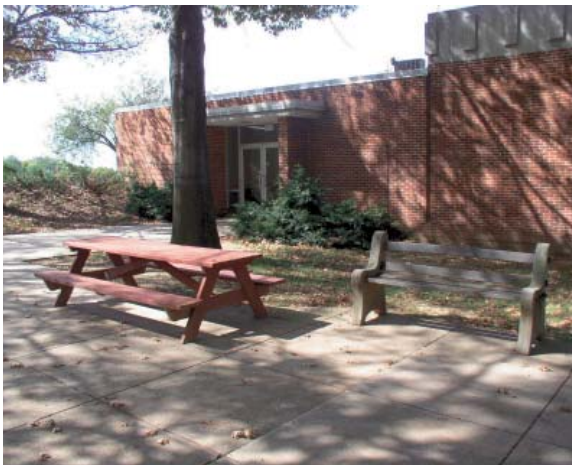
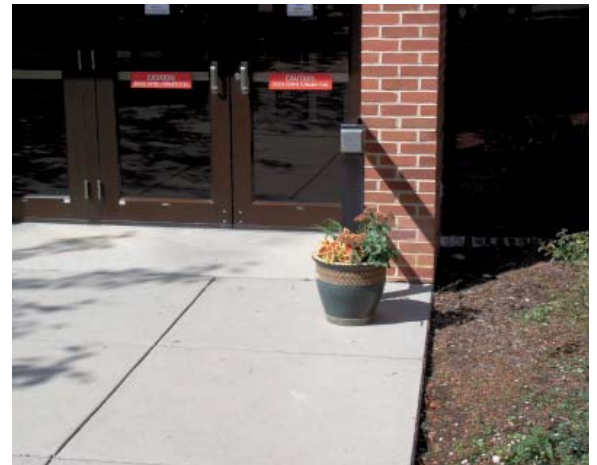
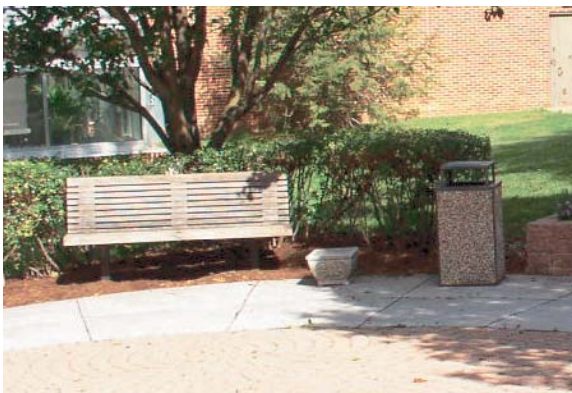
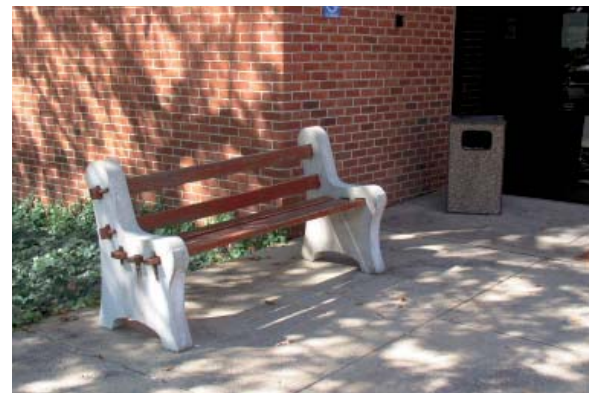
A variety of types and styles of benches, tables, trash receptacles and planters exist across the campus. The opportunity exists to establish a uniform aesthetic character, campus wide, through the use of stylistically complimentary and suitably scaled furnishings.

In addition to aesthetic appropriateness, the longevity and maintenance of site furnishings should be considered when specifying.

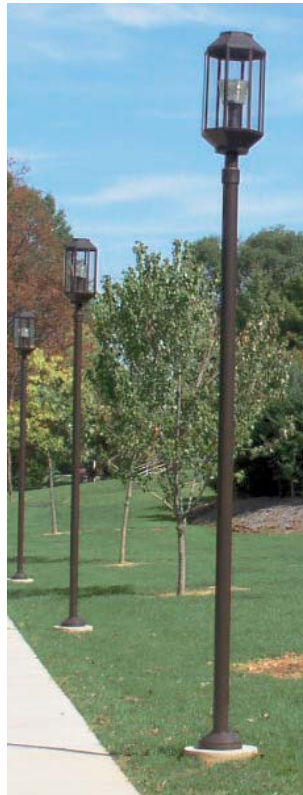
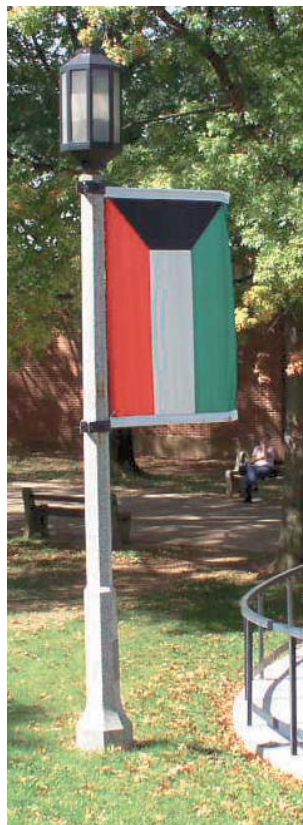
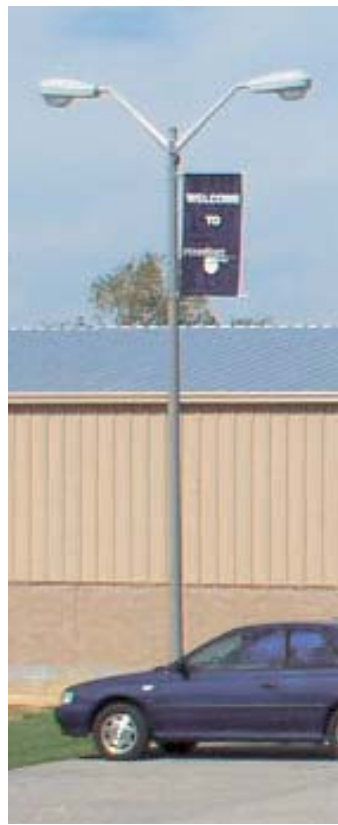
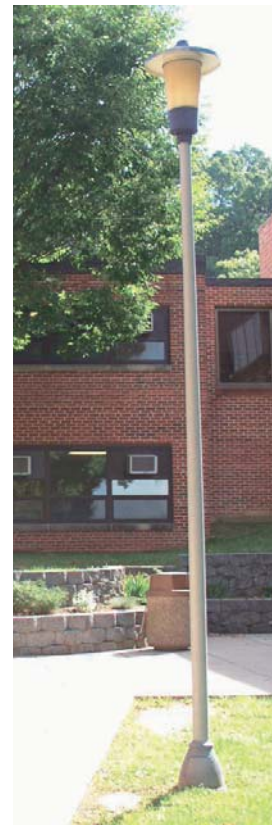
Exterior lighting across the campus is relatively uniform. Fixtures and poles appear to be in good repair and are appropriately scaled. Walkway lights are not cut-off fixtures. Lamping is high pressure sodium.

Plan for phased replacement of any antiquated, inefficient pedestrian walkway lighting. Propose the use of metal halide lamps in cut-off luminaires mounted to poles. It has been noted that at the time of this assessment the campus has recently installed a significant quantity of the non-cutoff fixture shown at the far left. An inquiry with the fixture manufacturer indicates that retrofitting the design to a cutoff standard is not presently possible. Prior to replacement of existing lights with a different style it is recommended that an attempt be made to modify the existing fixture to achieve cutoff compliance.

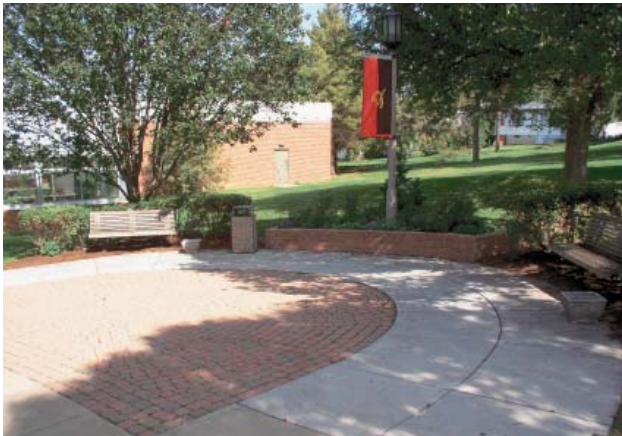
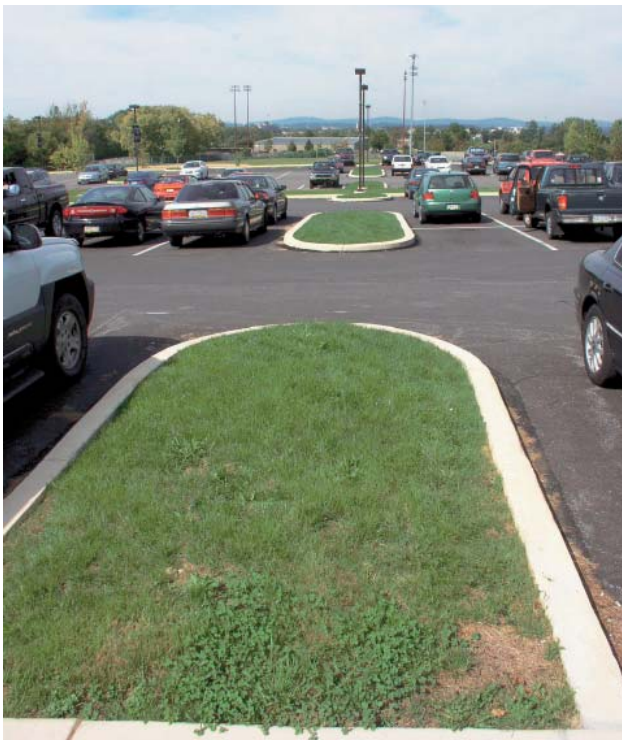
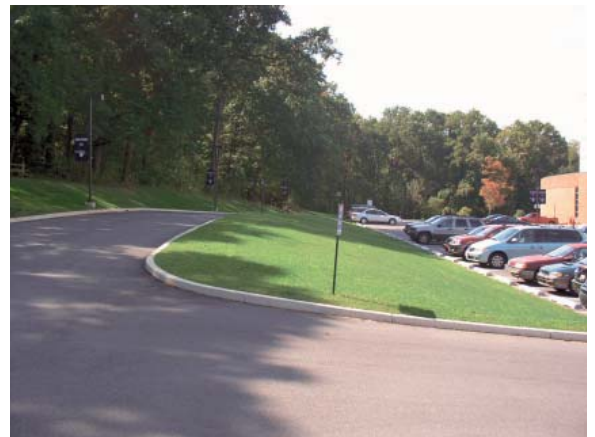
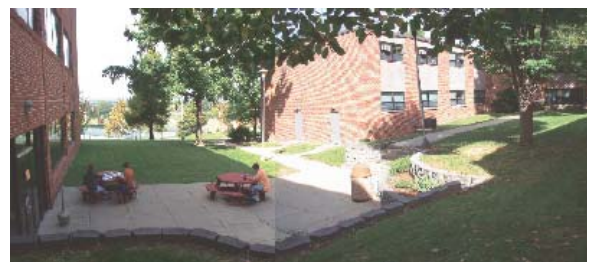
The landscape aesthetic of the campus is characterized by large expanses of turf. Ornamental plantings where present, are conservative and appropriate. Opportunities to screen objectionable views such as parking and mechanical equipment are noted. Gathering spaces are sparsely furnished. The softening benefit of landscape plantings in strategic locations is absent.

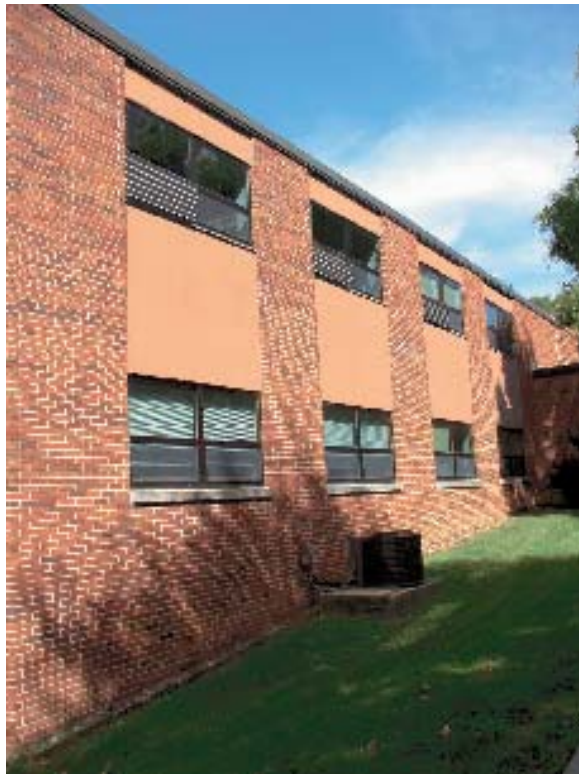
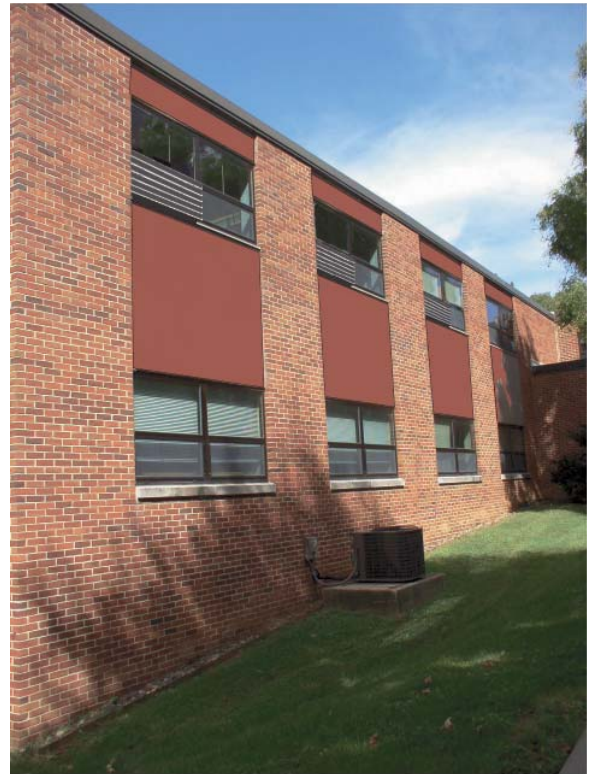
1a

Parged finished panels on Main Building are in need of repair or replacement. Inspect, repair, replace and repaint.

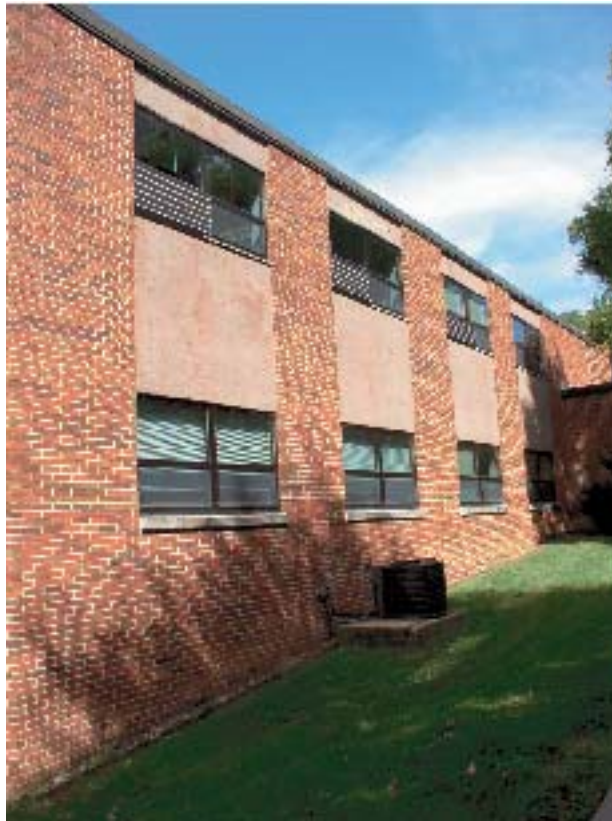
1b

Air conditioning units protruding from windows are unsightly. The marketplace offers new, efficient window units that are housed primarily on the interior of the room with a more integrated exhaust grill. Installation of this type of unit will improve the aesthetics of the building.

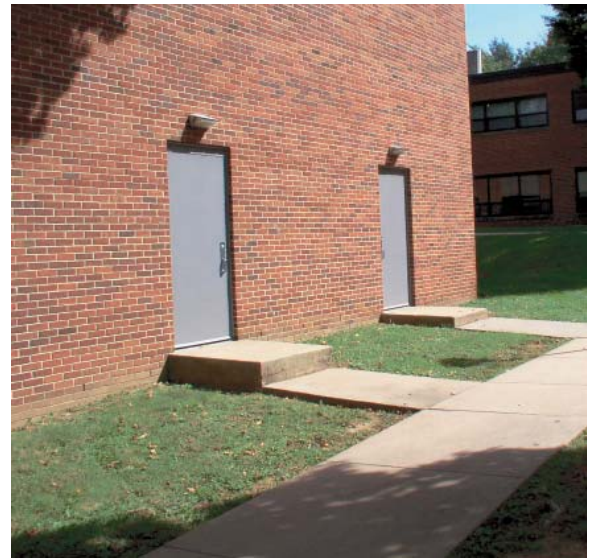
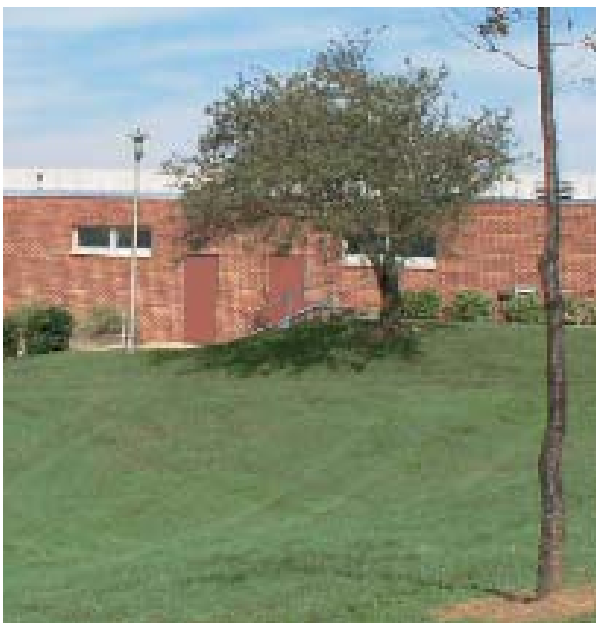
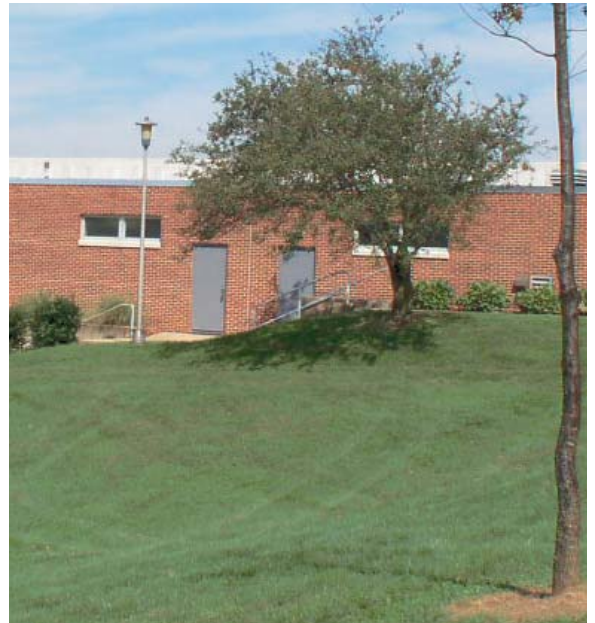
1c

Color of painted exterior doors should be consistent with other trim elements on the building.

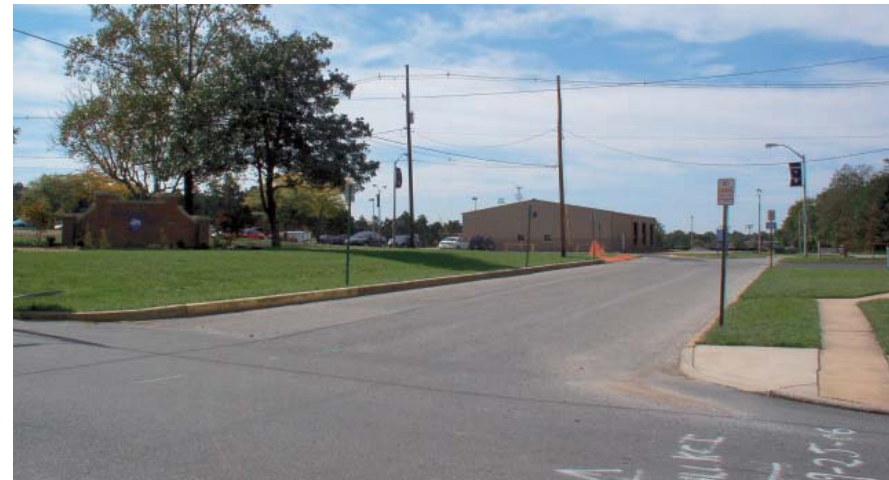
View of maintenance building along Springdale Street

The streetscape along Albemarle Street is often the first impression perspective students and visitors have of the campus. Landscape upgrades to this area are needed to enhance the aesthetics of this important campus open space.

Remove gravel, replace topsoil and re-seed temporary parking area. Install a shrub buffer screen along the parking lot perimeter. Supplement the landscape planting around the entrance sign. Supplementing the planting along Springdale Avenue will also aid in screening the view of the newly constructed maintenance building.

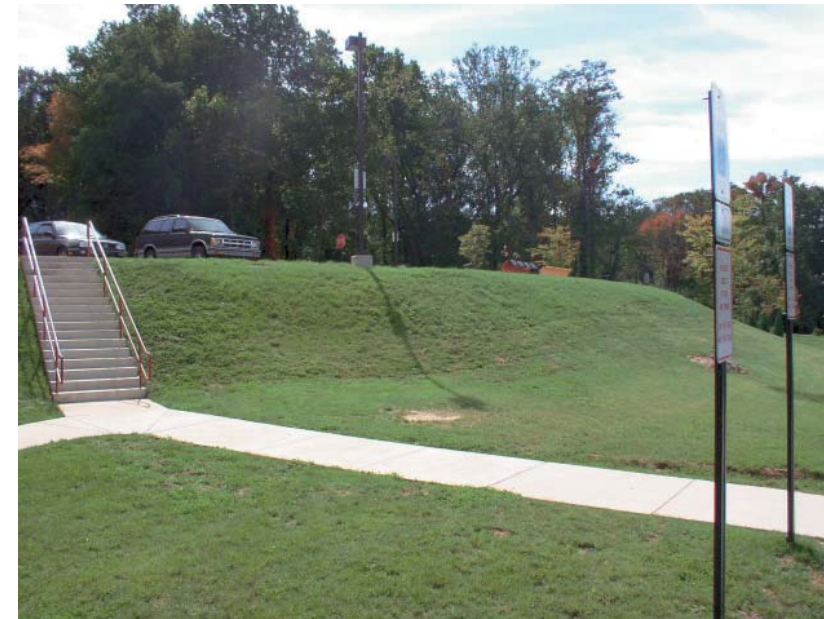
2 - Slope at service area / loading dock

The service area/loading dock area of the Pullo Center and Glatfelter Library Building is prominently visible upon entering the campus along the new entry drive. Landscape plantings needed to soften and diminish the scale of the building are absent or underplanted. Graded slopes currently planted with high maintenance turf should be replaced with trees, shrubs and groundcovers. The lower level pedestrian entrance from the parking lot is ill-defined and unremarkable.

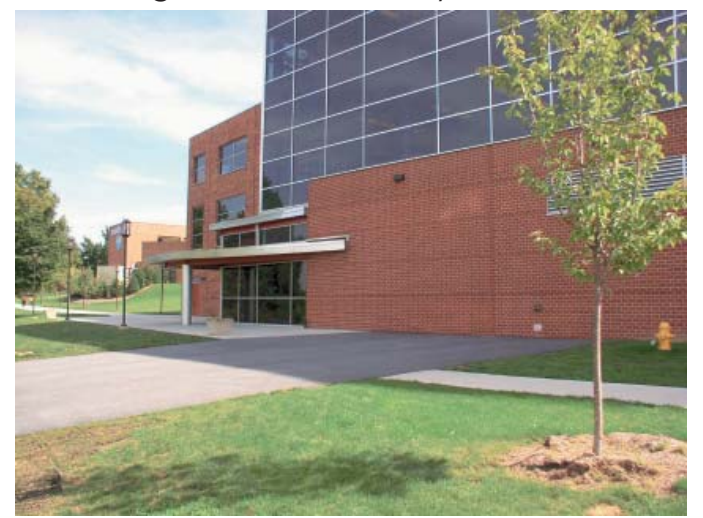
2 - Existing View of Library Entrance

The pedestrian entry experience from the Library/Auditorium parking lot is inadequate with respect to walkways and aesthetic quality. Propose the development of a drop-off/turn around and supplemental sidewalks. The new patio area should be furnished with bench seating and waste receptacles. The "soapbox derby" track is excessively wide. Propose the narrowing of the asphalt road while maintaining the required fire access to the building.
